Quality Assurance and Source Inspection

Contract #: 04-0120F4Cty: SF/ALA Rte: 80 PM: 13.2/13.9File #: 69.28**WELDING INSPECTION REPORT****Resident Engineer:** Siegenthaler, Peter**Address:** 333 Burma Road**City:** Oakland, CA 94607**Report No:** WIR-022343**Date Inspected:** 06-Mar-2011**Project Name:** SAS Superstructure**OSM Arrival Time:** 1900**Prime Contractor:** American Bridge/Fluor Enterprises, a JV**OSM Departure Time:** 700**Contractor:** Zhenhua Port Machinery Company, Ltd (ZPMC), Changxing Island **Location:** Shanghai, China**CWI Name:** See below**CWI Present:** Yes No**Inspected CWI report:** Yes No N/A**Rod Oven in Use:** Yes No N/A**Electrode to specification:** Yes No N/A**Weld Procedures Followed:** Yes No N/A**Qualified Welders:** Yes No N/A**Verified Joint Fit-up:** Yes No N/A**Approved Drawings:** Yes No N/A**Approved WPS:** Yes No N/A**Delayed / Cancelled:** Yes No N/A**Bridge No:** 34-0006**Component:** OBG**Summary of Items Observed:**

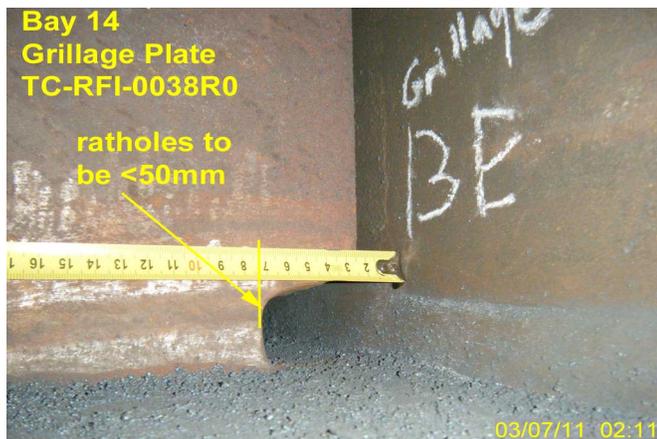
This QA Inspector performed random document review of “Team China request for information (TC-RFI)” document # TC-RFI-0038R0. This RFI addresses OBG lift 13A, add rat holes for Plate C X3789A and proposal to modify grillage plate B. This QA Inspector performed random visual inspections of the rat holes listed in the RFI and observed ZPMC appears to have completed the rat holes as referenced in the RFI. This QA Inspector took random photographs of the welds and copies of the photographs have been placed in “TC-RFI Documentation” folder located on Team China common Z drive. (see photo below)

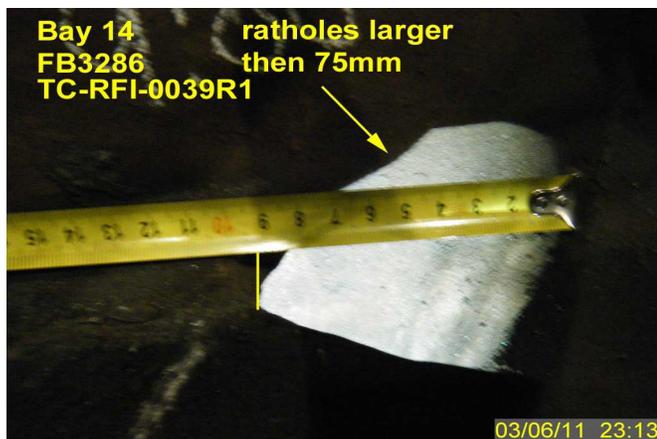
This QA Inspector performed random document review of “Team China request for information (TC-RFI)” document # TC-RFI-0039R0. This RFI addresses OBG 13AE and 13AW stiffener diaphragm plates and pier E2 stiffener plates, cope sizes. This QA Inspector performed random visual inspections of the cope holes listed in the RFI and observed ZPMC appears to have completed the cope holes as referenced in the RFI. This QA Inspector took random photographs of the welds and copies of the photographs have been placed in “TC-RFI

Documentation” folder located on Team China common Z drive. (see photo below)
