**DEPARTMENT OF TRANSPORTATION**

Contract #: 04-0120F4Cty: SF/ALA Rte: 80 PM: 13.2/13.9File #: 1.28**WELDING INSPECTION REPORT****Resident Engineer:** Siegenthaler, Peter**Address:** 333 Burma Road**City:** Oakland, CA 94607**Report No:** WIR-022375**Date Inspected:** 01-Apr-2011**Project Name:** SAS Superstructure**OSM Arrival Time:** 700**Prime Contractor:** American Bridge/Fluor Enterprises, a JV**OSM Departure Time:** 1530**Contractor:** American Bridge/Fluor Enterprises, a JV**Location:** Job Site**CWI Name:** See Report Below**CWI Present:** Yes No**Inspected CWI report:** Yes No N/A**Rod Oven in Use:** Yes No N/A**Electrode to specification:** Yes No N/A**Weld Procedures Followed:** Yes No N/A**Qualified Welders:** Yes No N/A**Verified Joint Fit-up:** Yes No N/A**Approved Drawings:** Yes No N/A**Approved WPS:** Yes No N/A**Delayed / Cancelled:** Yes No N/A**Bridge No:** 34-0006**Component:** Orthotropic Box Girders**Summary of Items Observed:**

## WELDING INSPECTION REPORT

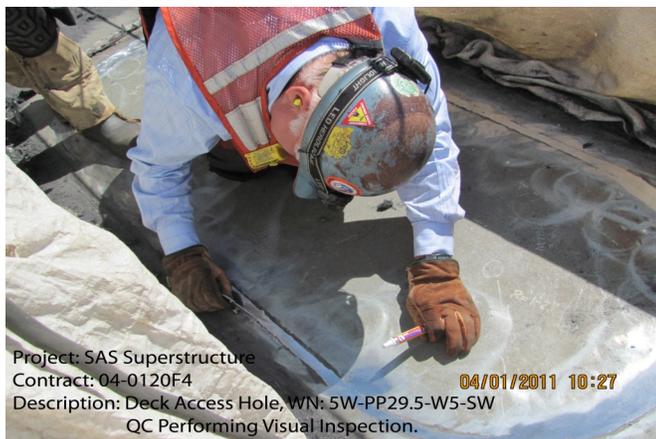
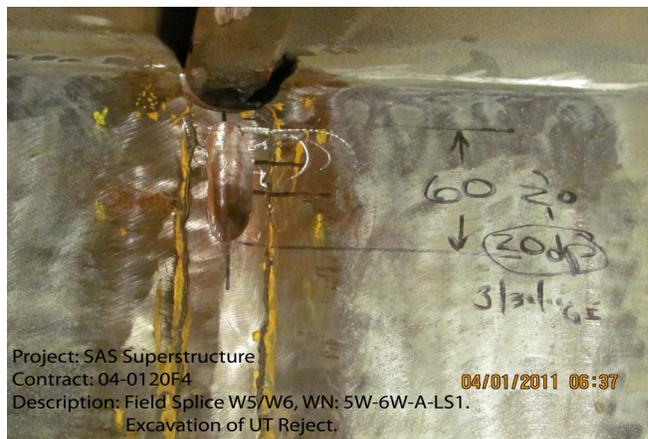
The digital photographs on page 3 of this report illustrate some of the work observed during this scheduled shift.
