DEPARTMENT OF TRANSPORTATION

Quality Assurance and Source Inspection

Contract #: 04-0120F4Cty: SF/ALA Rte: 80 PM: 13.2/13.9File #: 69.28**WELDING INSPECTION REPORT****Resident Engineer:** Siegenthaler, Peter**Address:** 333 Burma Road**City:** Oakland, CA 94607**Report No:** WIR-022385**Date Inspected:** 04-Apr-2011**Project Name:** SAS Superstructure**OSM Arrival Time:** 700**Prime Contractor:** American Bridge/Fluor Enterprises, a JV**OSM Departure Time:** 1900**Contractor:** Zhenhua Port Machinery Company, Ltd (ZPMC), Changxing Island **Location:** Shanghai, China**CWI Name:** Zhu Zhong Hai**CWI Present:** Yes No**Inspected CWI report:** Yes No N/A**Rod Oven in Use:** Yes No N/A**Electrode to specification:** Yes No N/A**Weld Procedures Followed:** Yes No N/A**Qualified Welders:** Yes No N/A**Verified Joint Fit-up:** Yes No N/A**Approved Drawings:** Yes No N/A**Approved WPS:** Yes No N/A**Delayed / Cancelled:** Yes No N/A**Bridge No:** 34-0006**Component:** OBG Segments**Summary of Items Observed:**

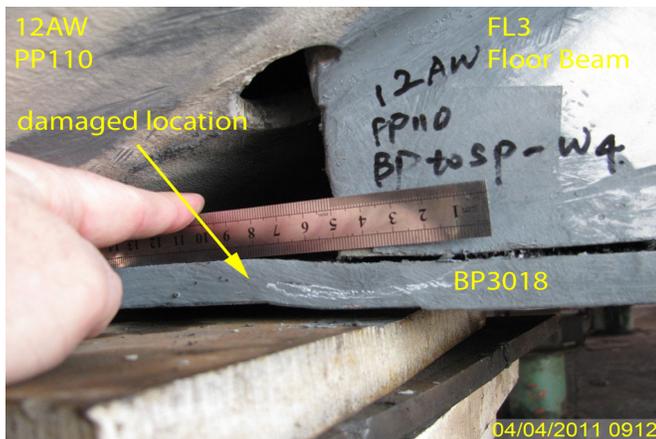
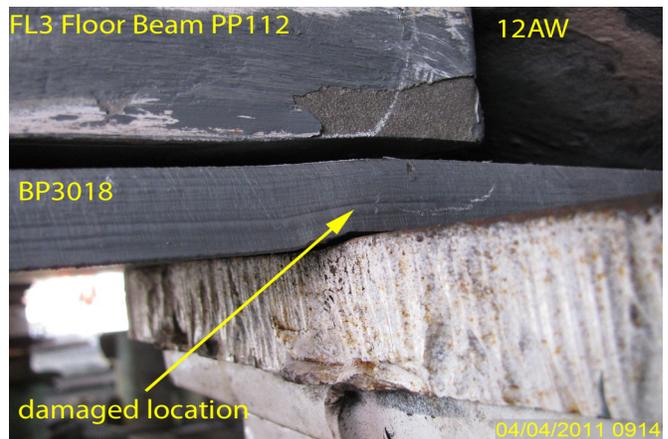
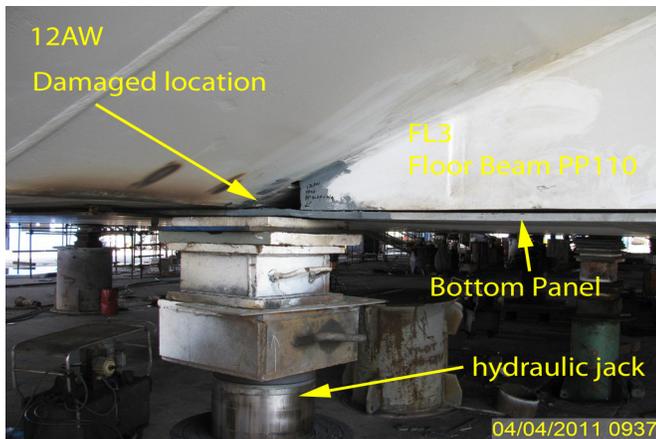
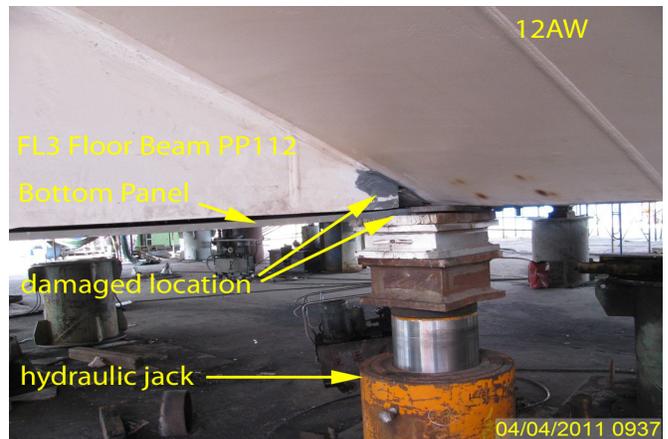
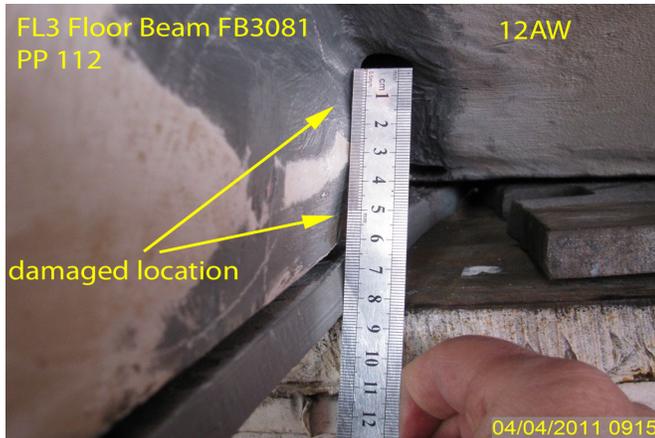
Segment 12AW

- FL3 Floor Beam web and Bottom Panel were damaged (bent) during alignment of Lift 12 West with segment 13AW using hydraulic jacks.
- Bottom Panel damaged at Panel Points 110 and 112.
- FL3 web plate damaged at Panel Point 112
- FL3 Floor Beam is identified as: FB3081, web plate # X3183G and is 22mm in thickness
- Bottom Panel is identified as: BP3018, plate # X3161A and is 16mm in thickness
- The material is identified as Seismic Performance Critical Member (SPCM).
- The Segment is located in OBG Trial Assembly yard.

An Incident Report was written for this issue.
