DEPARTMENT OF TRANSPORTATION

Contract #: 04-0120F4Cty: SF/ALA Rte: 80 PM: 13.2/13.9File #: 69.28**WELDING INSPECTION REPORT****Resident Engineer:** Siegenthaler, Peter**Address:** 333 Burma Road**City:** Oakland, CA 94607**Report No:** WIR-022396**Date Inspected:** 05-Apr-2011**Project Name:** SAS Superstructure**OSM Arrival Time:** 1500**Prime Contractor:** American Bridge/Fluor Enterprises, a JV**OSM Departure Time:** 300**Contractor:** Zhenhua Port Machinery Company, Ltd (ZPMC), Changxing Island **Location:** Shanghai, China**CWI Name:** See Below**CWI Present:** Yes No**Inspected CWI report:** Yes No N/A**Rod Oven in Use:** Yes No N/A**Electrode to specification:** Yes No N/A**Weld Procedures Followed:** Yes No N/A**Qualified Welders:** Yes No N/A**Verified Joint Fit-up:** Yes No N/A**Approved Drawings:** Yes No N/A**Approved WPS:** Yes No N/A**Delayed / Cancelled:** Yes No N/A**Bridge No:** 34-0006**Component:** OBG**Summary of Items Observed:**

WELDING INSPECTION REPORT

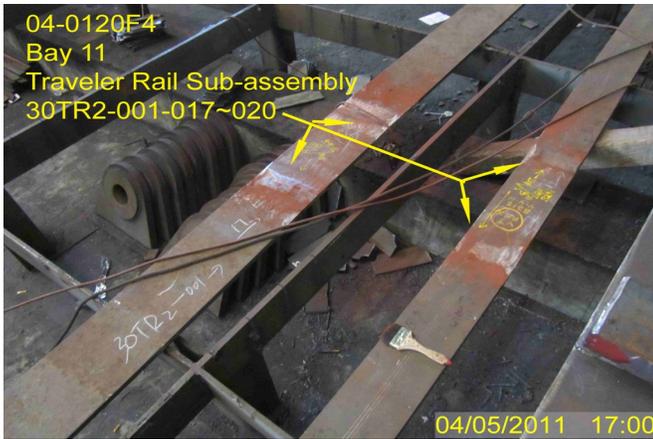
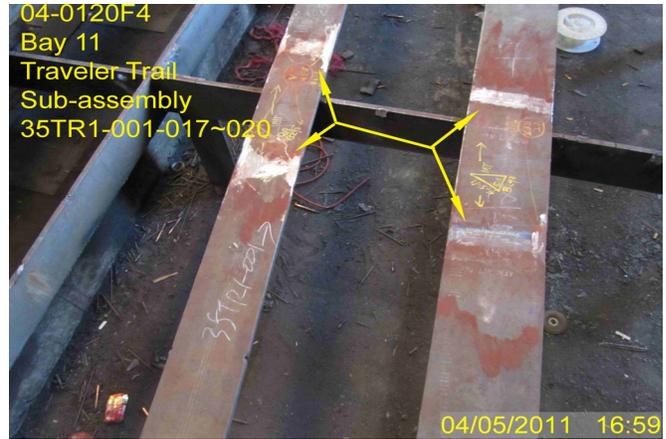
At the time of the verification it was noted that the above component appeared to be within compliance of the contract documents. See Caltrans Magnetic Particle Test Report (TL6028), dated 04-05-2011 for additional information.

The following digital pictures illustrate MT inspected subassemblies.
