**DEPARTMENT OF TRANSPORTATION**

Quality Assurance and Source Inspection

Contract #: 04-0120F4Cty: SF/ALA Rte: 80 PM: 13.2/13.9File #: 82.28**WELDING INSPECTION REPORT****Resident Engineer:** Siegenthaler, Peter**Address:** 333 Burma Road**City:** Oakland, CA 94607**Report No:** WIR-022404**Date Inspected:** 18-Mar-2011**Project Name:** SAS Superstructure**OSM Arrival Time:** 700**Prime Contractor:** American Bridge/Fluor Enterprises, a JV**OSM Departure Time:** 1530**Contractor:** Westmont Industries**Location:** Santa Fe Springs, CA.**CWI Name:** Ruben Dominguez**CWI Present:** Yes No**Inspected CWI report:** Yes No N/A**Rod Oven in Use:** Yes No N/A**Electrode to specification:** Yes No N/A**Weld Procedures Followed:** Yes No N/A**Qualified Welders:** Yes No N/A**Verified Joint Fit-up:** Yes No N/A**Approved Drawings:** Yes No N/A**Approved WPS:** Yes No N/A**Delayed / Cancelled:** Yes No N/A**Bridge No:** 34-0006**Component:** Travelers**Summary of Items Observed:**

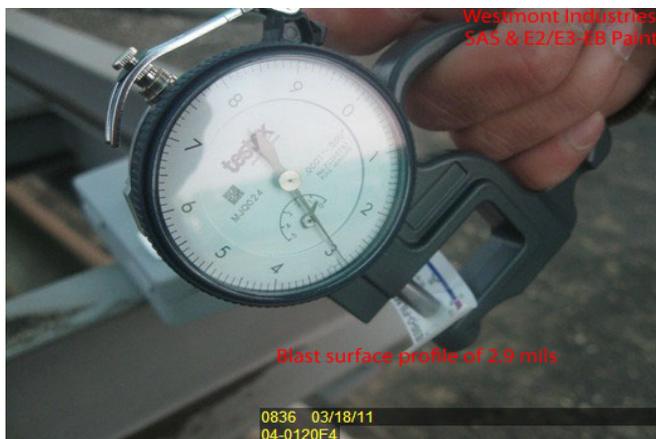
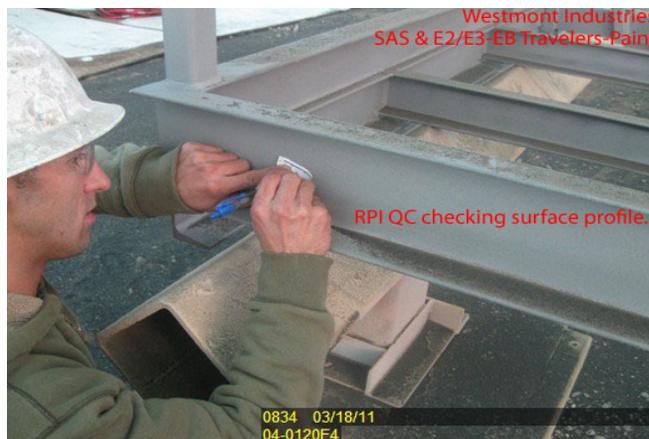
This QA Inspector then performed random visual testing on the above mentioned assemblies. During testing, this QA Inspector utilized white chalk to mark up minor areas of base metal mill scale which appeared to have been missed during sandblasting. This QA Inspector marked up minor areas of the base metal at or nearby completed welds, which appeared to be weld spatter deposited during the previous welding activities. Additionally, this QA Inspector marked up minor areas of sharp edges, which appeared to have not been broken. After marking up the areas, this QA Inspector informed RPI Representative Mr. Carlos Torres of the areas marked and Mr. Torres explained that once the weld spatter was removed and the edges broken, that a sweep blast will be performed on all of the marked areas. This QA Inspector then informed shop superintendent Mr. George Grayum of the minor weld spatter and edges. Mr. Grayum explained that a shop helper will be instructed to fix the areas. Later, this QA Inspector was informed by Mr. Torres that the sweep blast was complete. This QA Inspector then performed visual testing on the areas which were marked and the testing appeared to be in compliance with SSPC-10. This QA Inspector then observed RPI Coating Quality Control Representative Mr. Andrew Gonzales performing what appeared to be random surface profile checks on the blasted base metal surfaces. This QA Inspector observed Mr. Gonzales utilizing what appeared to be Testex Press-O-Film and a micrometer to perform the testing. Initially, this QA Inspector observed Mr. Gonzales applying the film to the blasted surface then utilize one end of a pen to perform rubbing activities on the clear portion of the test strip. This QA Inspector then observed Mr. Gonzales utilize a micrometer to measure the surface profile on the clear film part of the strip in which the rubbing was performed. Mr. Gonzales explained to this QA Inspector that the initial setting on the micrometer was set at 2mils over, due to the thickness of the Press-O-Film paper. During observation, this QA Inspector observed that the readings appeared to be 2.9mils, 2.9mils, 3.0mils, 3.0mils and 3.0mils. This QA Inspector observed that all of the random readings appeared to be within a range of 2.8mils - 3.1mils. This QA Inspector noted that the contract requires a surface profile of 1.57mils (40um) - 3.15mils (80um) and the above mentioned tested profile, appears to be in compliance with the contract requirements. After surface profile testing, this QA Inspector then observed Mr. Torres perform a test for soluble salts on the previously blasted base metal areas. This QA Inspector observed the testing being performed at random areas which appeared to meet or exceed one test per 200 square meters, per the contract requirements. After testing, this QA Inspector observed that the soluble salt content appeared to be 0

Parts Per Million (PPM). This QA Inspector was then informed by Mr. Torres that primer application will soon start. Later, this QA Inspector observed RPI Coating performing what appeared to be primer application activities, within what appeared to be an 8 hr. time frame from the above mentioned sweep blasting activities.

This QA Inspector observed that the activities mentioned above, appeared to be in compliance with the contract requirements and this QA Inspector observed no non-conforming issues, on this date.
