Contract #: 04-0120F4Cty: SF/ALA Rte: 80 PM: 13.2/13.9File #: 1.28**WELDING INSPECTION REPORT****Resident Engineer:** Siegenthaler, Peter**Address:** 333 Burma Road**City:** Oakland, CA 94607**Report No:** WIR-022411**Date Inspected:** 04-Apr-2011**Project Name:** SAS Superstructure**OSM Arrival Time:** 700**Prime Contractor:** American Bridge/Fluor Enterprises, a JV**OSM Departure Time:** 1530**Contractor:** American Bridge/Fluor Enterprises, a JV**Location:** Job Site**CWI Name:** See Report Below**CWI Present:** Yes No**Inspected CWI report:** Yes No N/A**Rod Oven in Use:** Yes No N/A**Electrode to specification:** Yes No N/A**Weld Procedures Followed:** Yes No N/A**Qualified Welders:** Yes No N/A**Verified Joint Fit-up:** Yes No N/A**Approved Drawings:** Yes No N/A**Approved WPS:** Yes No N/A**Delayed / Cancelled:** Yes No N/A**Bridge No:** 34-0006**Component:** Orthotropic Box Girders**Summary of Items Observed:**

WELDING INSPECTION REPORT

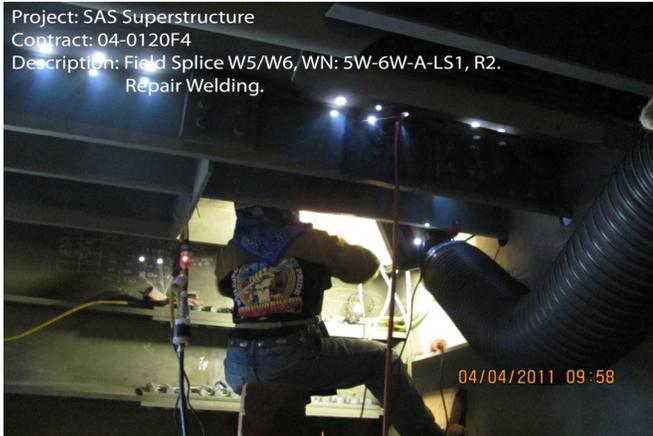
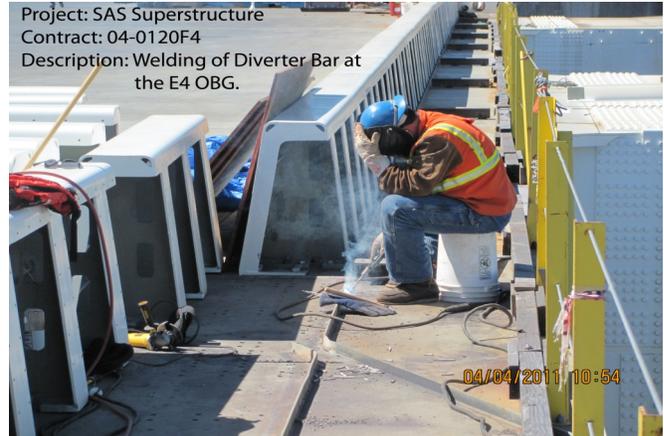
The digital photographs on page 3 of this report illustrate some of the work observed during this scheduled shift.
