DEPARTMENT OF TRANSPORTATION

Contract #: 04-0120F4Cty: SF/ALA Rte: 80 PM: 13.2/13.9File #: 69.28**WELDING INSPECTION REPORT****Resident Engineer:** Siegenthaler, Peter**Address:** 333 Burma Road**City:** Oakland, CA 94607**Report No:** WIR-022482**Date Inspected:** 09-Apr-2011**Project Name:** SAS Superstructure**OSM Arrival Time:** 700**Prime Contractor:** American Bridge/Fluor Enterprises, a JV**OSM Departure Time:** 1900**Contractor:** Zhenhua Port Machinery Company, Ltd (ZPMC), Changxing Island **Location:** Shanghai, China**CWI Name:** An Qing Xiang**CWI Present:** Yes No**Inspected CWI report:** Yes No N/A**Rod Oven in Use:** Yes No N/A**Electrode to specification:** Yes No N/A**Weld Procedures Followed:** Yes No N/A**Qualified Welders:** Yes No N/A**Verified Joint Fit-up:** Yes No N/A**Approved Drawings:** Yes No N/A**Approved WPS:** Yes No N/A**Delayed / Cancelled:** Yes No N/A**Bridge No:** 34-0006**Component:** OBG**Summary of Items Observed:**

Bay 14

OBG Seg 14W:

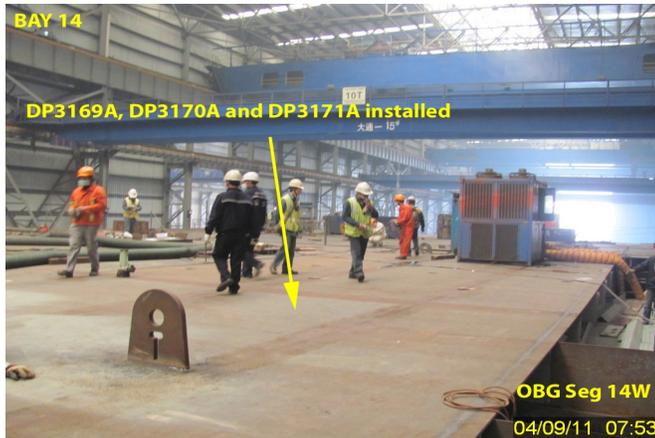
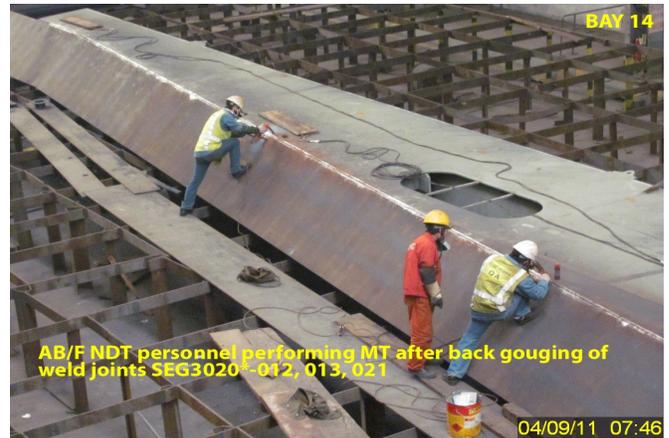
During random in process visual inspection this QA Inspector observed that AB/F NDT personnel were performing Magnetic Particle Testing (MT) after back gouging of the weld joints SEG3020*-012, 013 and 021 joining DP3168A and DP3184A to Edge Plate EP3029A. The weld designations are identified as follows.

During random in process visual inspection this QA Inspector observed the deck panels DP3169A, DP3170A and DP3171A was installed towards north side of segment 14W in between PP125 to PP128.3 by ZPMC. Attached photograph provide additional details.
