DEPARTMENT OF TRANSPORTATION

Contract #: 04-0120F4Cty: SF/ALA Rte: 80 PM: 13.2/13.9File #: 1.28**WELDING INSPECTION REPORT****Resident Engineer:** Siegenthaler, Peter**Address:** 333 Burma Road**City:** Oakland, CA 94607**Report No:** WIR-022501**Date Inspected:** 12-Apr-2011**Project Name:** SAS Superstructure**OSM Arrival Time:** 700**Prime Contractor:** American Bridge/Fluor Enterprises, a JV**OSM Departure Time:** 1530**Contractor:** American Bridge/Fluor Enterprises, a JV**Location:** Job Site

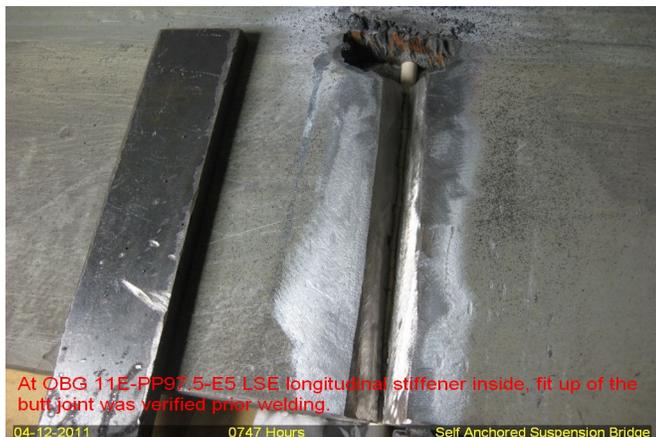
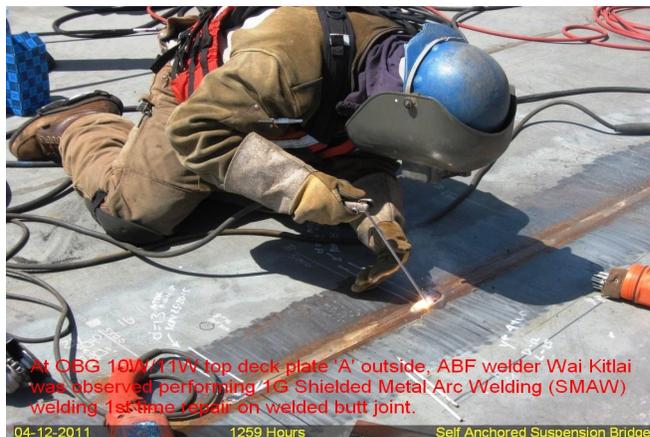
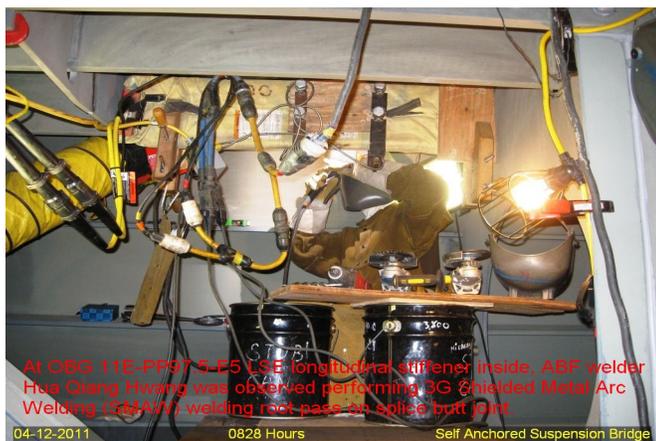
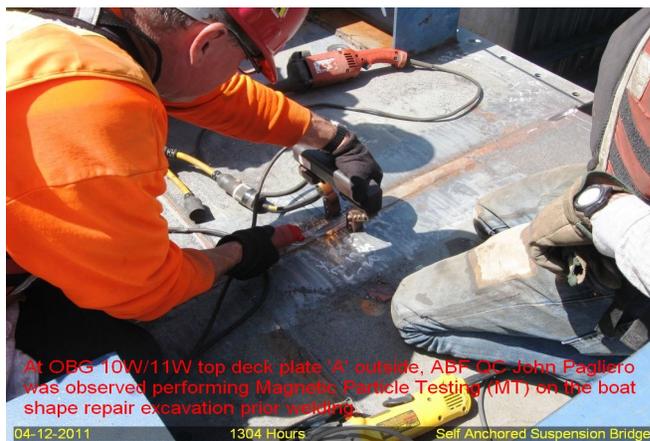
At OBG 11E-PP97.5-E5 LSE longitudinal stiffener inside, QA randomly observed ABF welder Hua Qiang Hwang perform 3G (vertical) Shielded Metal Arc Welding (SMAW) complete joint penetration (CJP) welding root pass to cover pass on the one side of the stiffener splice butt joint. The stiffener plates being welded are made of high strength plate material HPS 485W and has a thickness of 30mm. The joint has a double V joint preparation that was welded from one side and after the completion from one side, to be back gouged; Non Destructive Testing (NDT) tested using Magnetic Particle Testing (MT) and back welded to the other side. The welder was noted using E9018H4R with 1/8" diameter electrode implementing Caltrans approved welding procedure specification (WPS) ABF-WPS-D1.5-1012-3. The joint being welded was root welded using a ceramic backing. The splice joint was preheated to greater than 200 degrees Fahrenheit using Miller Proheat 35 Induction Heating System heater blanket located at the opposite side of the plate prior/during welding. The QA Inspector noted the ABF QC Fred Von Hoff was on site monitoring the in process preheats and welding parameters. During the shift, QA noted ABF QC Fred Von Hoff was closely monitoring the issuance of E9018H4R electrodes due to its limited exposure time allowed. During the shift, cover pass welding on both sides of the stiffener was completed and the welder was instructed by QC to hold and maintain the preheat of 200°F for three more hours after welding as required. This access hole location was originally intended to be an access hole but to be relocated (for unknown reason) after the two longitudinal stiffeners (LSW & LSE) have already been cut. The two cut longitudinal stiffener weld locations are being welded to restore the plate.

At OBG 10E/11E side plate 'C1' inside, QA randomly observed ABF/JV qualified welder Sungtao, Huang ID # 3794 perform CJP groove (splice) welding root pass on the splice butt joint. The welder was observed perform manual welding in the 3G (vertical) position utilizing a dual shield Flux Cored Arc Welding (FCAW-G) with E71T-1M, 1/16" diameter wire electrode and implementing Caltrans approved Welding Procedure Specification (WPS) ABF-WPS-D15-3042B-1. The joint being welded has a single V-groove butt joint with backing bar. The plate being welded was preheated to >150 °F using propane gas torch prior welding. During welding, ABF Quality Control (QC) William Sherwood was noted monitoring the welding parameters of the welder. At the end of the shift, root pass welding at location mentioned above was completed and fill pass welding will continue tomorrow.

At OBG 10W/11W side plate 'C2' (4577mm to 5277mm) inside, QA randomly observed ABF/JV qualified welder Fred Kaddu perform root pass to fill pass welding on the Complete Joint Penetration (CJP) splice butt joint where the track mounted Bug-o FCAW welder nozzle holder has limited access. The welder was observed manually welding in the 3G (vertical) position utilizing a Shielded Metal Arc Welding (SMAW) with 1/8" diameter E7018H4R electrode and implementing Caltrans approved Welding Procedure Specification (WPS) ABF-WPS-D15-1040B. The joint being welded has a single V-groove butt joint with steel backing bar. During welding, ABF Quality Control (QC) William Sherwood was noted monitoring the welding parameters of the welder. Prior welding, QA randomly verified the fit up where the welder would be welding and noted a root gap of 5mm and alignment of 2mm which appears in conformance to the contract requirements. During the shift, fill pass SMAW welding was still continuing and should remain tomorrow.

At OBG 10W/11W top deck plate 'A' outside, QA randomly observed ABF/JV qualified welder Wai Kitlai perform CJP repair welding. The welder was noted welding in 1G (flat) position utilizing SMAW with 1/8" diameter E7018H4R electrode implementing new Caltrans approved Welding Procedure Specification (WPS) ABF-WPS-D15-1003 Repair. The new repair procedure includes putting in place a copper backing alongside the typical steel backing bar when the repair excavation is expected to occur at the edge of the steel backing. The first time welding repairs were excavated to a boat shape profile and were tested with Magnetic Particle Testing (MT) prior welding. During welding, ABF QC John Pagliero was noted monitoring the welder and his welding parameters. QA noted parameter during welding was 140 amperes which appears in compliance to the WPS. The locations of the repairs were noted below;
