DEPARTMENT OF TRANSPORTATION

Contract #: 04-0120F4Cty: SF/ALA Rte: 80 PM: 13.2/13.9File #: 1.28**WELDING INSPECTION REPORT****Resident Engineer:** Siegenthaler, Peter**Address:** 333 Burma Road**City:** Oakland, CA 94607**Report No:** WIR-022537**Date Inspected:** 13-Apr-2011**Project Name:** SAS Superstructure**OSM Arrival Time:** 700**Prime Contractor:** American Bridge/Fluor Enterprises, a JV**OSM Departure Time:** 1530**Contractor:** American Bridge/Fluor Enterprises, a JV**Location:** Jobsite**CWI Name:** Gary Ehram**CWI Present:** Yes No**Inspected CWI report:** Yes No N/A**Rod Oven in Use:** Yes No N/A**Electrode to specification:** Yes No N/A**Weld Procedures Followed:** Yes No N/A**Qualified Welders:** Yes No N/A**Verified Joint Fit-up:** Yes No N/A**Approved Drawings:** Yes No N/A**Approved WPS:** Yes No N/A**Delayed / Cancelled:** Yes No N/A**Bridge No:** 34-0006**Component:** SAS OBG**Summary of Items Observed:**

1. Access Plate Longitudinal Stiffener Field Splice @ 8W PP70.5 W5
2. Lifting Lug Hole #2 @ 7W PP55 W3

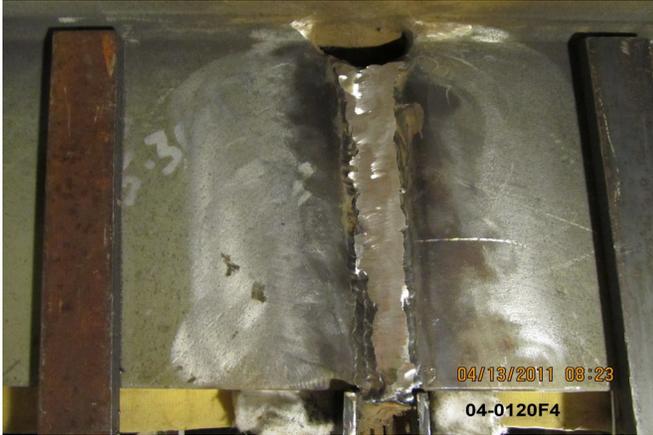
1. Longitudinal Stiffener Field Splice 8W PP70.5 W5

The QA Inspector observed that the ABF welder Jin Pei Wang had completed welding the west end face B of the Longitudinal Stiffener (LS) on the access plate located at PP70.5. The QA Inspector randomly performed a Visual Inspection of the ground and blended weld surface and it appeared to be acceptable. The QA observed the welder begin to install the induction heating blankets on face A of the east end of the LS to ensure the minimum required preheat for grade 485W HPS steel was achieved prior to welding. The QA Inspector randomly verified utilizing a 200°F temperature indicating marker and noted the minimum required preheat had been achieved. The QA Inspector noted that the root gap varied in width from 7mm-10mm throughout the length of the root gap. The QA Inspector observed the QC Inspector identified as Gary Ehram performed a Visual Inspection of the completed weld and found it to be acceptable. It was noted by the QA Inspector that the QC annotated dimensions of the root gap adjacent the joint for the welder to repair. The QA Inspector periodically observed the welder repairing the joint. It was noted by the QA Inspector the ABF welder did not complete the repairs on the QA Inspectors shift.

There was conversation with the QC Gary Ehram pertaining to the excessive root gap on the LS, to which the QC generally stated; "I do not like it and I marked the dimensions next to the joint for the welder to repair".

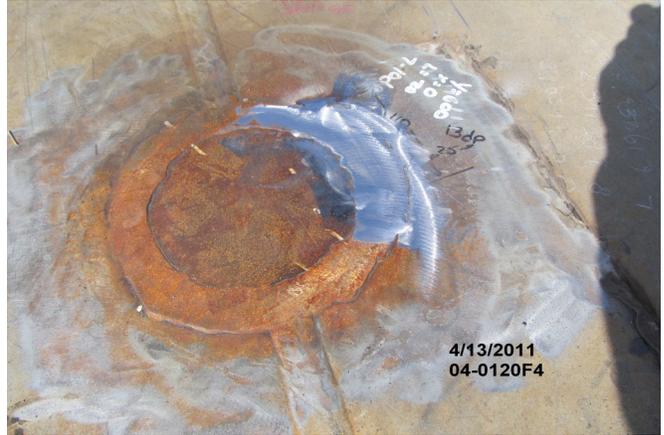
2. Lifting Lug Hole #3 7W PP55 W3

The QA Inspector observed the ABF Welder Darcell Jackson had completed the repair of the UT Indications at y=610mm. The QA Inspector recorded the measurements of the excavation to be 13mm's deep 140mm's long and 25mm's wide. The QA Inspector noted the measured ground flush condition to be +.5mm.
