**DEPARTMENT OF TRANSPORTATION**

Contract #: 04-0120F4Cty: SF/ALA Rte: 80 PM: 13.2/13.9File #: 1.28**WELDING INSPECTION REPORT****Resident Engineer:** Siegenthaler, Peter**Address:** 333 Burma Road**City:** Oakland, CA 94607**Report No:** WIR-022541**Date Inspected:** 15-Apr-2011**Project Name:** SAS Superstructure**OSM Arrival Time:** 700**Prime Contractor:** American Bridge/Fluor Enterprises, a JV**OSM Departure Time:** 1530**Contractor:** American Bridge/Fluor Enterprises, a JV**Location:** Job Site**CWI Name:** See Report Below**CWI Present:** Yes No**Inspected CWI report:** Yes No N/A**Rod Oven in Use:** Yes No N/A**Electrode to specification:** Yes No N/A**Weld Procedures Followed:** Yes No N/A**Qualified Welders:** Yes No N/A**Verified Joint Fit-up:** Yes No N/A**Approved Drawings:** Yes No N/A**Approved WPS:** Yes No N/A**Delayed / Cancelled:** Yes No N/A**Bridge No:** 34-0006**Component:** Orthotropic Box Girders**Summary of Items Observed:**

# WELDING INSPECTION REPORT

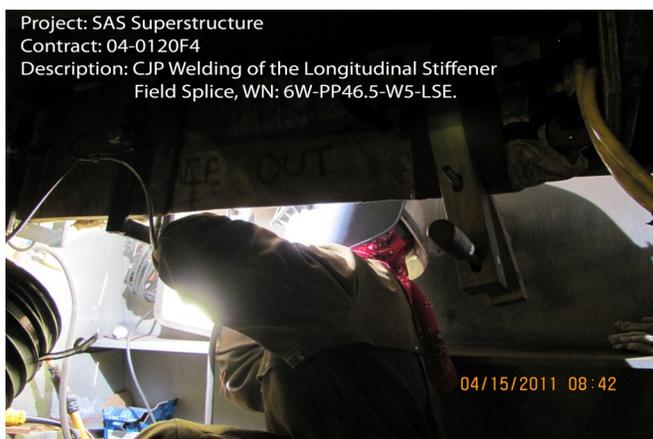
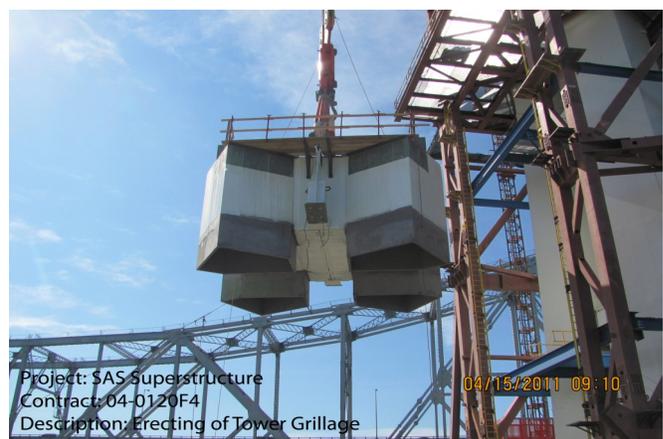
The QAI also observed the CJP welding of the longitudinal stiffener located at the deck access hole identified as WN: 6W-PP46.5-W5-LSW. The welding was performed by Xiao Jian Wan ID-9677 utilizing the WPS identified as ABF-WPS-D15-1012-3, Rev. 0. The welding parameters were verified by the QC inspector Gary Ehram and appeared to comply with the contract specifications. The CJP welding was not completed during this shift.

At Panel Point 108 at E11, located along E5, the "A" deck longitudinal stiffener was flame cut to accommodate a deck access hole. The layout and the cutting of the stiffeners was performed in error. See Summary of Conversations for additional information.

The digital photographs below illustrate some of the work observed during this scheduled shift.

In a conversation with Lead Inspector, Bonifacio Daquinag, Jr., this QAI inquired the issue of the layout and cutting of the "A" deck longitudinal stiffeners in error. Mr. Daquinag informed this QAI that this issue has been reported and forwarded to William Norris, Document Control personnel, for resolution by way of generating an NCR or a Request for Information (RFI). The document also addresses the hole restoration of three (3) pilot holes drilled in the deck which were utilized as a reference to transfer the layout to the stiffeners from the deck.
