**DEPARTMENT OF TRANSPORTATION**

Contract #: 04-0120F4Cty: SF/ALA Rte: 80 PM: 13.2/13.9File #: 1.28**WELDING INSPECTION REPORT****Resident Engineer:** Siegenthaler, Peter**Address:** 333 Burma Road**City:** Oakland, CA 94607**Report No:** WIR-022543**Date Inspected:** 15-Apr-2011**Project Name:** SAS Superstructure**OSM Arrival Time:** 700**Prime Contractor:** American Bridge/Fluor Enterprises, a JV**OSM Departure Time:** 1530**Contractor:** American Bridge/Fluor Enterprises, a JV**Location:** Job Site

## WELDING INSPECTION REPORT

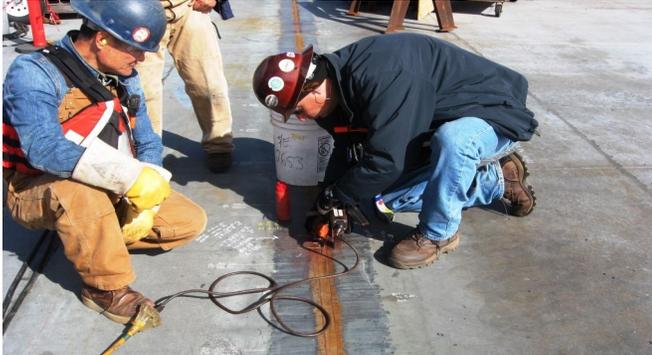
04-15-2011 0935 Hours Self Anchored Suspension Bridge

At OBG 10W/11W top deck plate 'A' outside, ABF QC William Sherwood was observed performing Magnetic Particle Testing (MT) on the 2nd time repair excavation prior welding.

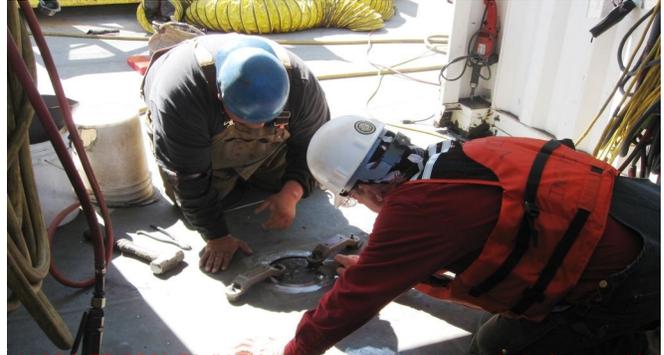
04-15-2011 1110 Hours Self Anchored Suspension Bridge

At OBG 7E-PP53-E3-#4 lifting lug access hole to top deck plate outside, ABF QC Fred Von Hoff was noted inspecting the fit up alignment of the infill plate to the top deck plate.

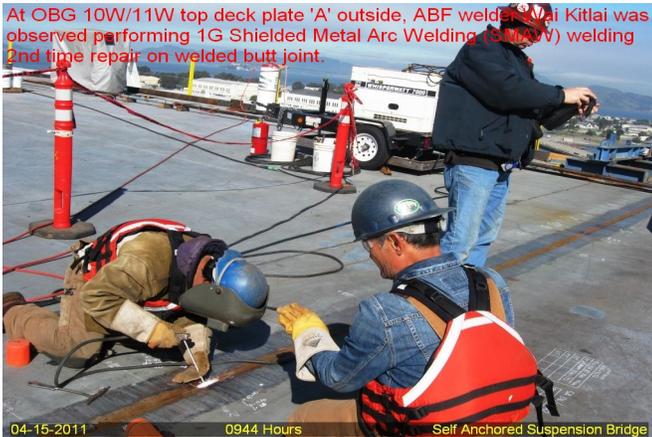
04-15-2011 0944 Hours Self Anchored Suspension Bridge

At OBG 10W/11W top deck plate 'A' outside, QA randomly observed ABF/JV qualified welder Wai Kitlai perform CJP repair welding. The welder was noted welding in 1G (flat) position utilizing SMAW with 1/8" diameter E7018H4R electrode implementing new Caltrans approved Welding Procedure Specification (WPS) ABF-WPS-D15-1003 Repair. The new repair procedure includes putting in place a copper backing alongside the typical steel backing bar when the repair excavation is expected to occur at the edge of the steel backing. The second time welding repairs were excavated to a boat shape profile and were tested with Magnetic Particle Testing (MT) prior welding. During welding, ABF QC William Sherwood was noted monitoring the welder and his welding parameters. QA noted parameter during welding was 138 amperes which appears in compliance to the WPS. The locations of the repairs were noted below;

Location	Y-dimension	Length	Width	Depth	Remarks
1. A2	4290mm	100mm	20mm	14mm	Completed (R2)
2. A5	5090mm	100mm	21mm	21mm	Completed (R2)

At OBG 10W/11W top deck plate 'A' outside, ABF welder Wai Kitlai was observed performing 1G Shielded Metal Arc Welding (SMAW) welding 2nd time repair on welded butt joint.

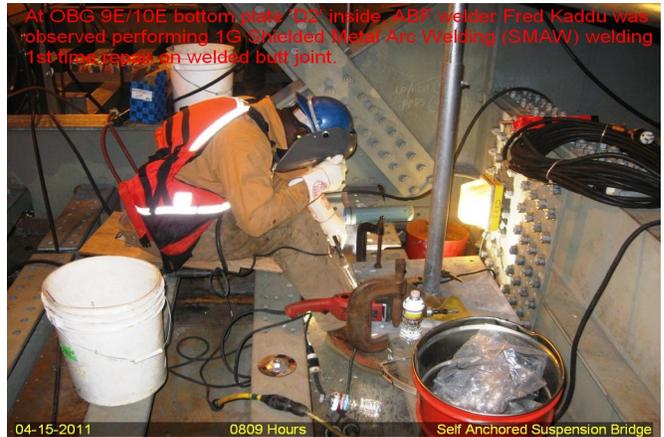
04-15-2011 0809 Hours Self Anchored Suspension Bridge

At OBG 9E/10E bottom plate 'D2' inside, QA randomly observed ABF/JV qualified welder Fred Kaddu ID # 2188 perform CJP groove welding repair. The welder was observed welding in the 1G (flat) position utilizing Shielded Metal Arc Welding (SMAW) with 5/32" diameter E7018H4R electrode implementing welding procedure ABF-WPS-D15-1001-Repairs. The repair excavation located at Y=3330mm and was having excavation profile of 110mm long x 22mm wide x 18mm deep was preheated to more than 140 degree Fahrenheit using propane gas torch prior welding. During the shift, ABF QC William Sherwood was noted monitoring the welder. Prior welding, ABF QC William Sherwood was also observed performing Magnetic Particle Testing (MT) on the boat shape repair excavation.

At OBG 9E/10E bottom plate 'D' inside, ABF welder Fred Kaddu was observed performing 1G Shielded Metal Arc Welding (SMAW) welding 1st time repair on welded butt joint.
