DEPARTMENT OF TRANSPORTATION

Contract #: 04-0120F4Cty: SF/ALA Rte: 80 PM: 13.2/13.9File #: 99.28**WELDING INSPECTION REPORT****Resident Engineer:** Siegenthaler, Peter**Address:** 333 Burma Road**City:** Oakland, CA 94607**Report No:** WIR-022594**Date Inspected:** 16-Apr-2011**Project Name:** SAS Superstructure**OSM Arrival Time:** 700**Prime Contractor:** American Bridge/Fluor Enterprises, a JV**OSM Departure Time:** 1900**Contractor:** Zhenhua Port Machinery Company, Ltd (ZPMC) Chanxing Island**Location:** Shanghai, China**CWI Name:** Mr. Liu Hua Jie**CWI Present:** Yes No**Inspected CWI report:** Yes No N/A**Rod Oven in Use:** Yes No N/A**Electrode to specification:** Yes No N/A**Weld Procedures Followed:** Yes No N/A**Qualified Welders:** Yes No N/A**Verified Joint Fit-up:** Yes No N/A**Approved Drawings:** Yes No N/A**Approved WPS:** Yes No N/A**Delayed / Cancelled:** Yes No N/A**Bridge No:** 34-0006**Component:** OBG Segment**Summary of Items Observed:**

WELDING INSPECTION REPORT

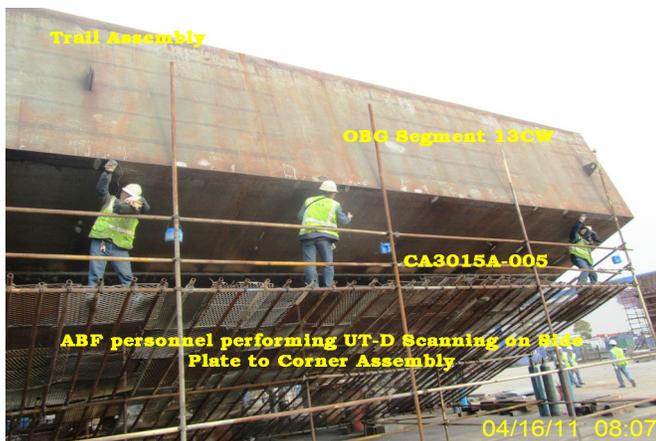
This QA inspector observed ABF personnel performed Ultrasonic Testing (UT) 'D' Scanning on Side Plate to Corner Assembly of OBG Segment 13CW. The weld number is identified as CA3015A-005. See the attached picture.

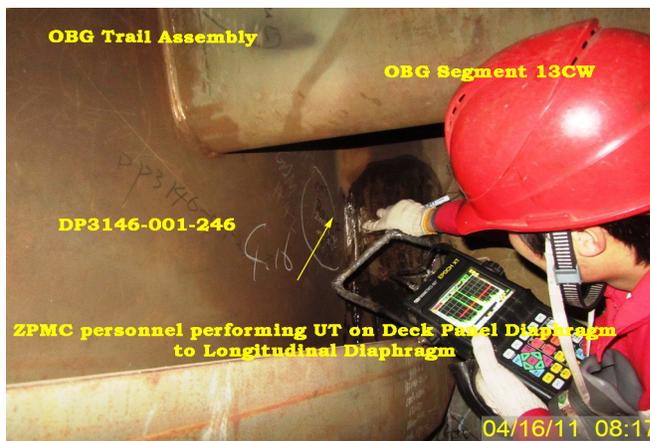
This QA inspector observed ZPMC personnel performed Ultrasonic Testing (UT) on Deck Panel Diaphragm to Longitudinal Diaphragm of OBG Segment 13CW. The weld number is identified as DP3146-001-246. See the attached picture.
