DEPARTMENT OF TRANSPORTATION

Contract #: 04-0120F4Cty: SF/ALA Rte: 80 PM: 13.2/13.9File #: 99.28**WELDING INSPECTION REPORT****Resident Engineer:** Siegenthaler, Peter**Address:** 333 Burma Road**City:** Oakland, CA 94607**Report No:** WIR-022606**Date Inspected:** 02-Apr-2011**Project Name:** SAS Superstructure**OSM Arrival Time:** 700**Prime Contractor:** American Bridge/Fluor Enterprises, a JV**OSM Departure Time:** 1900**Contractor:** Zhenhua Port Machinery Company, Ltd (ZPMC) Chanxing Island**Location:** Shanghai, China**CWI Name:** Mr. An Qing Xing**CWI Present:** Yes No**Inspected CWI report:** Yes No N/A**Rod Oven in Use:** Yes No N/A**Electrode to specification:** Yes No N/A**Weld Procedures Followed:** Yes No N/A**Qualified Welders:** Yes No N/A**Verified Joint Fit-up:** Yes No N/A**Approved Drawings:** Yes No N/A**Approved WPS:** Yes No N/A**Delayed / Cancelled:** Yes No N/A**Bridge No:** 34-0006**Component:** OBG Segment**Summary of Items Observed:**

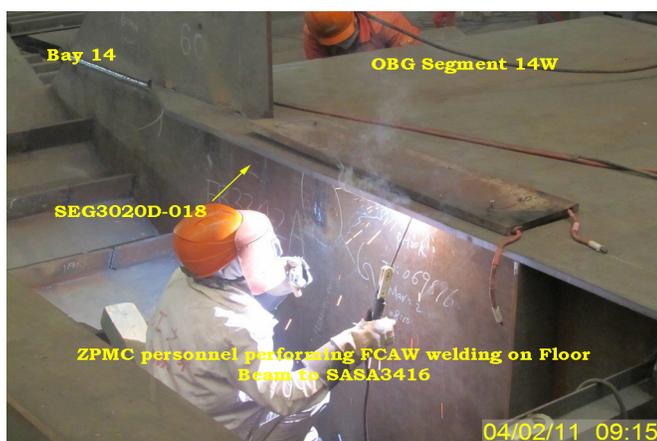
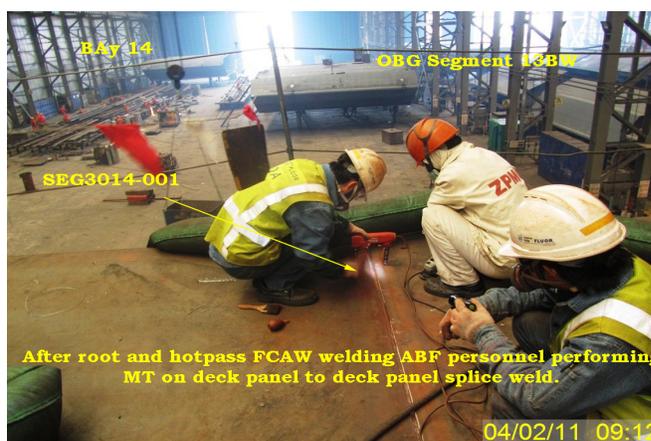
This QA inspector observed ABF personnel performed Magnetic particle Testing (MT) on Bottom Plate RS stiffener at panel point 122 to 122.5 bike path side of OBG Segment 13BW. See the attached pictures.
