**DEPARTMENT OF TRANSPORTATION**

Contract #: 04-0120F4Cty: SF/ALA Rte: 80 PM: 13.2/13.9File #: 69.28**WELDING INSPECTION REPORT****Resident Engineer:** Siegenthaler, Peter**Address:** 333 Burma Road**City:** Oakland, CA 94607**Report No:** WIR-022734**Date Inspected:** 20-Apr-2011**Project Name:** SAS Superstructure**OSM Arrival Time:** 1900**Prime Contractor:** American Bridge/Fluor Enterprises, a JV**OSM Departure Time:** 700**Contractor:** Zhenhua Port Machinery Company, Ltd (ZPMC), Changxing Island **Location:** Shanghai, China

**OBG Trial Assembly**

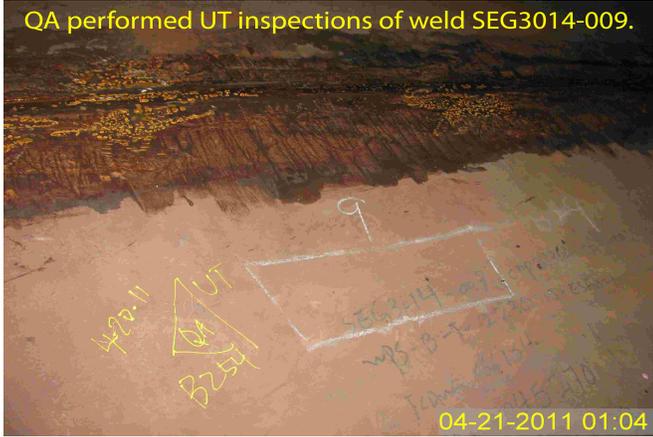
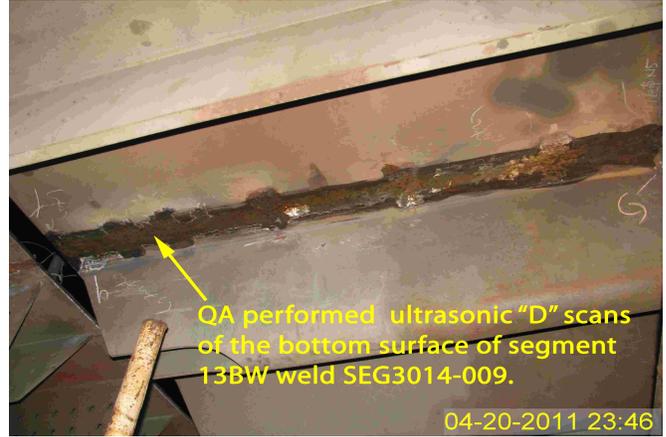
ABF issued ultrasonic inspection report number UT-13W-022R1 stating that OBG segment 13BW weld SEG3014-003 joining deck plate DP3136A to DP3135A and report number UT-13W-019R1 stating that OBG segment 13BW weld SEG3014-009 joining deck plate DP3130A to DP3129A have both been ultrasonically inspected and accepted using scanning patterns A, B, C, E on the exterior and scanning pattern D on the interior of the welds. This QA Inspector performed random visual and ultrasonic inspections of the welds listed above using scanning patterns A, B, C, E on the exterior and scanning pattern D on the interior of the welds and items observed by this QA Inspector appear to comply with AWS D1.5 UT requirements. For additional information on these inspections see this QA Inspector's TL6027 Ultrasonic Test Report and the photographs below.

QA performed UT inspections of weld SEG3014-009.
