DEPARTMENT OF TRANSPORTATION

Contract #: 04-0120F4Cty: SF/Ala Rte: 80 PM: 13.2/13.9File #: 69.28**WELDING INSPECTION REPORT****Resident Engineer:** Siegenthaler, Peter**Address:** 333 Burma Road**City:** Oakland, CA 94607**Report No:** WIR-022752**Date Inspected:** 01-Apr-2011**Project Name:** SAS Superstructure**OSM Arrival Time:** 1900**Prime Contractor:** American Bridge/Fluor Enterprises, a JV**OSM Departure Time:** 700**Contractor:** Zhenhua Port Machinery Company, Ltd (ZPMC), Changxing Island **Location:** Shanghai, China**CWI Name:** See below**CWI Present:** Yes No**Inspected CWI report:** Yes No N/A**Rod Oven in Use:** Yes No N/A**Electrode to specification:** Yes No N/A**Weld Procedures Followed:** Yes No N/A**Qualified Welders:** Yes No N/A**Verified Joint Fit-up:** Yes No N/A**Approved Drawings:** Yes No N/A**Approved WPS:** Yes No N/A**Delayed / Cancelled:** Yes No N/A**Bridge No:** 34-0006**Component:** OBG Components**Summary of Items Observed:**

WELDING INSPECTION REPORT

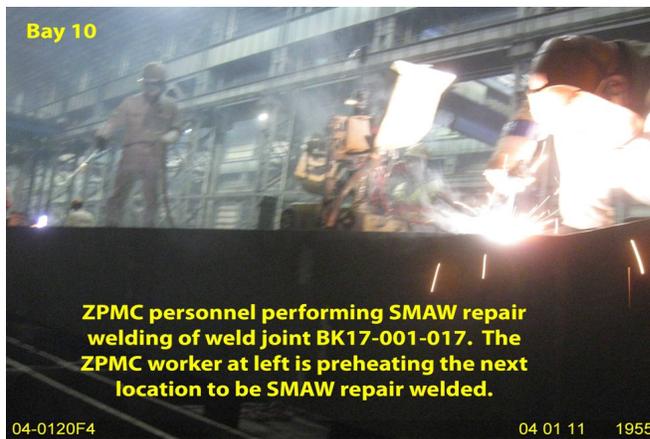
SMAW repair welding of weld joint BK17-001-017 located on PCMK OBG bike path cantilever beam. Welders were identified as 057220, 040582. QC was identified as QC1. Weld variables recorded by QC1 appeared to comply with WPS-B-T-2211-TC-U4c as verbally identified by QC1. QC1 informed this QA Inspector that no ZPMC Weld Repair Report existed because the repair welding was in response to ZPMC visual testing (VT). See photo below of ZPMC personnel welding and preheating at the next location of SMAW welding at weld joint BK17-001-017 between passes of SAW welding. Before preheating and SMAW welding, the areas had been ground in response to ZPMC personnel observing indications during VT inspection. Also see photo below of QC1's record of SAW welding as presented to this QA Inspector.

Weld record maintained by QC1 during SAW welding of weld joint BK17-001-017
