Contract #: 04-0120F4Cty: SF/Ala Rte: 80 PM: 13.2/13.9File #: 69.28**WELDING INSPECTION REPORT****Resident Engineer:** Siegenthaler, Peter**Address:** 333 Burma Road**City:** Oakland, CA 94607**Report No:** WIR-022757**Date Inspected:** 08-Apr-2011**Project Name:** SAS Superstructure**OSM Arrival Time:** 1900**Prime Contractor:** American Bridge/Fluor Enterprises, a JV**OSM Departure Time:** 700**Contractor:** Zhenhua Port Machinery Company, Ltd (ZPMC), Changxing Island **Location:** Shanghai, China**CWI Name:** See below**CWI Present:** Yes No**Inspected CWI report:** Yes No N/A**Rod Oven in Use:** Yes No N/A**Electrode to specification:** Yes No N/A**Weld Procedures Followed:** Yes No N/A**Qualified Welders:** Yes No N/A**Verified Joint Fit-up:** Yes No N/A**Approved Drawings:** Yes No N/A**Approved WPS:** Yes No N/A**Delayed / Cancelled:** Yes No N/A**Bridge No:** 34-0006**Component:** OBG and Tower Components**Summary of Items Observed:**

WELDING INSPECTION REPORT

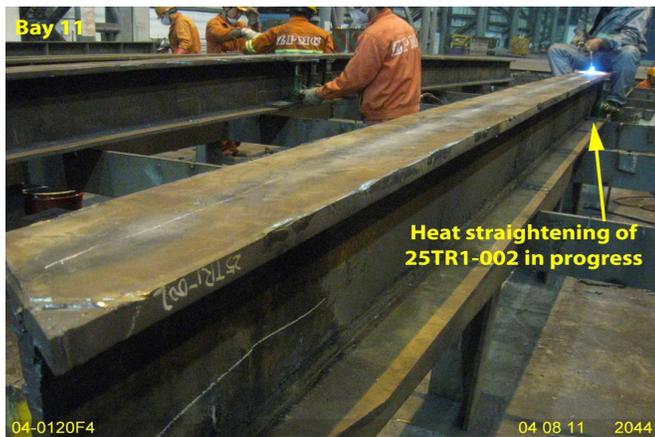
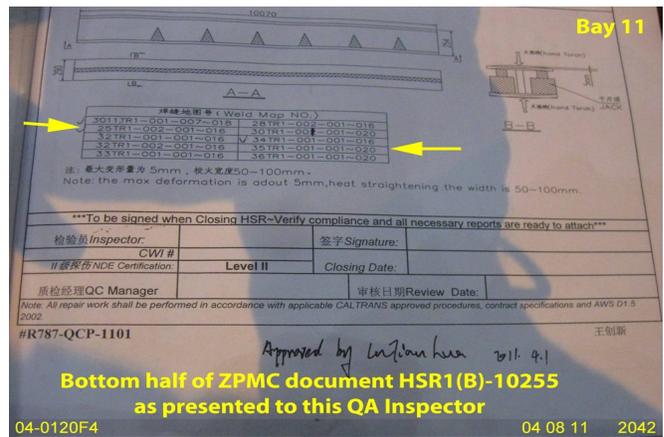
Bay 11

Heat straightening of 34TR1-001-001~016, 25TR1-002-001~016 located on PCMK OBG traveler rail. QC was identified as QC1. Assisting QC1 at this location and appearing to be monitoring the heat straightening operation and recording data was QCA2, who was not a CWI. Heat treatment variables recorded by QCA2 appeared to comply with ZPMC document HSR1(B)-10255 as presented to this QA Inspector and verbally identified by QCA2.

See photos below showing ZPMC document HSR1(B)-10255 as presented to this QA Inspector and some of the heat straightening operation in progress.

Top half of ZPMC document HSR1(B)-10255
as presented to this QA Inspector
