DEPARTMENT OF TRANSPORTATION

Contract #: 04-0120F4Cty: SF/ALA Rte: 80 PM: 13.2/13.9File #: 1.28**WELDING INSPECTION REPORT****Resident Engineer:** Siegenthaler, Peter**Address:** 333 Burma Road**City:** Oakland, CA 94607**Report No:** WIR-022768**Date Inspected:** 15-Apr-2011**Project Name:** SAS Superstructure**OSM Arrival Time:** 700**Prime Contractor:** American Bridge/Fluor Enterprises, a JV**OSM Departure Time:** 1530**Contractor:** American Bridge/Fluor Enterprises, a JV**Location:** Job Site**CWI Name:** Steve Jensen**CWI Present:** Yes No**Inspected CWI report:** Yes No N/A**Rod Oven in Use:** Yes No N/A**Electrode to specification:** Yes No N/A**Weld Procedures Followed:** Yes No N/A**Qualified Welders:** Yes No N/A**Verified Joint Fit-up:** Yes No N/A**Approved Drawings:** Yes No N/A**Approved WPS:** Yes No N/A**Delayed / Cancelled:** Yes No N/A**Bridge No:** 34-0006**Component:** Tower**Summary of Items Observed:**

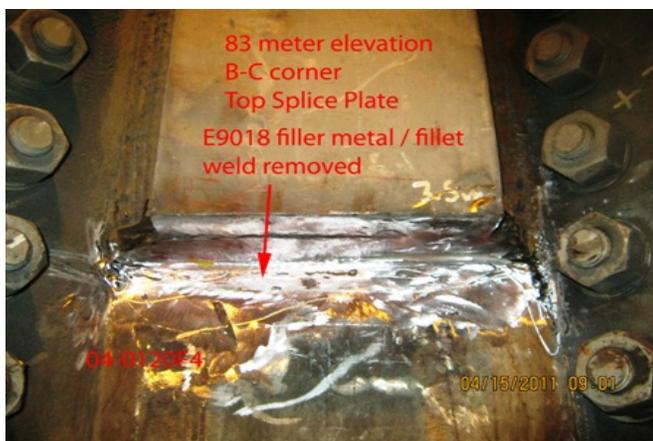
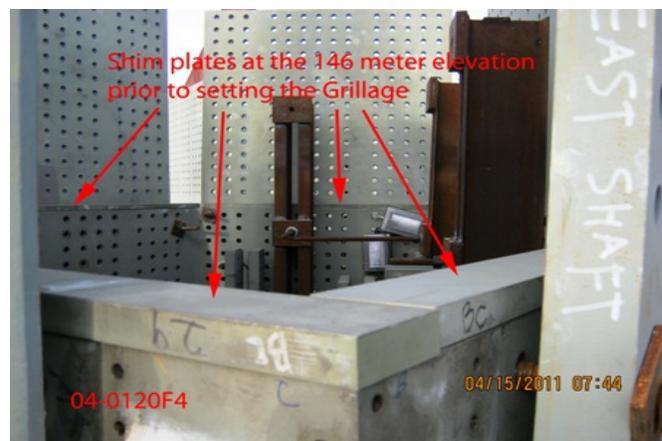
Tower Elevation – 146: This QA Inspector observed the shim plates have been placed on top of the tower sections (North, South, East and West) but that tack welding has not been performed as of approximately 0745 hours this date. This QA Inspector spoke with ABF Engineer Mark McDonald later this date and was informed the shim plates will not be tack welded to the tower sections. This QA Inspector informed Caltrans Engineer Doug Wright of this conversation and information. See photo below of shim plates in position.
