DEPARTMENT OF TRANSPORTATION

Quality Assurance and Source Inspection

Contract #: 04-0120F4Cty: SF/ALA Rte: 80 PM: 13.2/13.9File #: 1.28**WELDING INSPECTION REPORT****Resident Engineer:** Siegenthaler, Peter**Address:** 333 Burma Road**City:** Oakland, CA 94607**Report No:** WIR-022770**Date Inspected:** 20-Apr-2011**Project Name:** SAS Superstructure**OSM Arrival Time:** 700**Prime Contractor:** American Bridge/Fluor Enterprises, a JV**OSM Departure Time:** 1730**Contractor:** American Bridge/Fluor Enterprises, a JV**Location:** Job Site**CWI Name:** See Report Below**CWI Present:** Yes No**Inspected CWI report:** Yes No N/A**Rod Oven in Use:** Yes No N/A**Electrode to specification:** Yes No N/A**Weld Procedures Followed:** Yes No N/A**Qualified Welders:** Yes No N/A**Verified Joint Fit-up:** Yes No N/A**Approved Drawings:** Yes No N/A**Approved WPS:** Yes No N/A**Delayed / Cancelled:** Yes No N/A**Bridge No:** 34-0006**Component:** Orthotropic Box Girders**Summary of Items Observed:**

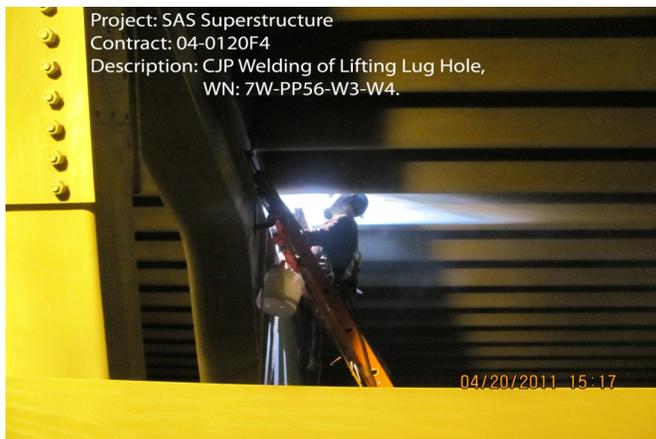
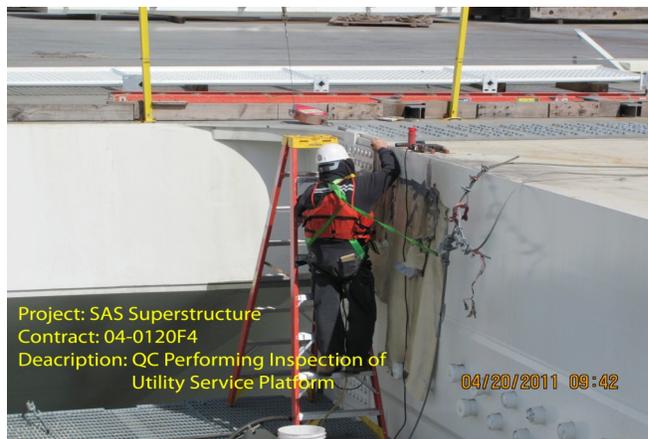
The digital photographs on page 3 of this report illustrate some of the work observed during this scheduled shift.
