**DEPARTMENT OF TRANSPORTATION**

Contract #: 04-0120F4Cty: SF/ALA Rte: 80 PM: 13.2/13.9File #: 69.28**WELDING INSPECTION REPORT****Resident Engineer:** Siegenthaler, Peter**Address:** 333 Burma Road**City:** Oakland, CA 94607**Report No:** WIR-022858**Date Inspected:** 20-Apr-2011**Project Name:** SAS Superstructure**OSM Arrival Time:** 700**Prime Contractor:** American Bridge/Fluor Enterprises, a JV**OSM Departure Time:** 1900**Contractor:** Zhenhua Port Machinery Company, Ltd (ZPMC), Changxing Island **Location:** Shanghai, China**CWI Name:** An Qing Xiang**CWI Present:** Yes No**Inspected CWI report:** Yes No N/A**Rod Oven in Use:** Yes No N/A**Electrode to specification:** Yes No N/A**Weld Procedures Followed:** Yes No N/A**Qualified Welders:** Yes No N/A**Verified Joint Fit-up:** Yes No N/A**Approved Drawings:** Yes No N/A**Approved WPS:** Yes No N/A**Delayed / Cancelled:** Yes No N/A**Bridge No:** 34-0006**Component:** OBG**Summary of Items Observed:**

OBG Segment 13BW

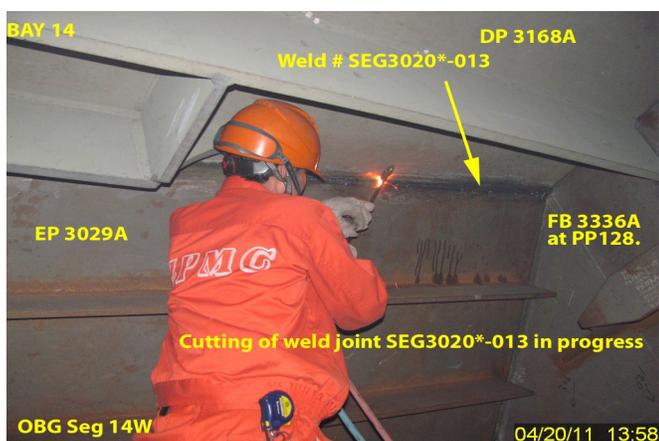
During random in process visual inspection this QA Inspector observed that ZPMC personnel were performing cutting of the weld joint SEG3020\*-013 for the alignment of deck plate as per Welding Repair Report (WRR) B-WR20776. Attached photograph provide additional details.
