**DEPARTMENT OF TRANSPORTATION**

Contract #: 04-0120F4Cty: SF/ALA Rte: 80 PM: 13.2/13.9File #: 1.28**WELDING INSPECTION REPORT****Resident Engineer:** Siegenthaler, Peter**Address:** 333 Burma Road**City:** Oakland, CA 94607**Report No:** WIR-022943**Date Inspected:** 20-Apr-2011**Project Name:** SAS Superstructure**OSM Arrival Time:** 700**Prime Contractor:** American Bridge/Fluor Enterprises, a JV**OSM Departure Time:** 1530**Contractor:** American Bridge/Fluor Enterprises, a JV**Location:** Job Site**CWI Name:** Steve Jensen**CWI Present:** Yes No**Inspected CWI report:** Yes No N/A**Rod Oven in Use:** Yes No N/A**Electrode to specification:** Yes No N/A**Weld Procedures Followed:** Yes No N/A**Qualified Welders:** Yes No N/A**Verified Joint Fit-up:** Yes No N/A**Approved Drawings:** Yes No N/A**Approved WPS:** Yes No N/A**Delayed / Cancelled:** Yes No N/A**Bridge No:** 34-0006**Component:** Tower**Summary of Items Observed:**

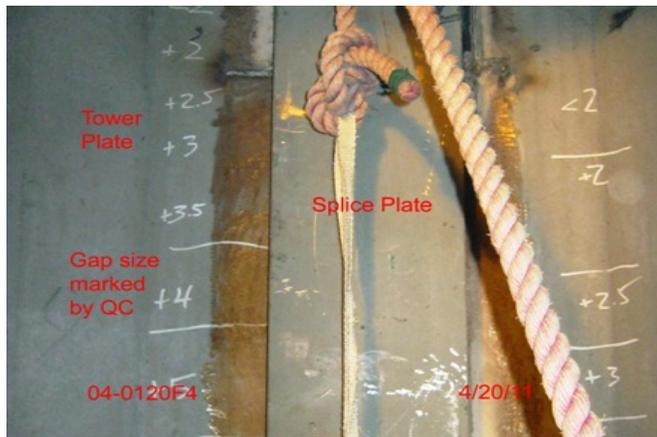
QC Inspector Steve Jensen has documented the fit up gap adjacent to the weld area in an effort to keep welding personnel informed of the additional weld size required when the gap is greater than 2 mm the entire gap is added to the referenced weld size. See photo below.
