DEPARTMENT OF TRANSPORTATION

Contract #: 04-0120F4Cty: SF/ALA Rte: 80 PM: 13.2/13.9File #: 1.28**WELDING INSPECTION REPORT****Resident Engineer:** Siegenthaler, Peter**Address:** 333 Burma Road**City:** Oakland, CA 94607**Report No:** WIR-022947**Date Inspected:** 20-Apr-2011**Project Name:** SAS Superstructure**OSM Arrival Time:** 700**Prime Contractor:** American Bridge/Fluor Enterprises, a JV**OSM Departure Time:** 1730**Contractor:** American Bridge/Fluor Enterprises, a JV**Location:** Job Site

WELDING INSPECTION REPORT

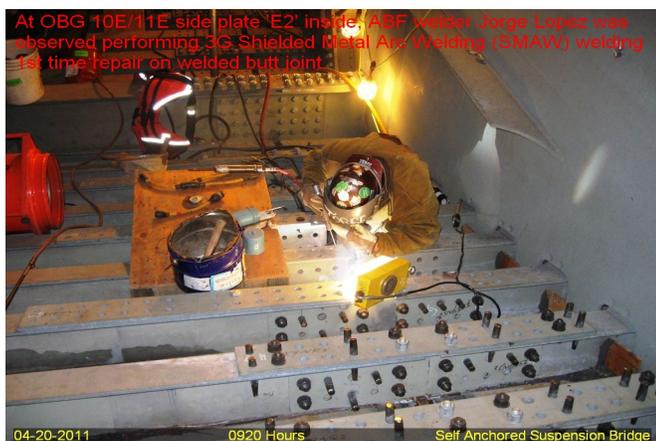
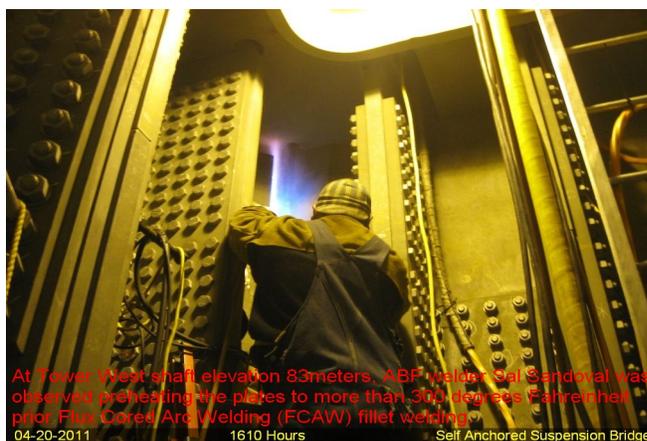
temperature gauge to verify the preheat temperature of more than 300°F. The welding appeared to comply with Welding Procedure Specification (WPS) ABF-WPS-D15-F2200-3. The welding of the vertical fillet welds was still continuing and should remain tomorrow. Before the end of the shift, at around 1630hours, the welder has stopped fillet welding and ABF personnel were noted covering the weld with heater blanket in preparation for the three hours holding of preheat temperature of more than 300°F as required. ABF personnel were using Miller Proheat 35 Induction Heating System to hold the preheat of more than 300°F that was programmed to step down 95°F per hour until the completion of three hours. Since this step down preheating of the plate after welding that was implemented by ABF was contrary to the Caltrans Special Provision, an incident report will be generated.

At Northwest C-D corner, lower splice plate: This QA Inspector randomly observed ABF welding personnel Gil Peralta performing production welding on the bottom half of the splice plate using the self shielded Flux Cored Arc Welding (FCAW) process. This QA Inspector observed a propane gas torch was being used to preheat areas prior to welding. This QA Inspector observed QC Inspector Steve Jensen using an infra red temperature gauge to verify the preheat temperature of more than 300°F. This QA Inspector performed a visual verification of the welding profile that was being welded and noted unacceptable fill passes on the fillet weld. This was relayed to ABF QC Steve Jensen later during the end of the shift due to QC was not present at the site at the time. QC has informed this QA that he will take a look first thing in the morning tomorrow. The welding of the vertical fillet welds was still continuing and should remain tomorrow. Before the end of the shift, at around 1630hours, the welder has stopped fillet welding and ABF personnel were noted covering the weld with heater blanket in preparation for the three hours holding of preheat temperature of more than 300°F as required. ABF personnel were using Miller Proheat 35 Induction Heating System to hold the preheat of more than 300°F that was programmed to step down 95°F per hour until the completion of three hours. Since this step down preheating of the plate after welding that was implemented by ABF was contrary to the Caltrans Special Provision, an incident report will be generated.

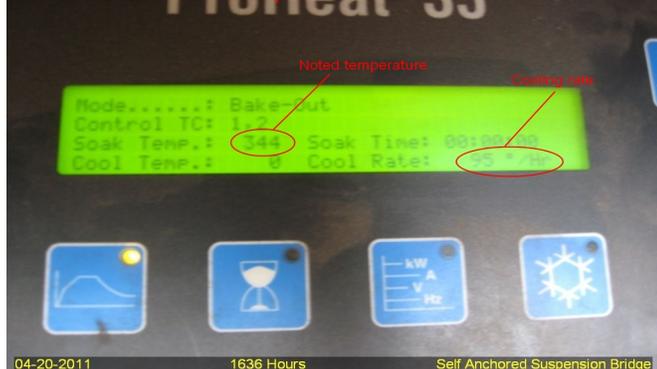
At Tower West shaft, elevation 83meters the Miller Proheat 35 Induction Heating System was programmed to a cooling rate of 95 degrees.F per hour as shown on the control panel of the machine.

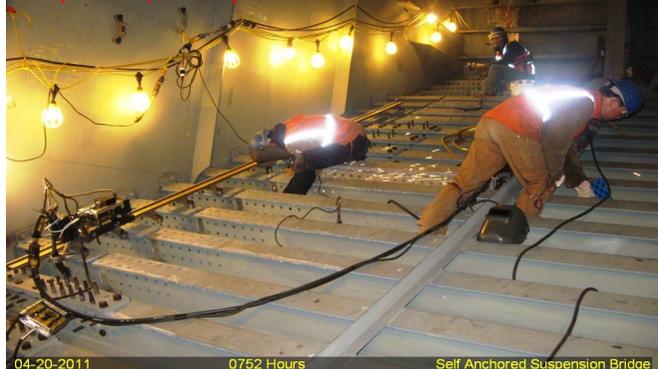
At OBG 10E/11E side plate 'C2' (0mm to 2638mm) inside, QA randomly observed ABF/JV qualified welder Sungtao, Huang ID # 3794 continuing to perform CJP groove (splice) welding cover pass on the splice butt joint. The welder was observed perform automatic welding in the 3G (vertical) position utilizing a dual shield Flux Cored Arc Welding (FCAW-G) with E71T-1M, 1/16" diameter wire electrode and implementing Caltrans approved Welding Procedure Specification (WPS) ABF-WPS-D15-3042B-1. The joint being welded has a single V-groove butt joint with backing bar. The splice joint was preheated and maintained to greater than 150 degrees Fahrenheit using Miller Proheat 35 Induction Heating System heater blankets located at the opposite side of the plate prior/during welding. During welding, ABF Quality Control (QC) John Pagliero was noted monitoring the welding parameters of the welder. At the end of the shift, cover pass welding was completed and the welder has moved to 'C2' (2638mm to 5277mm) inside of the same OBG.

At OBG 10E/11E side plate 'C2' inside, ABF welder Songtao, Huang was observed performing 3G Flux Cored Arc Welding (FCAW-G) welding cover pass on splice butt joint.
