Contract #: 04-0120F4Cty: SF/ALA Rte: 80 PM: 13.2/13.9File #: 1.28**WELDING INSPECTION REPORT****Resident Engineer:** Siegenthaler, Peter**Address:** 333 Burma Road**City:** Oakland, CA 94607**Report No:** WIR-022961**Date Inspected:** 21-Apr-2011**Project Name:** SAS Superstructure**OSM Arrival Time:** 700**Prime Contractor:** American Bridge/Fluor Enterprises, a JV**OSM Departure Time:** 1530**Contractor:** American Bridge/Fluor Enterprises, a JV**Location:** Job Site**CWI Name:** Steve Jensen**CWI Present:** Yes No**Inspected CWI report:** Yes No N/A**Rod Oven in Use:** Yes No N/A**Electrode to specification:** Yes No N/A**Weld Procedures Followed:** Yes No N/A**Qualified Welders:** Yes No N/A**Verified Joint Fit-up:** Yes No N/A**Approved Drawings:** Yes No N/A**Approved WPS:** Yes No N/A**Delayed / Cancelled:** Yes No N/A**Bridge No:** 34-0006**Component:** Tower**Summary of Items Observed:**

WELDING INSPECTION REPORT

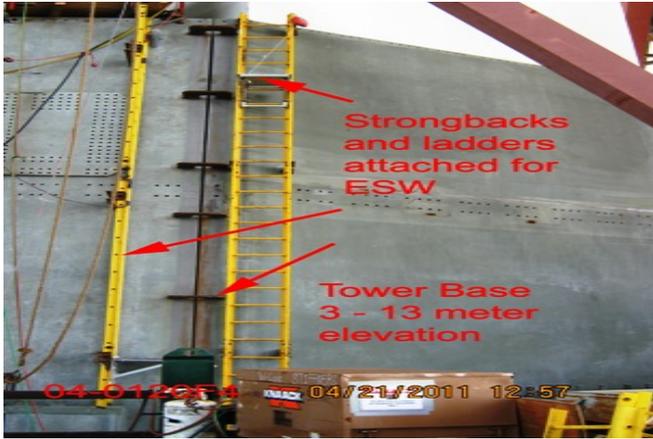
Tower Base – 3 to 13 Meter elevation; This QA Inspector observed the various pates used as temporary attachments for the Electro Slag Welding (ESW) as follows: This QA Inspector observed ABF welding personnel Rick Clayborn (#2773) and Morgan Winter (#3305) in the process of fitting up the strong backs for ESW on the East side. The strong backs and metal ladder at the Southwest corner appeared to be completed (see photo below). This QA Inspector observed QC Inspector Pat Swain periodically monitoring the work at this location.
