DEPARTMENT OF TRANSPORTATION

Contract #: 04-0120F4Cty: SF/ALA Rte: 80 PM: 13.2/13.9File #: 69.28**WELDING INSPECTION REPORT****Resident Engineer:** Siegenthaler, Peter**Address:** 333 Burma Road**City:** Oakland, CA 94607**Report No:** WIR-022973**Date Inspected:** 25-Apr-2011**Project Name:** SAS Superstructure**OSM Arrival Time:** 700**Prime Contractor:** American Bridge/Fluor Enterprises, a JV**OSM Departure Time:** 1900**Contractor:** Zhenhua Port Machinery Company, Ltd (ZPMC), Changxing Island **Location:** Shanghai, China**CWI Name:** Li Yan Hua**CWI Present:** Yes No**Inspected CWI report:** Yes No N/A**Rod Oven in Use:** Yes No N/A**Electrode to specification:** Yes No N/A**Weld Procedures Followed:** Yes No N/A**Qualified Welders:** Yes No N/A**Verified Joint Fit-up:** Yes No N/A**Approved Drawings:** Yes No N/A**Approved WPS:** Yes No N/A**Delayed / Cancelled:** Yes No N/A**Bridge No:** 34-0006**Component:** OBG**Summary of Items Observed:**

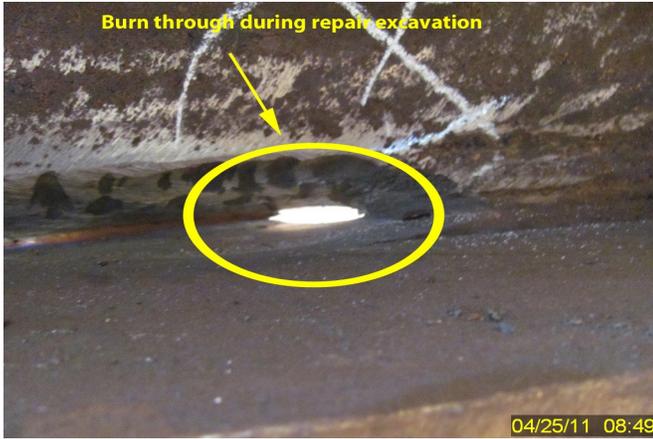
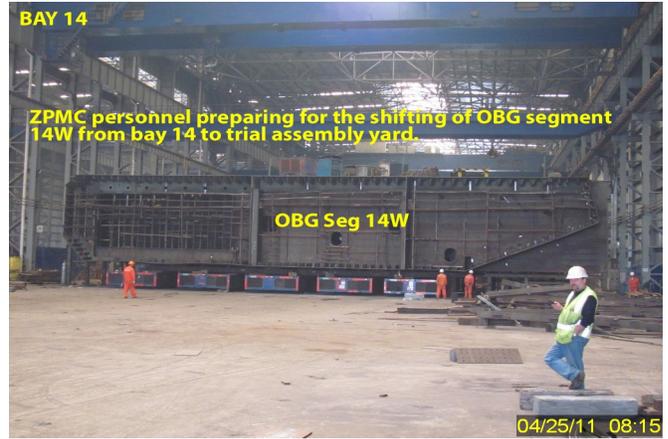
During random in process visual inspection this QA Inspector observed that ZPMC personnel performing repair welding on the weld joint TR3027TR2-001-011 of traveler rail TR3027. The welders were identified as 045246 and 066361 and were observed welding in 2G position. During inspection burn through was observed at one location and depth of repair excavations were noted more than 65% of thickness at five locations. This was not in compliance with Welding Repair Report (WRR) B-WR 20755. This issue was discussed with ZPMC CWI Mr. Li Yan Hua and after discussion Mr. Li Yan Hua stopped the repair welding operation and informed this QA Inspector that ZPMC will prepare Critical Welding Repair (CWR) report for this weld joint. Attached photograph provide additional details.
