DEPARTMENT OF TRANSPORTATION

Quality Assurance and Source Inspection

Contract #: 04-0120F4Cty: SF/ALA Rte: 80 PM: 13.2/13.9File #: 1.28**WELDING INSPECTION REPORT****Resident Engineer:** Siegenthaler, Peter**Address:** 333 Burma Road**City:** Oakland, CA 94607**Report No:** WIR-022994**Date Inspected:** 25-Apr-2011**Project Name:** SAS Superstructure**OSM Arrival Time:** 700**Prime Contractor:** American Bridge/Fluor Enterprises, a JV**OSM Departure Time:** 1530**Contractor:** American Bridge/Fluor Enterprises, a JV**Location:** Job Site**CWI Name:** Steve Jensen**CWI Present:** Yes No**Inspected CWI report:** Yes No N/A**Rod Oven in Use:** Yes No N/A**Electrode to specification:** Yes No N/A**Weld Procedures Followed:** Yes No N/A**Qualified Welders:** Yes No N/A**Verified Joint Fit-up:** Yes No N/A**Approved Drawings:** Yes No N/A**Approved WPS:** Yes No N/A**Delayed / Cancelled:** Yes No N/A**Bridge No:** 34-0006**Component:** Tower**Summary of Items Observed:**

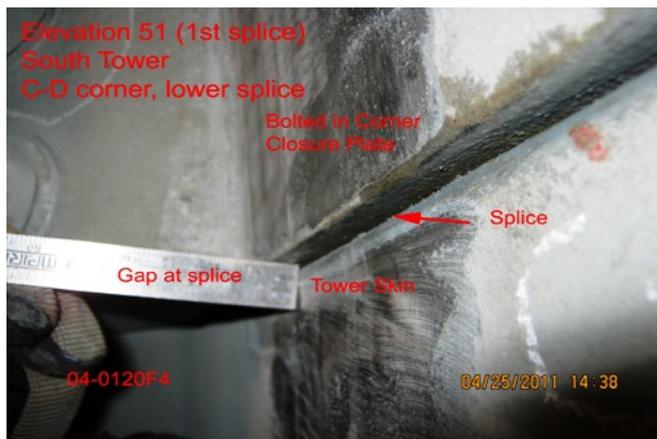
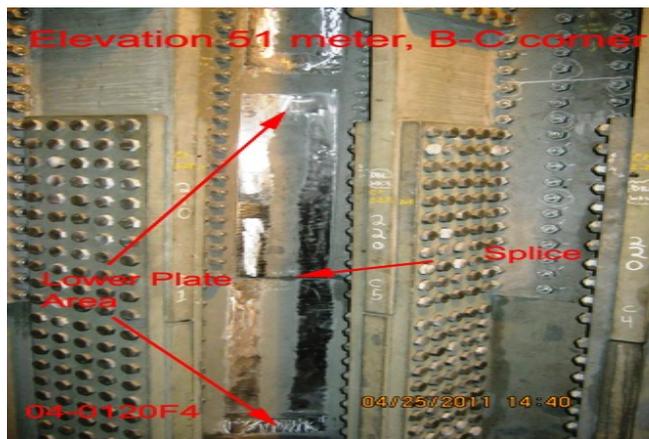
West - B-C corner, upper and lower plate: This QA Inspector randomly observe QC Inspector Steve Jensen perform a visual inspection on the welding. This QA Inspector observed multiple areas marked for additional welding and/or grinding by QC Inspector Steve Jensen. . This QA Inspector observed several areas where the weld appeared to need additional cleaning to remove slag and/or dark smoke residue prior to performing the final visual inspection. This QA Inspector informed QC Inspector Steve Jensen of this condition and was informed that ABF personnel had tried a long wire length steel brush on the 9-inch grinder, but it found to be difficult to fit into multiple areas. QC Inspector Steve Jensen concurred there were areas that should be cleaned better and that ABF personnel were looking at different solutions for this problem.

West – C-D corner, lower plate: This QA Inspector observed ABF welding personnel Richard Garcia (#5892) using the Flux Cored Arc Welding (FCAW) process for production welding. This QA Inspector observed QC Inspector Steve Jensen inform ABF welding personnel Richard Garcia of several areas where additional weld was required to correct under fill. This QA Inspector was informed by QC Inspector Steve Jensen of the following welding parameters; 245 amperes and 21.5 volts at a travel speed of 95 mm per minute to produce a heat input of 3.46 KJ per mm. The welding observed by this QA Inspector appeared to comply with Welding Procedure Specification (WPS) ABF-WPS-D15-2200-3. /This QA Inspector observed welding appeared to be completed by approximately 1145 hours this date at this location and the splice plate covered with an induction heat blanket for a 3 hour/300°F post heat.
