DEPARTMENT OF TRANSPORTATION

Contract #: 04-0120F4Cty: SF/ALA Rte: 80 PM: 13.2/13.9File #: 69.28**WELDING INSPECTION REPORT****Resident Engineer:** Siegenthaler, Peter**Address:** 333 Burma Road**City:** Oakland, CA 94607**Report No:** WIR-023055**Date Inspected:** 06-Apr-2011**Project Name:** SAS Superstructure**OSM Arrival Time:** 700**Prime Contractor:** American Bridge/Fluor Enterprises, a JV**OSM Departure Time:** 1900**Contractor:** Zhenhua Port Machinery Company, Ltd (ZPMC), Changxing Island **Location:** Shanghai, China**CWI Name:** Xu Le Feng**CWI Present:** Yes No**Inspected CWI report:** Yes No N/A**Rod Oven in Use:** Yes No N/A**Electrode to specification:** Yes No N/A**Weld Procedures Followed:** Yes No N/A**Qualified Welders:** Yes No N/A**Verified Joint Fit-up:** Yes No N/A**Approved Drawings:** Yes No N/A**Approved WPS:** Yes No N/A**Delayed / Cancelled:** Yes No N/A**Bridge No:** 34-0006**Component:** OBG & TOWER Components**Summary of Items Observed:**

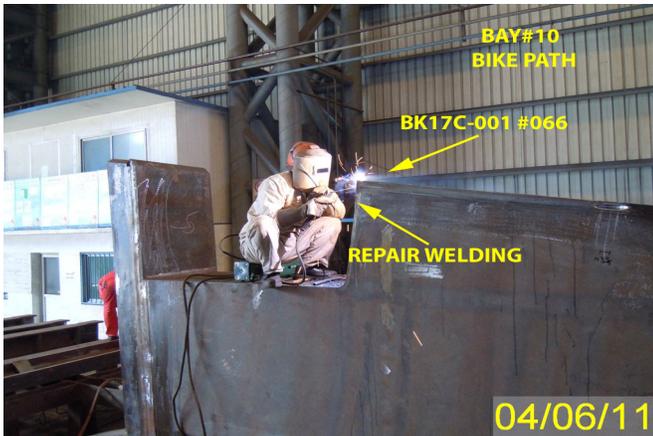
Repair welding of weld joint #066 located on Bike Path BK17C-001 as per the weld repair report # B-WR 20590. Welder is identified as 500363. ZPMC Quality Control (QC) Inspector is identified as Sun Zi Wang. The welding variables recorded by QC appeared to comply with the WPS-345-SMAW-2G (2F)-REPAIR. (See attached photo)

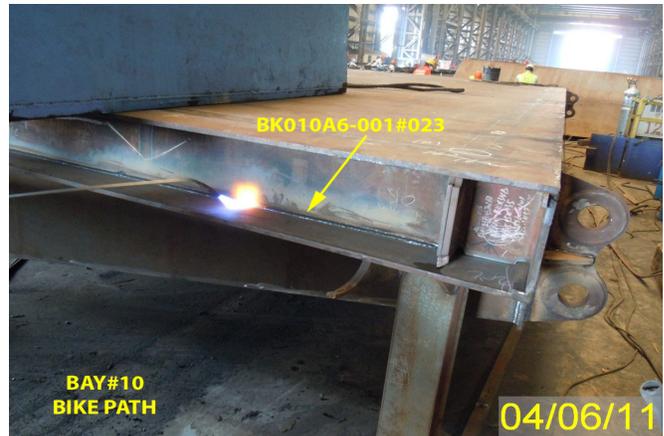
Weld joint #023 located on Bike path BK010A6-001. Welder is identified as 054069. ZPMC Quality Control (QC) Inspector is identified as Yu Zhi Lai. The welding variables recorded by QC appeared to comply with the WPS-B-T-2132-ESAB. (See attached photo)
