DEPARTMENT OF TRANSPORTATION

Quality Assurance and Source Inspection

Contract #: 04-0120F4Cty: SF/ALA Rte: 80 PM: 13.2/13.9File #: 1.28**WELDING INSPECTION REPORT****Resident Engineer:** Siegenthaler, Peter**Address:** 333 Burma Road**City:** Oakland, CA 94607**Report No:** WIR-023094**Date Inspected:** 26-Apr-2011**Project Name:** SAS Superstructure**OSM Arrival Time:** 700**Prime Contractor:** American Bridge/Fluor Enterprises, a JV**OSM Departure Time:** 1530**Contractor:** American Bridge/Fluor Enterprises, a JV**Location:** Job Site**CWI Name:** Fred Von Hoff**CWI Present:** Yes No**Inspected CWI report:** Yes No N/A**Rod Oven in Use:** Yes No N/A**Electrode to specification:** Yes No N/A**Weld Procedures Followed:** Yes No N/A**Qualified Welders:** Yes No N/A**Verified Joint Fit-up:** Yes No N/A**Approved Drawings:** Yes No N/A**Approved WPS:** Yes No N/A**Delayed / Cancelled:** Yes No N/A**Bridge No:** 34-0006**Component:** Orthotropic Box Girder**Summary of Items Observed:**

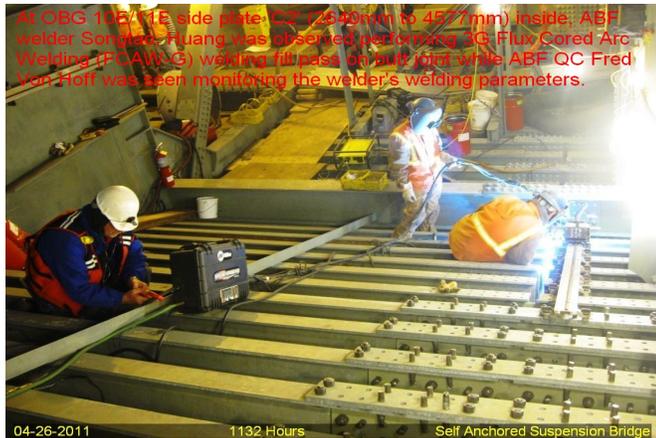
04-26-2011 1132 Hours Self Anchored Suspension Bridge

At OBG 10B-1E side plate-C2 (230mm to 457mm) inside, ABF welder Songhai Huang was observed performing 3G Flux Cored Arc Welding (FCAW-G) working fill pass on butt joint while ABF QC Fred von Hoff was seen monitoring the welder's welding parameters.

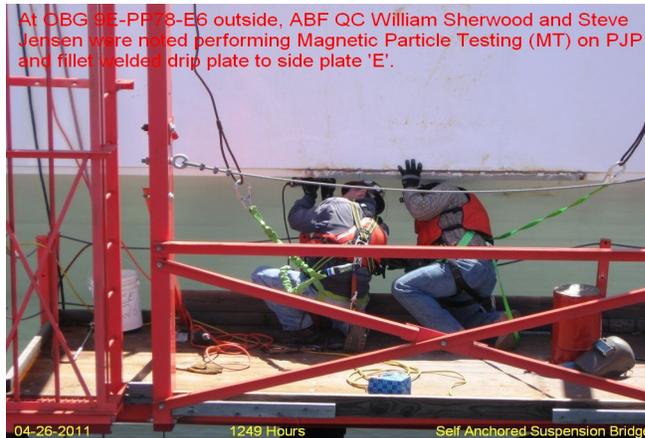
04-26-2011 1249 Hours Self Anchored Suspension Bridge

At OBG 9E-PP18-E6 outside, ABF QC William Sherwood and Steve Jensen were noted performing Magnetic Particle Testing (MT) on PJP and fillet welder drip plate to side plate 'E'.

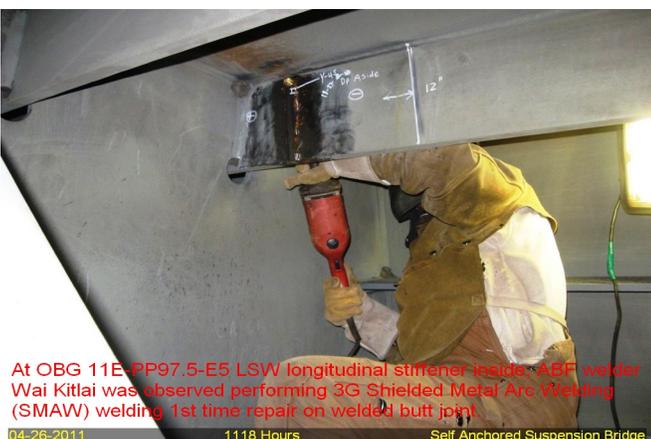
04-26-2011 1118 Hours Self Anchored Suspension Bridge

At OBG 11E-PP97.5-E5 LSW longitudinal stiffener inside, QA randomly observed ABF/JV qualified welder Wai Kitlai perform CJP groove first time welding repair. The welder was observed welding in the 3G (vertical) position utilizing Shielded Metal Arc Welding (SMAW) with 1/8" diameter E9018H4R electrode implementing welding procedure ABF-WPS-D15-1002-Repair. The repair excavation located at Y-dimension 45mm and having excavation profile of 50mm long x 20mm wide x 22mm deep was preheated to more than 200 degrees Fahrenheit using propylene gas torch prior welding. Prior welding, ABF QC Fred Von Hoff was also observed performing Magnetic Particle Testing (MT) on the boat shape repair excavation. During the shift, ABF QC Fred Von Hoff was noted monitoring the welder and his welding parameters. Repair welding at location mentioned above was completed at the end of the shift.

At OBG 11E-PP97.5-E5 LSW longitudinal stiffener inside, ABF welder Wai Kitlai was observed performing 3G Shielded Metal Arc Welding (SMAW) welding 1st time repair on welded butt joint.

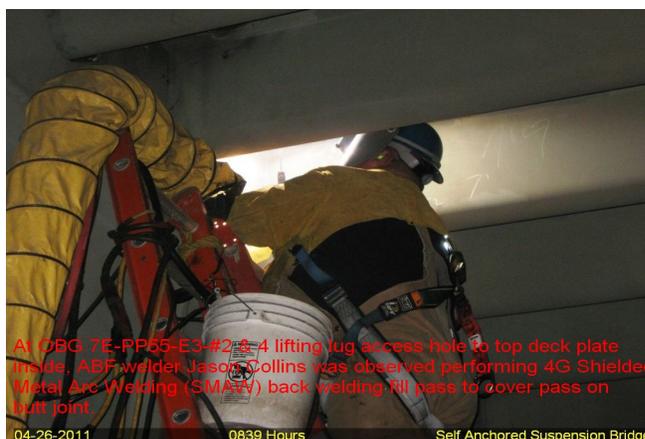
04-26-2011 0839 Hours Self Anchored Suspension Bridge

At OBG 7E-PP55-E3-#2 & 4 lifting lug access hole to top deck plate inside – ABF welder Jason Collins was observed 4G SMAW back welding fill pass to cover pass on the infill plate to top deck plate butt joints. The welder was noted using 1/8" diameter E7018H4R electrode implementing Caltrans approved Welding Procedure Specification (WPS) ABF-WPS-D15-1110A. Prior welding, ABF QC Fred Von Hoff was observed performing Magnetic Particle Testing (MT) on the back gouging and grinding of the butt joints. During welding, ABF QC Fred Von Hoff was noted monitoring the welder's welding parameters. At the end of the shift, cover pass welding on the bottom side location of the two butt joints was completed and the welder has moved to #1 & 3 access holes of the same OBG and performed back gouging using carbon air arc.

At OBG 7E-PP65-E3-#2 3/4 lifting lug access hole to top deck plate inside, ABF welder Jason Collins was observed performing 4G Shielded Metal Arc Welding (SMAW) back welding fill pass to cover pass on butt joint.
