DEPARTMENT OF TRANSPORTATION

Contract #: 04-0120F4Cty: SF/Ala Rte: 80 PM: 13.2/13.9File #: 69.28**WELDING INSPECTION REPORT****Resident Engineer:** Siegenthaler, Peter**Address:** 333 Burma Road**City:** Oakland, CA 94607**Report No:** WIR-023133**Date Inspected:** 24-Apr-2011**Project Name:** SAS Superstructure**OSM Arrival Time:** 1900**Prime Contractor:** American Bridge/Fluor Enterprises, a JV**OSM Departure Time:** 700**Contractor:** Zhenhua Port Machinery Company, Ltd (ZPMC), Changxing Island **Location:** Shanghai, China**CWI Name:** See below**CWI Present:** Yes No**Inspected CWI report:** Yes No N/A**Rod Oven in Use:** Yes No N/A**Electrode to specification:** Yes No N/A**Weld Procedures Followed:** Yes No N/A**Qualified Welders:** Yes No N/A**Verified Joint Fit-up:** Yes No N/A**Approved Drawings:** Yes No N/A**Approved WPS:** Yes No N/A**Delayed / Cancelled:** Yes No N/A**Bridge No:** 34-0006**Component:** OBG and Tower Components**Summary of Items Observed:**

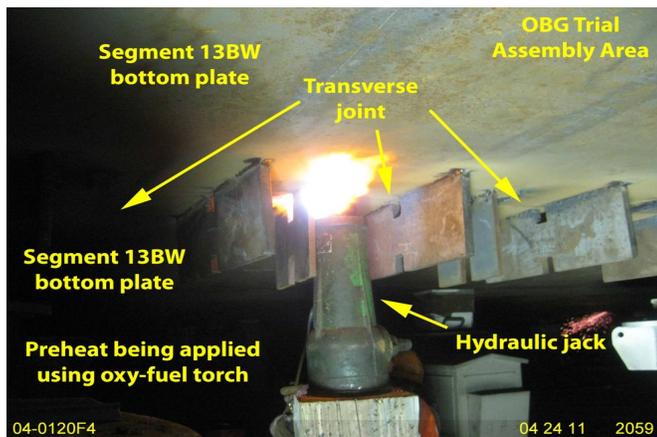
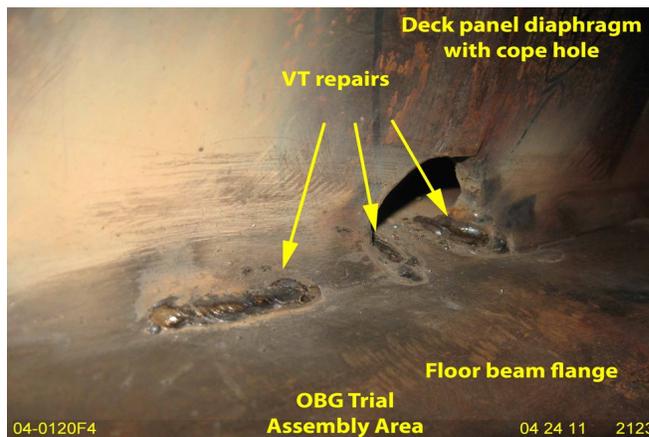
SMAW repair welding of various weld joints located inside PCMK OBG Segment 13CW, deck panel diaphragm to floor beam flange at panel points 123, 123.5, 124, and 124.5. Welder was identified as 045196. QC was identified as ABF CWI Wu Ke Wen (QC3). Weld variables recorded by QC3 appeared to comply with WPS-B-P-2212-TC-U4b as verbally identified by QC3. QC3 informed this QA Inspector that this repair was the response to indications observed during ZPMC or ABF visual testing. See photo below of typical weld repairs at a deck panel diaphragm cope hole at panel point 124.5.
