**DEPARTMENT OF TRANSPORTATION**

Contract #: 04-0120F4Cty: SF/ALA Rte: 80 PM: 13.2/13.9File #: 69.28**WELDING INSPECTION REPORT****Resident Engineer:**Siegenthaler, Peter**Address:** 333 Burma Road**City:** Oakland, CA 94607**Report No:** WIR-023198**Date Inspected:** 23-Apr-2011**Project Name:** SAS Superstructure**OSM Arrival Time:** 700**Prime Contractor:** American Bridge/Fluor Enterprises, a JV**OSM Departure Time:** 1900**Contractor:** Zhenhua Port Machinery Company, Ltd (ZPMC), Changxing Island **Location:** Shanghai,China**CWI Name:** Liu Hua Jie**CWI Present:** Yes No**Inspected CWI report:** Yes No N/A**Rod Oven in Use:** Yes No N/A**Electrode to specification:** Yes No N/A**Weld Procedures Followed:** Yes No N/A**Qualified Welders:** Yes No N/A**Verified Joint Fit-up:** Yes No N/A**Approved Drawings:** Yes No N/A**Approved WPS:** Yes No N/A**Delayed / Cancelled:** Yes No N/A**Bridge No:** 34-0006**Component:** OBG**Summary of Items Observed:**

OBG Trial Assembly

## WELDING INSPECTION REPORT

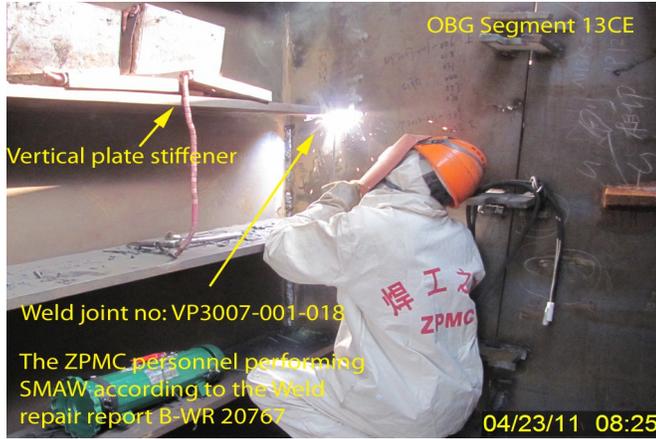
SMAW welding of weld joint No: VP3007-001-018 located on OBG Segment 13CE Vertical plate stiffener.

Welder is identified as #066656. ZPMC QC is identified as Mr. Wang Xu. Welding was performed with the weld repair report BWR-20767. The welding variables recorded by QC appeared to comply with the WPS-345-SMAW-4G(4F)-FCM-Repair-1. Please see the attached picture.

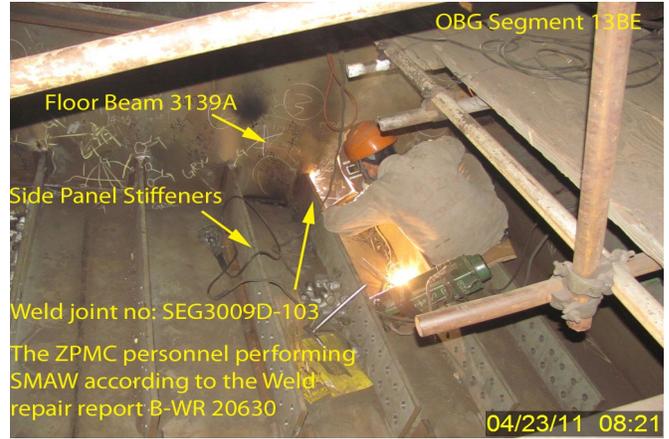
SMAW welding of weld joint No: SEG3009D-103 located on OBG Segment 13BE Side plate stiffener to Floor beam. Welder is identified as #051359. ZPMC QC is identified as Mr. Wang Xu. Welding was performed with the weld repair report BWR-20630. The welding variables recorded by QC appeared to comply with the WPS-345-SMAW-3G(3F)-FCM-Repair-1. Please see the attached picture.
