**DEPARTMENT OF TRANSPORTATION**

Contract #: 04-0120F4Cty: SF/ALA Rte: 80 PM: 13.2/13.9File #: 1.28**WELDING INSPECTION REPORT****Resident Engineer:** Siegenthaler, Peter**Address:** 333 Burma Road**City:** Oakland, CA 94607**Report No:** WIR-023225**Date Inspected:** 27-Apr-2011**Project Name:** SAS Superstructure**OSM Arrival Time:** 700**Prime Contractor:** American Bridge/Fluor Enterprises, a JV**OSM Departure Time:** 1530**Contractor:** American Bridge/Fluor Enterprises, a JV**Location:** Job Site**CWI Name:** Fred Von Hoff**CWI Present:** Yes No**Inspected CWI report:** Yes No N/A**Rod Oven in Use:** Yes No N/A**Electrode to specification:** Yes No N/A**Weld Procedures Followed:** Yes No N/A**Qualified Welders:** Yes No N/A**Verified Joint Fit-up:** Yes No N/A**Approved Drawings:** Yes No N/A**Approved WPS:** Yes No N/A**Delayed / Cancelled:** Yes No N/A**Bridge No:** 34-0006**Component:** Orthotropic Box Girder**Summary of Items Observed:**

## WELDING INSPECTION REPORT

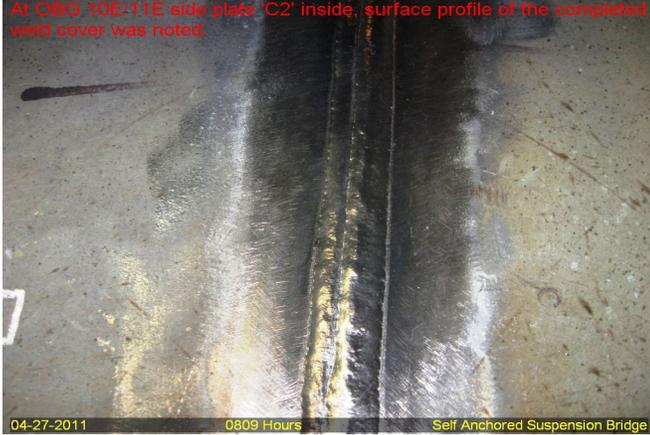
At OBG 10E/11E side plate 'C2' inside, surface profile of the completed weld cover was noted.

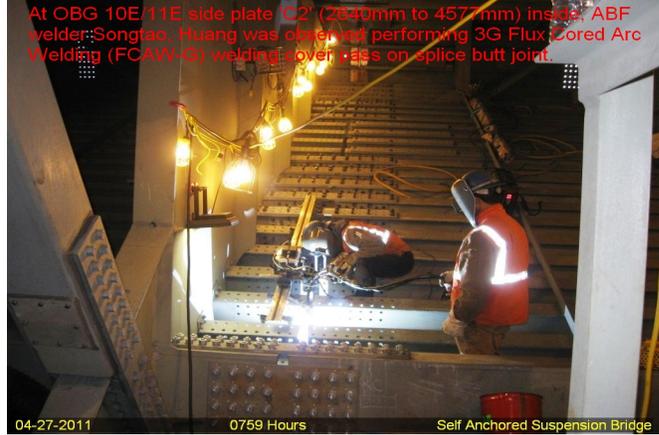
At OBG 10E/11E side plate 'C2' (2640mm to 4577mm) inside, QA randomly observed ABF/JV qualified welder Sungtao, Huang ID # 3794 continuing to perform CJP groove (splice) welding cover pass on the splice butt joint. The welder was observed perform automatic welding in the 3G (vertical) position utilizing a dual shield Flux Cored Arc Welding (FCAW-G) with E71T-1M, 1/16" diameter wire electrode and implementing Caltrans approved Welding Procedure Specification (WPS) ABF-WPS-D15-3042B-1. The joint being welded has a single V-groove butt joint with backing bar. The splice joint was preheated and maintained to greater than 150 degrees Fahrenheit using Miller Proheat 35 Induction Heating System heater blankets located at the opposite side of the plate prior/during welding. During welding, ABF Quality Control (QC) Fred Von Hoff was noted monitoring the welding parameters of the welder. During the shift, cover pass welding was completed and the welder has moved the welding equipment and accessories to side plate 'E' inside of the same OBG in preparation for the next welding task.

At OBG 10E/11E side plate 'C2' (2640mm to 4577 mm) inside, ABF welder: Songtao, Huang was observed performing 3G Flux Cored Arc Welding (FCAW-G) welding cover pass on splice butt joint.
