DEPARTMENT OF TRANSPORTATION

Contract #: 04-0120F4Cty: SF/ALA Rte: 80 PM: 13.2/13.9File #: 1.28**WELDING INSPECTION REPORT****Resident Engineer:** Siegenthaler, Peter**Address:** 333 Burma Road**City:** Oakland, CA 94607**Report No:** WIR-023228**Date Inspected:** 28-Apr-2011**Project Name:** SAS Superstructure**OSM Arrival Time:** 800**Prime Contractor:** American Bridge/Fluor Enterprises, a JV**OSM Departure Time:** 1630**Contractor:** American Bridge/Fluor Enterprises, a JV**Location:** Job Site

Bridge No: 34-0006**Component:** Tower**Summary of Items Observed:**

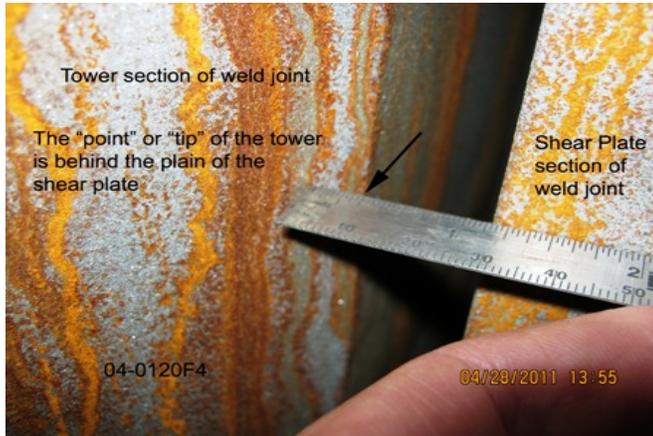
Later this date, at approximately 1100 hours this QA Inspector was requested to assist Structural Material Representative (SMR) Jason Lee obtain the actual root gap and off set measurement at the ESW weld joint on the tower in the field. This QA Inspector and SMR Jason Lee determined elevations at the 3-meter, 5-meter, 9-meter, 11-meter and 13-meter provided access for the measurements. This QA Inspector and SMR Jason Lee decided to use the weld joint numbers provided by QC personnel to track the measurement of the 20 weld joints (weld # 9 thru # 28). This QA Inspector used a stand 15-30 mm taper gauge to measure the root gaps and a Cambridge

gauge to measure the offset. See photo below of the offset found at weld joint # 16 and other joints typical to this configuration.
