DEPARTMENT OF TRANSPORTATION

Contract #: 04-0120F4Cty: SF/ALA Rte: 80 PM: 13.2/13.9File #: 69.28**WELDING INSPECTION REPORT****Resident Engineer:** Siegenthaler, Peter**Address:** 333 Burma Road**City:** Oakland, CA 94607**Report No:** WIR-023283**Date Inspected:** 04-May-2011**Project Name:** SAS Superstructure**OSM Arrival Time:** 1500**Prime Contractor:** American Bridge/Fluor Enterprises, a JV**OSM Departure Time:** 300**Contractor:** Zhenhua Port Machinery Company, Ltd (ZPMC), Changxing Island **Location:** Shanghai, China**CWI Name:** Mr. Li Yang**CWI Present:** Yes No**Inspected CWI report:** Yes No N/A**Rod Oven in Use:** Yes No N/A**Electrode to specification:** Yes No N/A**Weld Procedures Followed:** Yes No N/A**Qualified Welders:** Yes No N/A**Verified Joint Fit-up:** Yes No N/A**Approved Drawings:** Yes No N/A**Approved WPS:** Yes No N/A**Delayed / Cancelled:** Yes No N/A**Bridge No:** 34-0006**Component:** OBG Segment Assembly**Summary of Items Observed:**

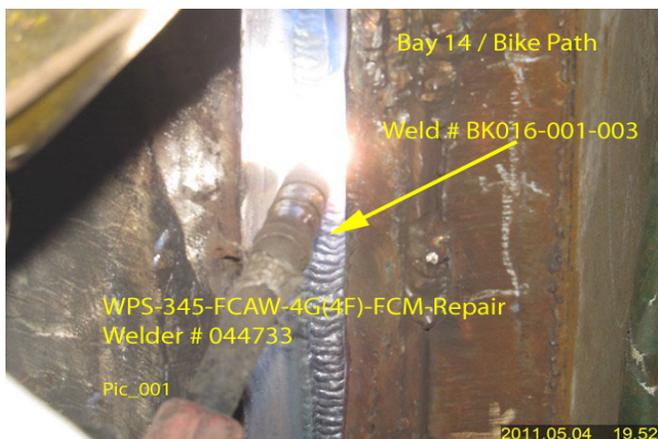
ZPMC personnel performed weld repair on Bike Path Cantilever weld # BK016-001-003 as per B-CWR # 2961 as follows.

- Back gauged existing weld ground smooth all weld faces to be welded
- ABF performed MT on back gauged area
- Fit up of backing strip and tack welded
- Root pass welding completed
- ABF performed MT on root pass welding
- Filling and capping weld completed

Flux Core Arc Welding (FCAW) in the 3G position performed for above weld repair. The welder is identified as 044733. Quality Control (QC) is identified as LI Yang. The welding variables recorded by QC appeared to comply with WPS- 345-FCAW-3G(3F)-FCM-Repair. See attached photograph Pic_001.
