DEPARTMENT OF TRANSPORTATION

Contract #: 04-0120F4Cty: SF/ALA Rte: 80 PM: 13.2/13.9File #: 99.28**WELDING INSPECTION REPORT****Resident Engineer:** Siegenthaler, Peter**Address:** 333 Burma Road**City:** Oakland, CA 94607**Report No:** WIR-023317**Date Inspected:** 05-May-2011**Project Name:** SAS Superstructure**OSM Arrival Time:** 700**Prime Contractor:** American Bridge/Fluor Enterprises, a JV**OSM Departure Time:** 1900**Contractor:** Zhenhua Port Machinery Company, Ltd (ZPMC) Chanxing Island **Location:** Shanghai, China**CWI Name:** Mr. LIU HUA JIE**CWI Present:** Yes No**Inspected CWI report:** Yes No N/A**Rod Oven in Use:** Yes No N/A**Electrode to specification:** Yes No N/A**Weld Procedures Followed:** Yes No N/A**Qualified Welders:** Yes No N/A**Verified Joint Fit-up:** Yes No N/A**Approved Drawings:** Yes No N/A**Approved WPS:** Yes No N/A**Delayed / Cancelled:** Yes No N/A**Bridge No:** 34-0006**Component:** OBG Segment**Summary of Items Observed:**

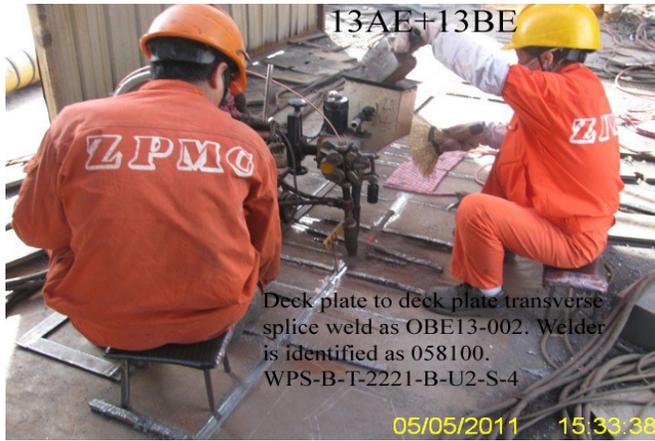
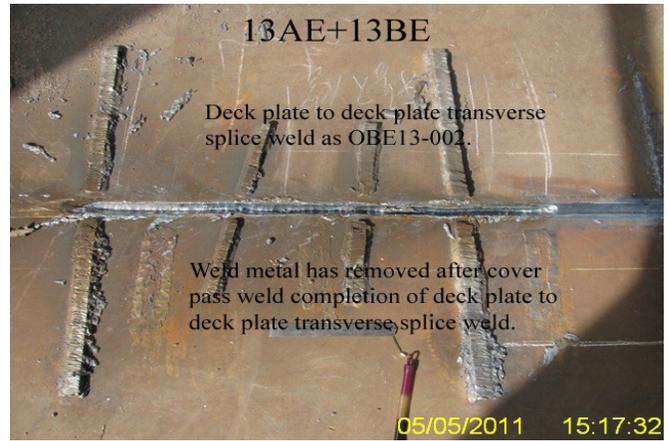
ZPMC welding personnel performing Submerge Arc Welding of Complete Joint Penetration welds joining the deck plate to deck plate transverse splice weld joint located on 13AE+13BE. The weld is designated as OBE13-002. The welder is identified as 058100. ZPMC QC Mr. WANG LI YANG was onsite monitoring the welding variables. The inprocess Submerge Arc Welding appears to be progressing in compliance with WPS-B-T-2221-B-U2-S-4. This QA inspector found without proper document weld metal has removed after cover pass weld completion of deck plate to deck plate transverse splice weld joint due to misalignment. ZPMC QC agrees to make the proper document before welding. Further weld detail mention in attached picture.
