**DEPARTMENT OF TRANSPORTATION**

Contract #: 04-0120F4Cty: SF/ALA Rte: 80 PM: 13.2/13.9File #: 69.28**WELDING INSPECTION REPORT****Resident Engineer:** Siegenthaler, Peter**Address:** 333 Burma Road**City:** Oakland, CA 94607**Report No:** WIR-023339**Date Inspected:** 05-May-2011**Project Name:** SAS Superstructure**OSM Arrival Time:** 700**Prime Contractor:** American Bridge/Fluor Enterprises, a JV**OSM Departure Time:** 1900**Contractor:** Zhenhua Port Machinery Company, Ltd (ZPMC), Changxing Island **Location:** Shanghai, China

Orthotropic Box Girder (OBG) at Trial Assembly Areas

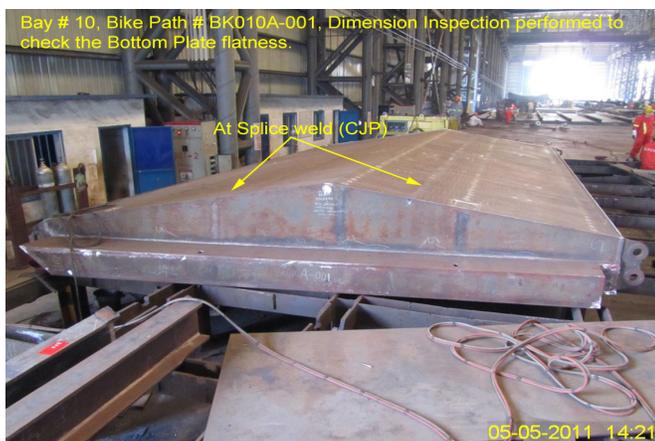
This QA Inspector performed Dimension Control Inspection on the Bike Path bottom plate for flatness check across the longitudinal butt weld. Flatness check was performed on following mentioned Bike Paths and Bike Path are identified as:

BK010A-001.

The QA Inspector measured the flatness using 600mm long straight edge across the Butt (CJP) weld and using 1500mm long straight edge between the stiffeners which are plug weld to bottom plate.

Observed flatness within the allowable tolerance.
