**DEPARTMENT OF TRANSPORTATION**

Contract #: 04-0120F4Cty: SF/ALA Rte: 80 PM: 13.2/13.9File #: 69.28**WELDING INSPECTION REPORT****Resident Engineer:** Siegenthaler, Peter**Address:** 333 Burma Road**City:** Oakland, CA 94607**Report No:** WIR-023362**Date Inspected:** 04-May-2011**Project Name:** SAS Superstructure**OSM Arrival Time:** 700**Prime Contractor:** American Bridge/Fluor Enterprises, a JV**OSM Departure Time:** 1900**Contractor:** Zhenhua Port Machinery Company, Ltd (ZPMC), Changxing Island **Location:** Shanghai, China

Orthotropic Box Girder (OBG) at Trial Assembly Areas

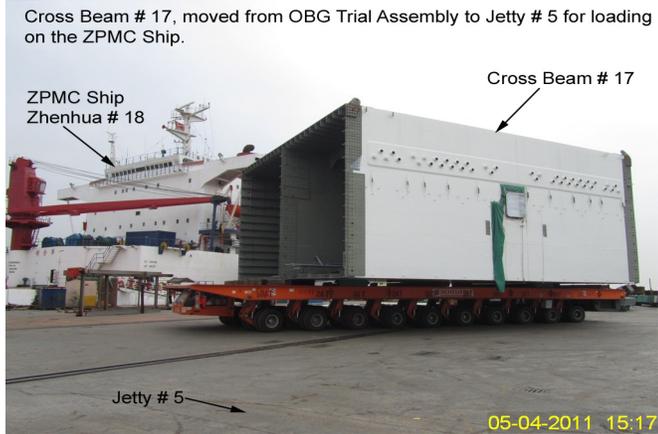
This QA Inspector observed that ZPMC personnel moved the Cross Beam # 17 from OBG Trial Assembly to the Jetty # 5, for loading on the ZPMC Ship Zhenhua # 18.
