Contract #: 04-0120F4Cty: SF/ALA Rte: 80 PM: 13.2/13.9File #: 69.28**WELDING INSPECTION REPORT****Resident Engineer:** Siegenthaler, Peter**Address:** 333 Burma Road**City:** Oakland, CA 94607**Report No:** WIR-023393**Date Inspected:** 07-May-2011**Project Name:** SAS Superstructure**OSM Arrival Time:** 700**Prime Contractor:** American Bridge/Fluor Enterprises, a JV**OSM Departure Time:** 1900**Contractor:** Zhenhua Port Machinery Company, Ltd (ZPMC), Changxing Island **Location:** Shanghai, China

Orthotropic Box Girder (OBG) at Trial Assembly Areas

Incident Report generated at Segment 12CW (Bottom Panel Distorted)

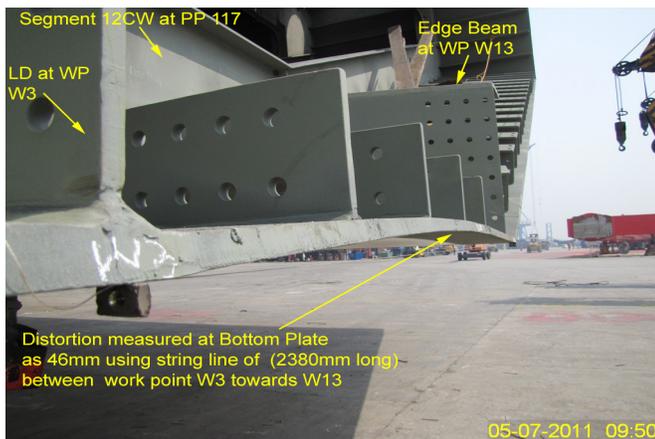
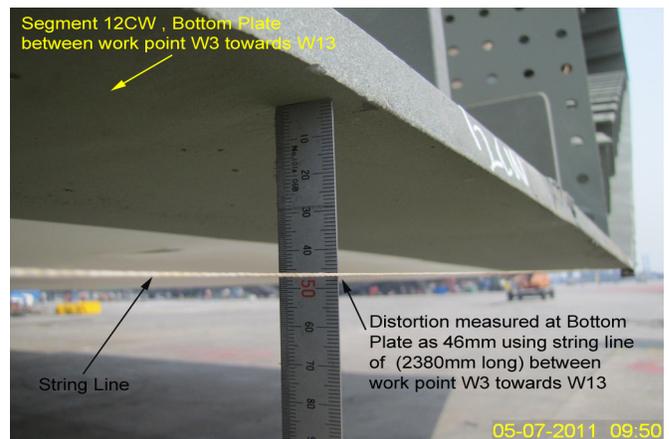
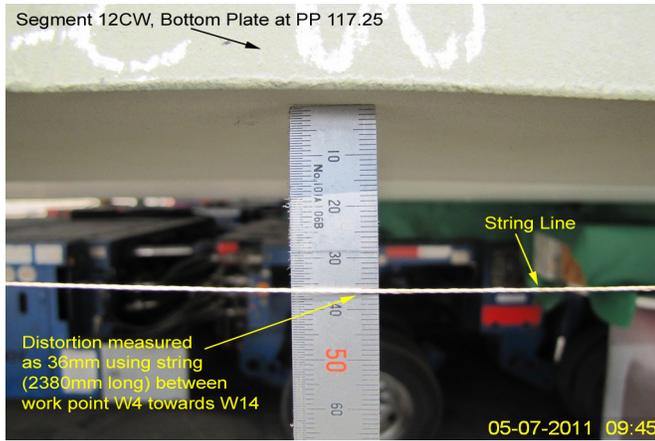
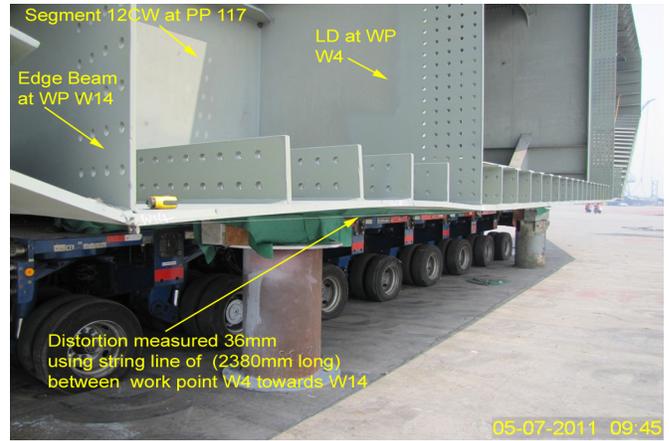
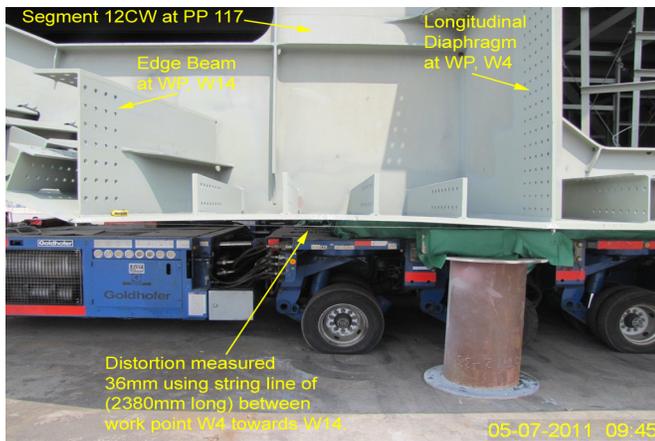
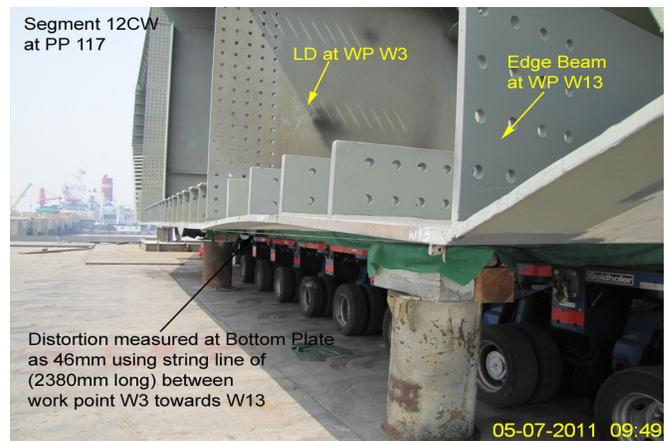
This Quality Assurance (QA) Inspector wrote an Incident Report for Bottom Panel distortion, distortion was observed between work point W3 towards W13 and work point W4 and work point W14 for Segment 12CW at PP 117.

Please reference the pictures attached for more comprehensive details.
