DEPARTMENT OF TRANSPORTATION

Contract #: 04-0120F4Cty: SF/ALA Rte: 80 PM: 13.2/13.9File #: 1.28**WELDING INSPECTION REPORT****Resident Engineer:** Siegenthaler, Peter**Address:** 333 Burma Road**City:** Oakland, CA 94607**Report No:** WIR-023444**Date Inspected:** 05-May-2011**Project Name:** SAS Superstructure**OSM Arrival Time:** 700**Prime Contractor:** American Bridge/Fluor Enterprises, a JV**OSM Departure Time:** 1730**Contractor:** American Bridge/Fluor Enterprises, a JV**Location:** Job Site**CWI Name:** Steve Jensen**CWI Present:** Yes No**Inspected CWI report:** Yes No N/A**Rod Oven in Use:** Yes No N/A**Electrode to specification:** Yes No N/A**Weld Procedures Followed:** Yes No N/A**Qualified Welders:** Yes No N/A**Verified Joint Fit-up:** Yes No N/A**Approved Drawings:** Yes No N/A**Approved WPS:** Yes No N/A**Delayed / Cancelled:** Yes No N/A**Bridge No:** 34-0006**Component:** SAS Tower**Summary of Items Observed:**

WELDING INSPECTION REPORT

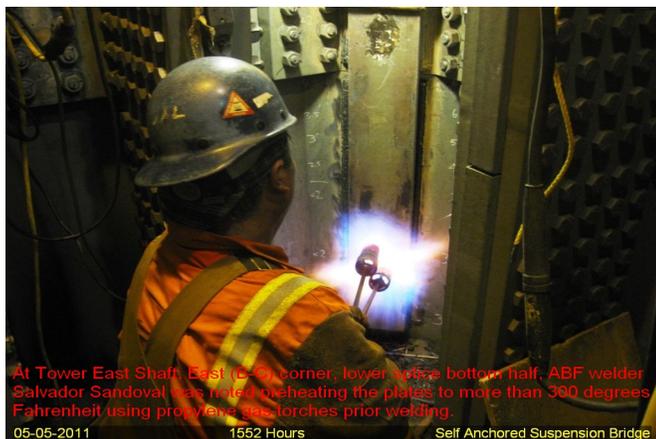
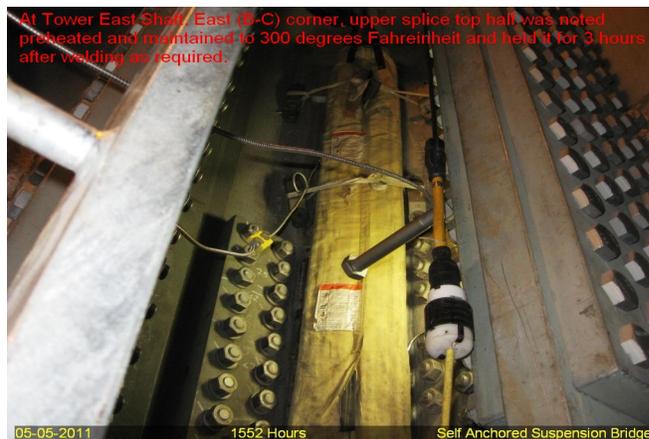
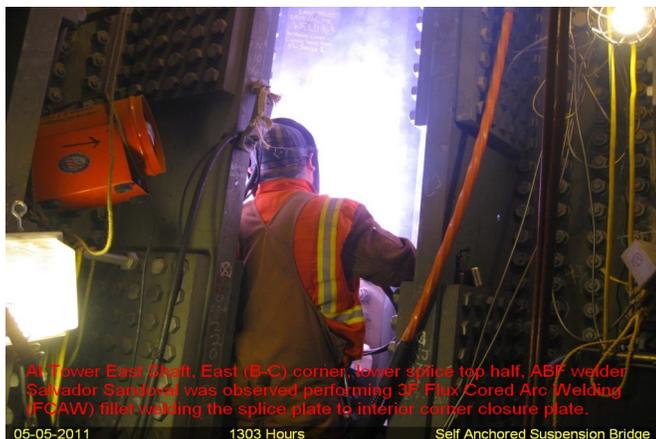
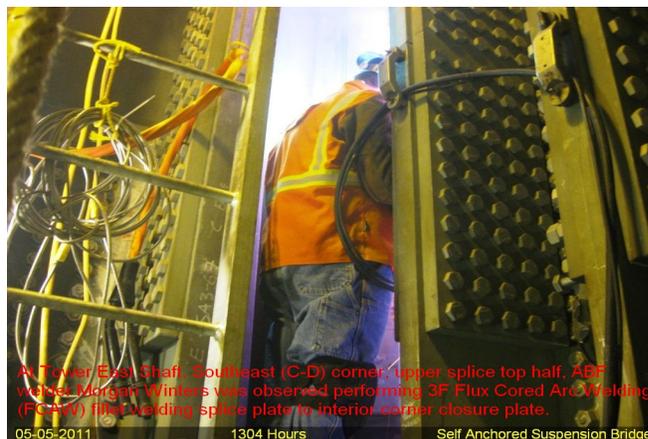
At East (B-C) corner, lower splice plate; this QA Inspector randomly observed ABF welding personnel Salvador Sandoval continuing to perform production welding on the top half of the splice plate using the self shielded Flux Cored Arc Welding (FCAW) process. This QA Inspector observed ABF personnel using propylene gas torch to preheat the plates to be welded prior to welding. This QA Inspector observed QC Inspector Steve Jensen using a Fluke infra red temperature gauge to verify the preheat temperature of more than 300°F. This QA Inspector performed a verification of the welding parameters and observed 270 amperes and 21.8 volts with a travel speed of 95 mm per minute with equivalent heat input of 3.72 KJ per mm. The welding appeared to comply with Welding Procedure Specification (WPS) ABF-WPS-D15-F2200-3. During the shift, the welder has completed the fillet weld cover on both sides of the joint. The welder has moved to the top of the plate and performed 2F fillet welding which was also completed during the shift. The welder has again moved to bottom half of the same splice and welded 3F fillet on the both sides of the joint until the end of the shift. Before the end of the shift, the welder has stopped fillet welding and ABF personnel were noted covering the weld with heater blanket in preparation for the three hours holding of preheat temperature of more than 300°F as required. ABF personnel were using Miller Proheat 35 Induction Heating System to hold the preheat that was programmed to shut off after three hours.

At Southeast (C-D) corner, upper splice top half, this QA randomly observed ABF welding personnel Morgan Winter continuing to perform 3F fillet welding the splice plate to interior corner closure plate. The welder was noted using Flux Cored Arc Welding (FCAW) with 1.8mm diameter E71T-8 wire electrode implementing ABF-WPS-D15-F2200-3. Prior welding, the welder was noted preheating the plates to more than 300°F using propylene gas torch. ABF QC Steve Jensen was noted monitoring the parameters of the welder and measured working current of 265 amperes and 20.0 volts with a travel speed of 90mm per minute which appears in compliance to the WPS. Welding of the vertical fillet on both sides of the plate was completed and the welder has moved to upper splice bottom half and also performed 3F fillet welding which the welder has also completed during the shift. The welder has left early due to some appointment and according to him; all he has left to weld is the overhead which should be done tomorrow. Before the end of the shift, ABF personnel were noted covering the weld with heater blanket and preheated and held the temperature of more than 300°F for three hours as required. ABF personnel were using Miller Proheat 35 Induction Heating System to hold the preheat that was programmed to shut off after three hours.

At Tower South Shaft South (C-D) corner, ABF welder Richard Garcia was observed performing fit up of the lower and upper splice plates to interior corner closure plate. The welder has tack welded using SMAW various temporary attachments to the interior corner closure plate and used wedges to hold the lower/upper splice plates in place. The welder was also noted preheating the plate to more than 225°F prior welding. ABF QC Steve Jensen was noted at site monitoring the welder and his welding parameter. During the shift, fit up of the splice plates at location mentioned above was completed. This QA has noted ABF QC Steve Jensen perform fit up verification on the installed splice plates. During the verification, the lower splice plate was noted having 6.5mm gap between the splice plate and the interior corner closure plate. ABF personnel have inserted two shim plates, one on each side of the plate. The shim on the left side of the plate was 3mm thick x 38mm wide x 630mm long and the one on the right side of the plate was 3mm thick x 38mm wide x 465mm long. All the rest of the joint fit up was having a reading of 2-3mm gap. According to ABF QC Steve Jensen, he will submit the gathered information to ABF and wait for the Engineer's approval for the use of shim before ABF could start tack welding.
