Contract #: 04-0120F4Cty: SF/ALA Rte: 80 PM: 13.2/13.9File #: 1.28**WELDING INSPECTION REPORT****Resident Engineer:** Siegenthaler, Peter**Address:** 333 Burma Road**City:** Oakland, CA 94607**Report No:** WIR-023450**Date Inspected:** 06-May-2011**Project Name:** SAS Superstructure**OSM Arrival Time:** 700**Prime Contractor:** American Bridge/Fluor Enterprises, a JV**OSM Departure Time:** 1530**Contractor:** American Bridge/Fluor Enterprises, a JV**Location:** Job Site**CWI Name:** Steve Jensen**CWI Present:** Yes No**Inspected CWI report:** Yes No N/A**Rod Oven in Use:** Yes No N/A**Electrode to specification:** Yes No N/A**Weld Procedures Followed:** Yes No N/A**Qualified Welders:** Yes No N/A**Verified Joint Fit-up:** Yes No N/A**Approved Drawings:** Yes No N/A**Approved WPS:** Yes No N/A**Delayed / Cancelled:** Yes No N/A**Bridge No:** 34-0006**Component:** SAS Tower**Summary of Items Observed:**

At Tower East Shaft Splice #2 @Elevation 83meters:

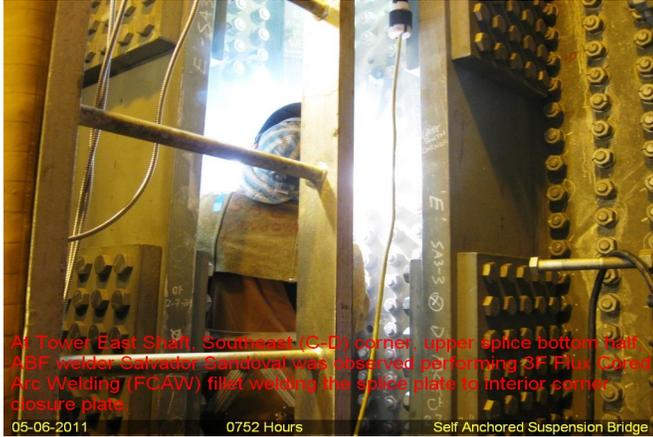
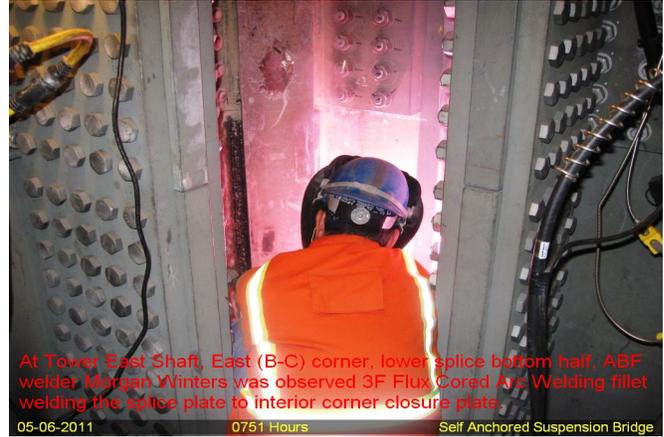
At East (B-C) corner, lower splice plate; this QA Inspector randomly observed ABF welding personnel Morgan Winters continuing to perform production welding on the bottom half of the splice plate using the self shielded Flux Cored Arc Welding (FCAW) process. This QA Inspector observed ABF personnel using propylene gas torch to preheat the plates to be welded prior to welding. This QA Inspector observed QC Inspector Steve Jensen using a Fluke infra red temperature gauge to verify the preheat temperature of more than 300°F. This QA Inspector performed a verification of the welding parameters and observed 265 amperes and 20.5 volts with a travel speed of 100 mm per minute with equivalent heat input of 3.26 KJ per mm. The welding appeared to comply with Welding Procedure Specification (WPS) ABF-WPS-D15-F2200-3. During the shift, the welder has completed the fillet weld cover on both sides of the joint and so with all the minor fixes due to surface profile. During the shift, ABF personnel were noted covering the weld with heater blanket in preparation for the three hours holding of preheat temperature of more than 300°F as required. ABF personnel were using Miller Proheat 35 Induction Heating System to hold the preheat that was programmed to shut off after three hours.

At Southeast (C-D) corner, upper splice top half, this QA randomly observed ABF welding personnel Salvador Sandoval perform 4F overhead fillet welding at the bottom of the plate. The welder was noted using Shielded Metal Arc Welding (SMAW) with 5/32" diameter E7018H4R electrode implementing ABF-WPS-D15-F1200A. Prior welding, the welder was noted preheating the plates to more than 225°F using propylene gas torch. ABF QC Steve Jensen was noted monitoring the parameters of the welder and measured working current of 184 amperes at the time of welding which appears in compliance to the WPS. Welding of the overhead fillet was completed during the shift and the welder also performed minor fixes due to surface profile. After the completion of the welding, ABF personnel were noted covering the weld with heater blanket and preheated and held the temperature of more than 300°F for three hours as required. ABF personnel were using Miller Proheat 35 Induction Heating System to hold the preheat that was programmed to shut off after three hours.

At Tower West Shaft West (B-C) corner, ABF welder Richard Garcia was observed performing fit up of the lower and upper splice plates to interior corner closure plate. The welder has tack welded using SMAW various temporary attachments to the interior corner closure plate and used wedges to hold the lower/upper splice plates in place. The welder was also noted preheating the plate to more than 225°F prior welding. ABF QC Steve Jensen was noted at site monitoring the welder and his welding parameter. The welder has completed the fit up on the West (B-C) corner and then moved to the other corner Northwest (C-D). The welder performed the same task as he did on the first corner and completed the fit up at the end of the shift. During the shift, fit up of the splice plates at location mentioned above was completed.
