**DEPARTMENT OF TRANSPORTATION**

Contract #: 04-0120F4Cty: SF/ALA Rte: 80 PM: 13.2/13.9File #: 1x.28**WELDING INSPECTION REPORT****Resident Engineer:** Siegenthaler, Peter**Address:** 333 Burma Road**City:** Oakland, CA 94607**Report No:** WIR-023480**Date Inspected:** 11-May-2011**Project Name:** SAS Superstructure**OSM Arrival Time:** 1430**Prime Contractor:** American Bridge/Fluor Enterprises, a JV**OSM Departure Time:** 2000**Contractor:** American Bridge/Fluor Enterprises, a JV**Location:** Job Site

**Bridge No:** 34-0006**Component:** Tower**Summary of Items Observed:**

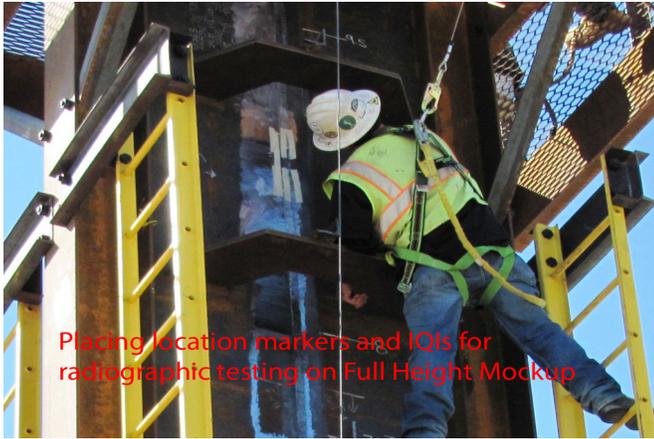
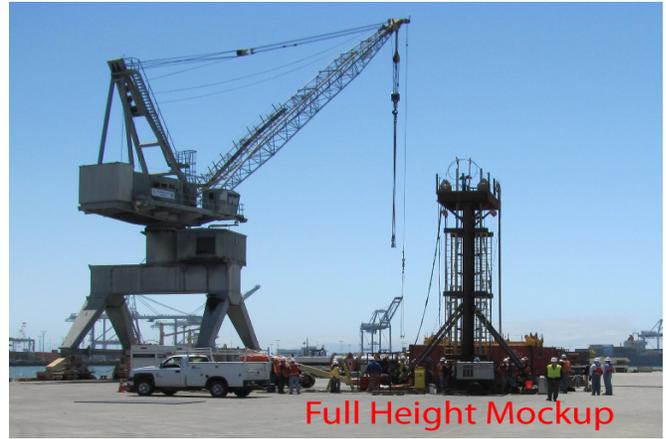
This Caltrans Quality Assurance Inspector witnessed the radiographic testing of the T1 Tower Shear Plate Welding Electroslag Full Height Mockup welded per the ABF welding procedure specification ABF-WPS-ESW-80-100TR. Assistant Structures Representative Mr. Douglas Wright requested radiography be performed at a location near the bottom of the weld joint and at 8.5 meters up. Joint detail is a square groove with 19mm root opening. Construction Materials Testing Inc. NDT Level II Inspector Mr. Ted Shoecraft assisted by Mr. Brian Rose performed radiography in accordance with Quality Control Procedure QC-RT-2A Bridge. Radiography was performed using a 34 curie Iridium 192 source at 25-inch source to film distance. The film utilized was AGFA D7. Two 'C' wire type image quality indicators and two location markers were placed in accordance with AWS figure 6.1C for each exposure. Exposure time was 3 hours and 20 minutes. After completing the first radiograph, Mr. Shoecraft performed a preliminary review. The film quality was interpreted for compliance with AWS D1.5-2002 Section 6.10. The weld quality were interpreted for compliance with AWS D1.5-2002 Section 6.26 paragraph 6.26.2.1 and Figure 6.8 (weld quality requirements for discontinuities occurring in tension welds) and the results met the requirements of Figure 6.4. The Quality Assurance Inspector concurred with NDT Level II Inspector Mr. Shoecraft's results. Caltrans lot number B228-005-11 was assigned for tracking purposes.
