**DEPARTMENT OF TRANSPORTATION**

Contract #: 04-0120F4Cty: SF/ALA Rte: 80 PM: 13.2/13.9File #: 1.28**WELDING INSPECTION REPORT****Resident Engineer:** Siegenthaler, Peter**Address:** 333 Burma Road**City:** Oakland, CA 94607**Report No:** WIR-023488**Date Inspected:** 12-May-2011**Project Name:** SAS Superstructure**OSM Arrival Time:** 700**Prime Contractor:** American Bridge/Fluor Enterprises, a JV**OSM Departure Time:** 1530**Contractor:** American Bridge/Fluor Enterprises, a JV**Location:** Jobsite

**Bridge No:** 34-0006**Component:** SAS OBG**Summary of Items Observed:**

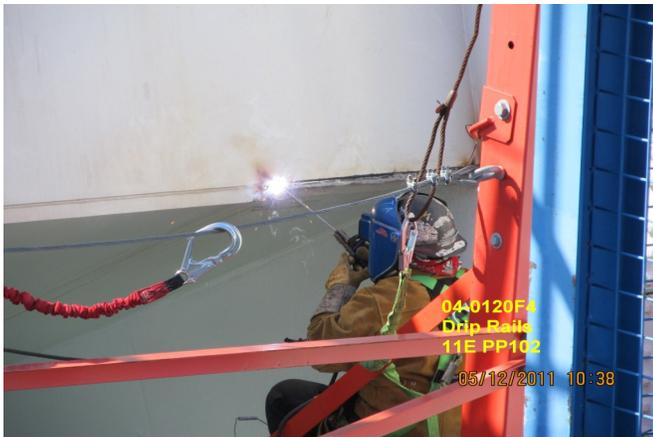
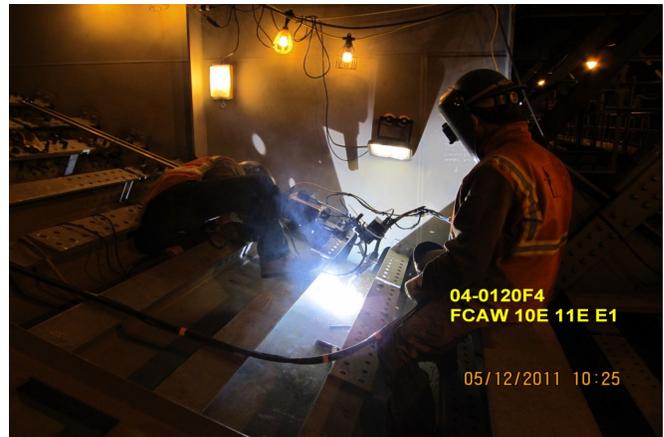
The QA Inspector noted and periodically observed ABF welder Gil Peralta performing Shielded Metal Arc Welding (SMAW) on the Drip Rail located at 11E PP102. The QA Inspector observed the QC inspector Fred Von Hoff as being present in order to monitor the progress and ensure the welding parameters were within the established WPS. The work was completed on this date and the QA Inspector noted that the work appeared to be in general conformance with the contract documents.

observed the QC inspector Fred Von Hoff as being present in order to monitor the progress and ensure the welding parameters were within the established WPS. The QA Inspector noted that the work was in progress and appeared to be in general conformance with the contract documents.

The QA Inspector performed a Magnetic Particle Test (MT) on the Lifting Lug Holes (LLH) #1- 4 at 8W PP64 W3. The QA Inspector tested 10% of the weld to verify the weld and testing by QC meet the requirements of the contract documents. . The QA Inspector noted that the work appeared to be free of defects and was found to be acceptable and in general conformance with the contract documents. Upon completion of the MT, the QA Inspector performed Ultrasonic Testing utilizing a G.E./Krautkramer USN 60. The QA Inspector also utilized the UT Procedure identified as SE-UT-D1.5-CT-100 Rev.4 during the examination. Upon completion of the testing, it was noted by the QA Inspector that no indications were present and the work was found to be acceptable.

The QA Inspector observed ABF welder Fred Kaddu preparing the joint geometry of the DAH plate located at 10W PP71 as related to the project. The QA Inspector noted that the work continued throughout the QA Inspectors shift and is in progress.
