**DEPARTMENT OF TRANSPORTATION**

Contract #: 04-0120F4Cty: SF/Ala Rte: 80 PM: 13.2/13.9File #: 69.28**WELDING INSPECTION REPORT****Resident Engineer:** Siegenthaler, Peter**Address:** 333 Burma Road**City:** Oakland, CA 94607**Report No:** WIR-023546**Date Inspected:** 03-May-2011**Project Name:** SAS Superstructure**OSM Arrival Time:** 1900**Prime Contractor:** American Bridge/Fluor Enterprises, a JV**OSM Departure Time:** 300**Contractor:** Zhenhua Port Machinery Company, Ltd (ZPMC), Changxing Island **Location:** Shanghai, China**CWI Name:** See below**CWI Present:** Yes No**Inspected CWI report:** Yes No N/A**Rod Oven in Use:** Yes No N/A**Electrode to specification:** Yes No N/A**Weld Procedures Followed:** Yes No N/A**Qualified Welders:** Yes No N/A**Verified Joint Fit-up:** Yes No N/A**Approved Drawings:** Yes No N/A**Approved WPS:** Yes No N/A**Delayed / Cancelled:** Yes No N/A**Bridge No:** 34-0006**Component:** OBG and Tower Components**Summary of Items Observed:**

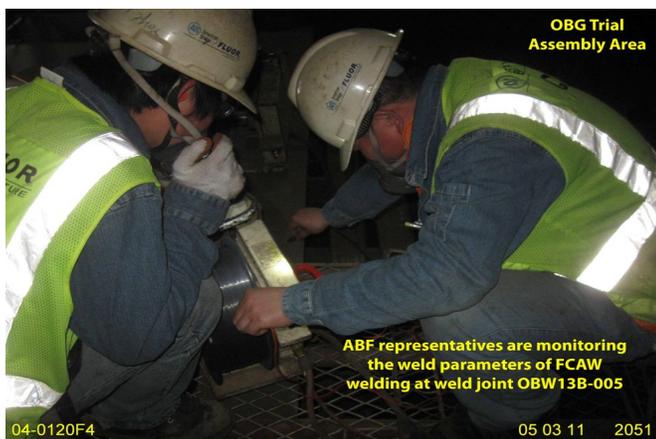
FCAW welding of weld joint OBW13B-005 located at the PCMK OBG 13AW/13BW bottom plate transverse joint. Welder was identified as 066673. QC was identified as QC3. Assisting QC3 at this location and appearing to be monitoring the welding operation and recording data was QCA3, who was not a CWI. appeared to comply with WPS-B-T-2231T-ESAB-1 as verbally identified by QCA3. See photo below of ABF representatives monitoring weld parameters at this location.
