DEPARTMENT OF TRANSPORTATION

Contract #: 04-0120F4Cty: SF/ALA Rte: 80 PM: 13.2/13.9File #: 1.28**WELDING INSPECTION REPORT****Resident Engineer:** Siegenthaler, Peter**Address:** 333 Burma Road**City:** Oakland, CA 94607**Report No:** WIR-023629**Date Inspected:** 14-May-2011**Project Name:** SAS Superstructure**OSM Arrival Time:** 700**Prime Contractor:** American Bridge/Fluor Enterprises, a JV**OSM Departure Time:** 1530**Contractor:** American Bridge/Fluor Enterprises, a JV**Location:** Job Site**CWI Name:** See Report Below**CWI Present:** Yes No**Inspected CWI report:** Yes No N/A**Rod Oven in Use:** Yes No N/A**Electrode to specification:** Yes No N/A**Weld Procedures Followed:** Yes No N/A**Qualified Welders:** Yes No N/A**Verified Joint Fit-up:** Yes No N/A**Approved Drawings:** Yes No N/A**Approved WPS:** Yes No N/A**Delayed / Cancelled:** Yes No N/A**Bridge No:** 34-0006**Component:** Orthotropic Box Girders**Summary of Items Observed:**

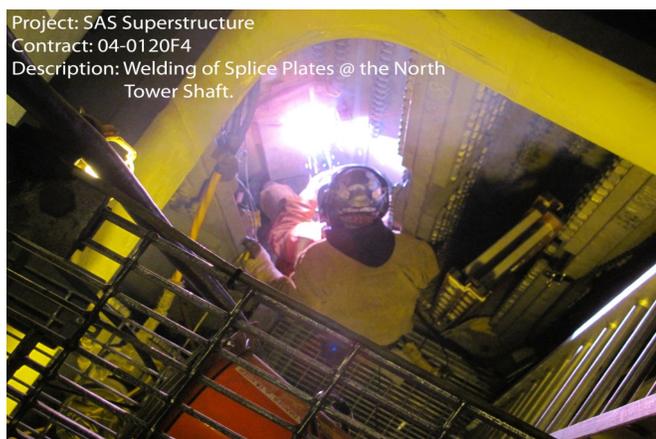
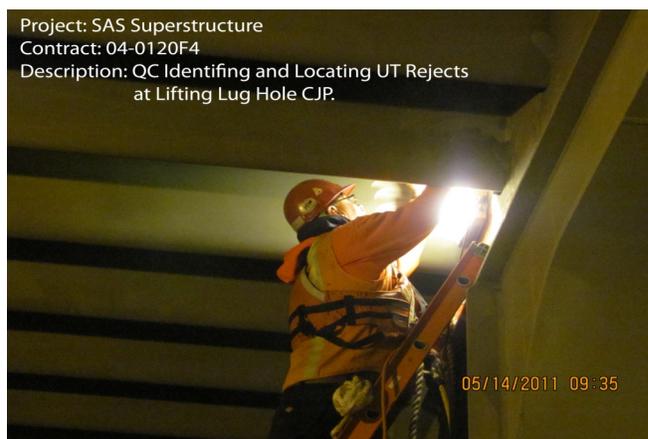
The digital photographs below illustrate some of the related work activities observed during this scheduled shift.
