**DEPARTMENT OF TRANSPORTATION**

Contract #: 04-0120F4Cty: SF/ALA Rte: 80 PM: 13.2/13.9File #: 1.28**WELDING INSPECTION REPORT****Resident Engineer:** Siegenthaler, Peter**Address:** 333 Burma Road**City:** Oakland, CA 94607**Report No:** WIR-023662**Date Inspected:** 16-May-2011**Project Name:** SAS Superstructure**OSM Arrival Time:** 700**Prime Contractor:** American Bridge/Fluor Enterprises, a JV**OSM Departure Time:** 1730**Contractor:** American Bridge/Fluor Enterprises, a JV**Location:** Job Site**CWI Name:** Steve Jensen**CWI Present:** Yes No**Inspected CWI report:** Yes No N/A**Rod Oven in Use:** Yes No N/A**Electrode to specification:** Yes No N/A**Weld Procedures Followed:** Yes No N/A**Qualified Welders:** Yes No N/A**Verified Joint Fit-up:** Yes No N/A**Approved Drawings:** Yes No N/A**Approved WPS:** Yes No N/A**Delayed / Cancelled:** Yes No N/A**Bridge No:** 34-0006**Component:** SAS Tower**Summary of Items Observed:**

## WELDING INSPECTION REPORT

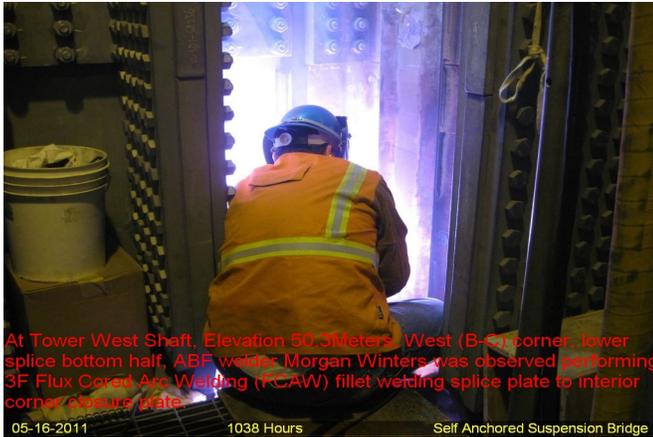
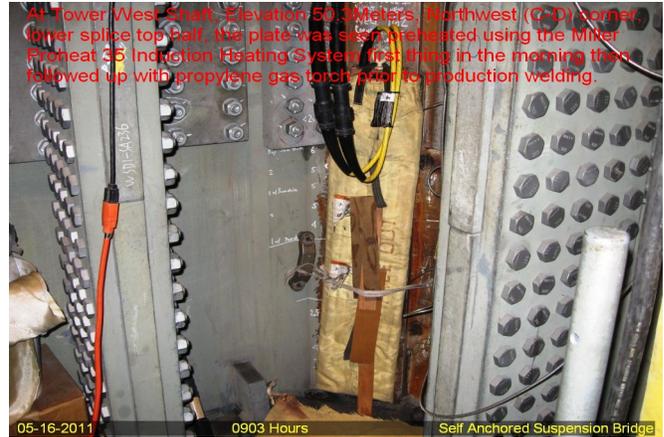
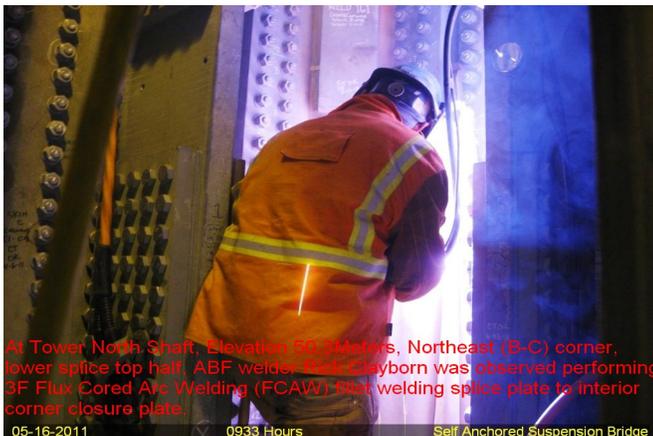
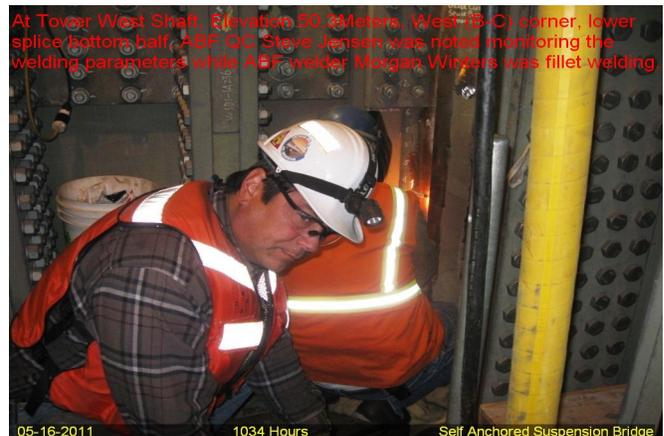
At Northwest (C-D) corner, lower splice plate; this QA Inspector randomly observed ABF welding personnel Salvador Sandoval (#2202) continuing to perform production welding on the top half of the splice plate using the self shielded Flux Cored Arc Welding (FCAW) process. This QA Inspector observed a propylene gas torch was being used to preheat areas prior to welding. This QA Inspector observed QC Inspector Steve Jensen using an infra red temperature gauge to verify the preheat temperature of more than 300°F. This QA Inspector performed a verification of the welding parameters and observed 265 amperes and 22.0 volts with a travel speed of 95 mm per minute with equivalent heat input of 3.68 KJ per mm. The welding appeared to comply with Welding Procedure Specification (WPS) ABF-WPS-D15-F2200-3. The welder continued fill pass fillet welding on both sides of the plate until 1700hours. Before the end of the shift, the welder has stopped fillet welding and ABF personnel were noted covering the weld with heater blanket in preparation for the three hours holding of preheat temperature of more than 300°F as required. ABF personnel were using Miller Proheat 35 Induction Heating System to hold the preheat that was programmed to shut off after three hours.

At West (B-C) corner, lower splice plate; This QA Inspector randomly observed ABF welding personnel Morgan Winters continuing to perform production welding on the bottom half of the lower splice plate using the self shielded Flux Cored Arc Welding (FCAW) process. This QA Inspector observed ABF personnel using a propylene gas torch on areas prior to welding. This QA Inspector observed QC Inspector Steve Jensen using a Fluke infra red temperature gauge to verify the preheat temperature of more than 300°F. This QA Inspector performed a verification of the welding parameters and observed 244 amperes and 19.8 volts with a travel speed of 95 mm per minute with equivalent heat input of 3.05 Kj per mm. The welding appeared to comply with Welding Procedure Specification (WPS) ABF-WPS-D15-F2200-3. At the end of the shift, fillet welding was still continuing and should remain tomorrow. Before the end of the shift, at around 1700hours, ABF personnel were noted covering the weld with heater blanket in preparation for the three hours holding of preheat temperature of more than 300°F as required. ABF personnel were using Miller Proheat 35 Induction Heating System to hold the preheat that was programmed to shut off after three hours.

At Northeast (B-C) corner, lower splice plate; This QA Inspector randomly observed ABF welding personnel Rick Clayborn perform production welding on the top half of the lower splice plate using the self shielded Flux Cored Arc Welding (FCAW) process. This QA Inspector observed ABF personnel using a propylene gas torch on areas prior to welding. This QA Inspector observed QC Inspector Steve Jensen using a Fluke infra red temperature gauge to verify the preheat temperature of more than 300°F. This QA Inspector performed a verification of the welding parameters and observed 270 amperes and 22.0 volts with a travel speed of 100 mm per minute with equivalent heat input of 3.56 Kj per mm. The welding appeared to comply with Welding Procedure Specification (WPS) ABF-WPS-D15-F2200-3. At the end of the shift, fillet welding was still continuing and should remain tomorrow. Before the end of the shift, at around 1700hours, ABF personnel were noted covering the weld with heater blanket in preparation for the three hours holding of preheat temperature of more than 300°F as required. ABF personnel were using Miller Proheat 35 Induction Heating System to hold the preheat that was programmed to shut off after three hours.

At Tower East Shaft, East (B-C) corner and Southeast (C-D) corner, ABF welder Richard Garcia was observed performing fit up of the lower splice plates to interior corner closure plate. The welder has tack welded various temporary attachments using SMAW to the interior corner closure plate and used wedges to hold the lower splice plates in place. The welder was also noted preheating the plates to more than 225°F prior welding. ABF QC Steve Jensen was noted at site monitoring the welder and his welding parameter. At the end of the shift, the fit up of the splice plates at location mentioned above was completed.
