**DEPARTMENT OF TRANSPORTATION**

Contract #: 04-0120F4Cty: SF/ALA Rte: 80 PM: 13.2/13.9File #: 1.28**WELDING INSPECTION REPORT****Resident Engineer:** Siegenthaler, Peter**Address:** 333 Burma Road**City:** Oakland, CA 94607**Report No:** WIR-023737**Date Inspected:** 17-May-2011**Project Name:** SAS Superstructure**OSM Arrival Time:** 700**Prime Contractor:** American Bridge/Fluor Enterprises, a JV**OSM Departure Time:** 1530**Contractor:** American Bridge/Fluor Enterprises, a JV**Location:** Job Site**CWI Name:** Steve Jensen**CWI Present:** Yes No**Inspected CWI report:** Yes No N/A**Rod Oven in Use:** Yes No N/A**Electrode to specification:** Yes No N/A**Weld Procedures Followed:** Yes No N/A**Qualified Welders:** Yes No N/A**Verified Joint Fit-up:** Yes No N/A**Approved Drawings:** Yes No N/A**Approved WPS:** Yes No N/A**Delayed / Cancelled:** Yes No N/A**Bridge No:** 34-0006**Component:** SAS Tower**Summary of Items Observed:**

At Tower West Shaft Splice #1 @Elevation 50.3meters:

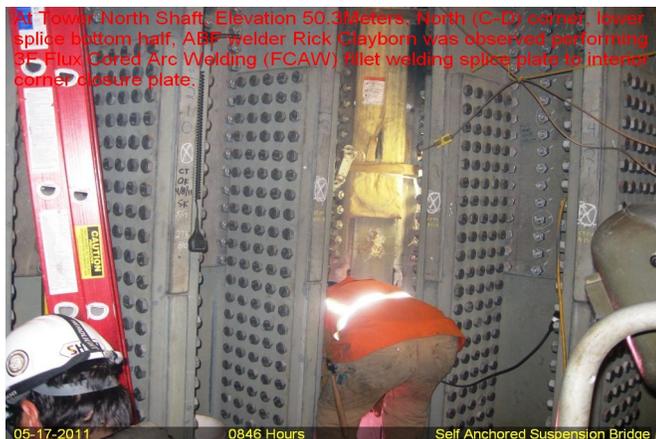
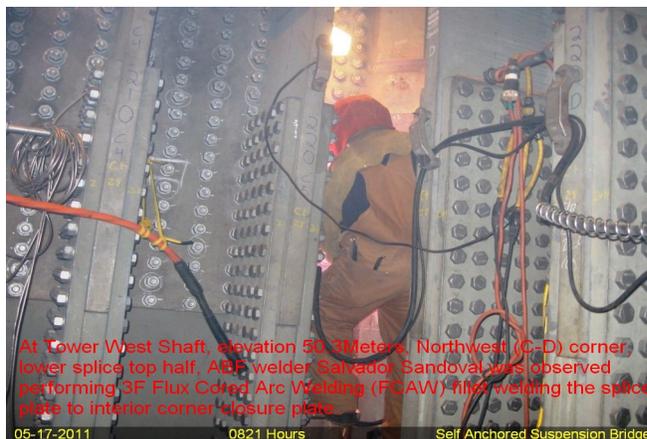
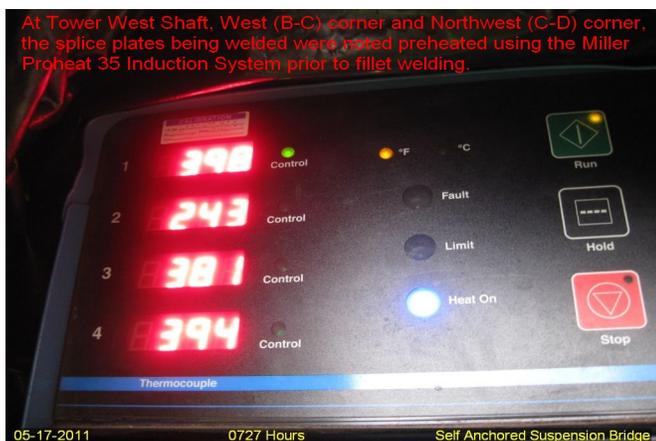
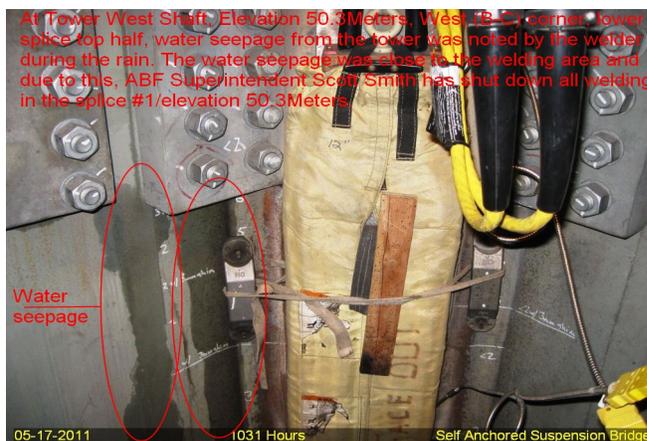
At Northwest (C-D) corner, lower splice plate; this QA Inspector randomly observed ABF welding personnel Salvador Sandoval (#2202) continuing to perform production welding on the top half of the splice plate using the self shielded Flux Cored Arc Welding (FCAW) process. This QA Inspector observed a propylene gas torch was being used to preheat areas prior to welding. This QA Inspector observed QC Inspector Steve Jensen using an infra red temperature gauge to verify the preheat temperature of more than 300°F. This QA Inspector performed a verification of the welding parameters and observed 270 amperes and 22.0 volts with a travel speed of 100 mm per minute with equivalent heat input of 3.56 KJ per mm. The welding appeared to comply with Welding Procedure Specification (WPS) ABF-WPS-D15-F2200-3. The welder continued fill pass fillet welding on both sides of the plate until 1000hours when some of the Tower splice joints were seeping water near the interior closure corner and ABF Superintendent Scott Smith has shut down his welding crew. After the first break at around 1015hours, the welder has stopped fillet welding and ABF personnel were noted covering the weld with heater blanket in preparation for the three hours holding of preheat temperature of more than 300°F as required. ABF personnel were using Miller Proheat 35 Induction Heating System to hold the preheat that was programmed to shut off after three hours.

At West (B-C) corner, lower splice plate; This QA Inspector randomly observed ABF welding personnel Morgan Winters continuing to perform production welding on the bottom half of the lower splice plate using the self shielded Flux Cored Arc Welding (FCAW) process. This QA Inspector observed ABF personnel using a propylene gas torch on areas prior to welding. This QA Inspector observed QC Inspector Steve Jensen using a Fluke infra red temperature gauge to verify the preheat temperature of more than 300°F. This QA Inspector performed a verification of the welding parameters and observed 258 amperes and 21.6 volts with a travel speed of 95 mm per minute with equivalent heat input of 3.52 Kj per mm. The welding appeared to comply with Welding Procedure Specification (WPS) ABF-WPS-D15-F2200-3. The welder continued fill pass fillet welding on both sides of the plate until 1000 hours when some of the Tower splice joints were seeping water near the interior closure corner and ABF Superintendent Scott Smith has shut down his welding crew. The water seepage was close to the joint where this welder was welding. After the first break at around 1015 hours, ABF personnel were noted covering the welds with heater blanket in preparation for the three hours holding of preheat temperature of more than 300°F as required. ABF personnel were using Miller Proheat 35 Induction Heating System to hold the preheat that was programmed to shut off after three hours.

At North (C-D) corner, lower splice plate; This QA Inspector randomly observed ABF welding personnel Rick Clayborn perform production welding on the bottom half of the lower splice plate using the self shielded Flux Cored Arc Welding (FCAW) process. This QA Inspector observed ABF personnel using a propylene gas torch on areas prior to welding. This QA Inspector observed QC Inspector Steve Jensen using a Fluke infra red temperature gauge to verify the preheat temperature of more than 300°F. This QA Inspector performed a verification of the welding parameters and observed 273 amperes and 22.1 volts with a travel speed of 85 mm per minute with equivalent heat input of 3.56 Kj per mm. The welding appeared to comply with Welding Procedure Specification (WPS) ABF-WPS-D15-F2200-3. The welder continued fill pass fillet welding on both sides of the plate until 1000 hours when some of the Tower splice joints were seeping water near the interior closure corner and ABF Superintendent Scott Smith has shut down his welding crew. After the first break at around 1015hours, ABF personnel were noted covering the welds with heater blanket in preparation for the three hours holding of preheat temperature of more than 300°F as required. ABF personnel were using Miller Proheat 35 Induction Heating System to hold the preheat that was programmed to shut off after three hours.

It was rainy day today and water seepage was going through the tower splice joints that were noted in one of the splice joint that was being welded. Due to the bad weather condition and this incident, ABF Superintendent Scott Smith has shut down the tower splice welding at 1100 hours.
