DEPARTMENT OF TRANSPORTATION

Contract #: 04-0120F4Cty: SF/ALA Rte: 80 PM: 13.2/13.9File #: 99.28**WELDING INSPECTION REPORT****Resident Engineer:** Siegenthaler, Peter**Address:** 333 Burma Road**City:** Oakland, CA 94607**Report No:** WIR-023895**Date Inspected:** 19-May-2011**Project Name:** SAS Superstructure**OSM Arrival Time:** 700**Prime Contractor:** American Bridge/Fluor Enterprises, a JV**OSM Departure Time:** 1900**Contractor:** Zhenhua Port Machinery Company, Ltd (ZPMC) Chanxing Island**Location:** Shanghai, China**CWI Name:** Mr. Shi Lei**CWI Present:** Yes No**Inspected CWI report:** Yes No N/A**Rod Oven in Use:** Yes No N/A**Electrode to specification:** Yes No N/A**Weld Procedures Followed:** Yes No N/A**Qualified Welders:** Yes No N/A**Verified Joint Fit-up:** Yes No N/A**Approved Drawings:** Yes No N/A**Approved WPS:** Yes No N/A**Delayed / Cancelled:** Yes No N/A**Bridge No:** 34-0006**Component:** OBG Segment**Summary of Items Observed:**

WELDING INSPECTION REPORT

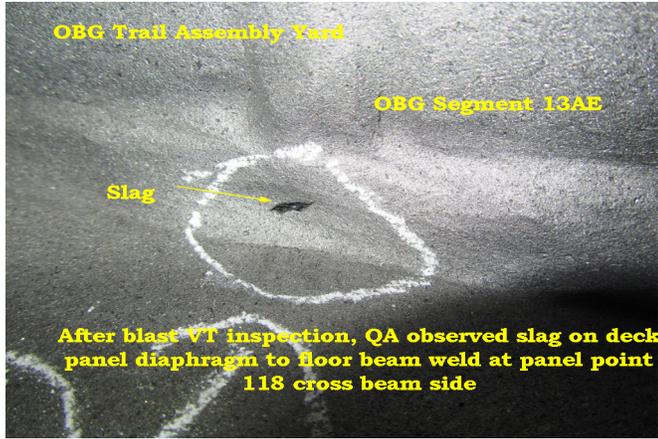
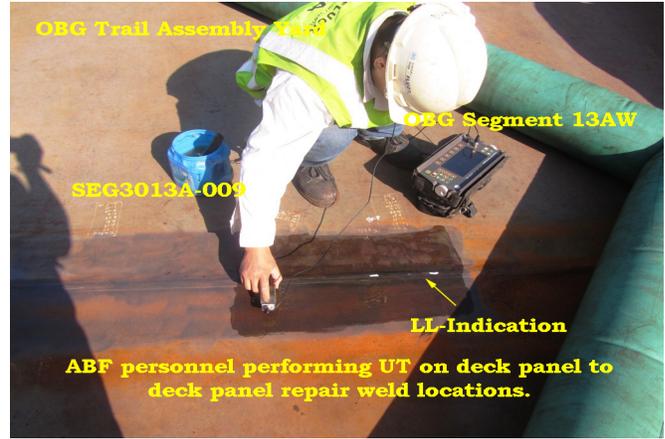
This QA Inspector performed a preliminary random visual inspection on OBG Segment 13AE, before the grit blast of the interior components of the deck panel U-ribs, floor beams, side plate, longitudinal diaphragm, edge beams and corner assemblies of this segment. The panel points are identified as PP117.5 to 119-1500 at cross beam side. Areas of visual weld defects that will require welding were marked and will be repaired before the blasting/coating is applied. ZPMC QC personnel are aware of these areas and were present during the inspection. See the attached picture.
