DEPARTMENT OF TRANSPORTATION

Contract #: 04-0120F4Cty: SF/ALA Rte: 80 PM: 13.2/13.9File #: 1.28**WELDING INSPECTION REPORT****Resident Engineer:** Siegenthaler, Peter**Address:** 333 Burma Road**City:** Oakland, CA 94607**Report No:** WIR-023906**Date Inspected:** 18-May-2011**Project Name:** SAS Superstructure**OSM Arrival Time:** 700**Prime Contractor:** American Bridge/Fluor Enterprises, a JV**OSM Departure Time:** 1530**Contractor:** American Bridge/Fluor Enterprises, a JV**Location:** Job Site**CWI Name:** Pat Swain**CWI Present:** Yes No**Inspected CWI report:** Yes No N/A**Rod Oven in Use:** Yes No N/A**Electrode to specification:** Yes No N/A**Weld Procedures Followed:** Yes No N/A**Qualified Welders:** Yes No N/A**Verified Joint Fit-up:** Yes No N/A**Approved Drawings:** Yes No N/A**Approved WPS:** Yes No N/A**Delayed / Cancelled:** Yes No N/A**Bridge No:** 34-0006**Component:** Tower**Summary of Items Observed:**

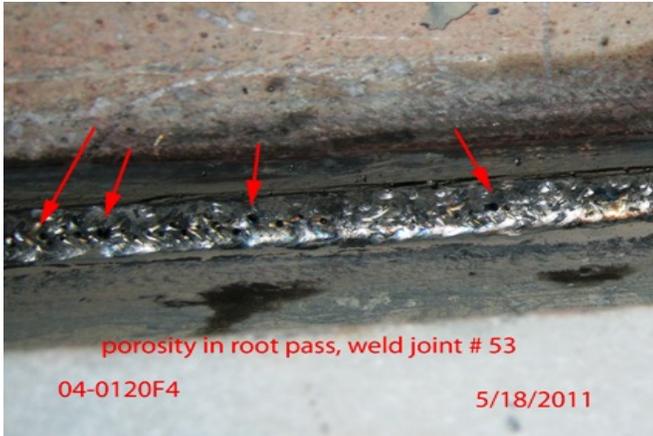
Welding (FCAW) process. This QA Inspector observed as QC Inspector Pat Swain verified the following welding parameters; Xiao Jian Wan (#9677) 285 amperes and 25.1 volts at a travel speed of 388 mm per minute to produce a heat input of 1.11 Kj per mm, Jin Quan Huang (#9340) 291 amperes and 25.3 volts at a travel speed of 500 mm per minute to produce a heat input of 0.88 Kj per mm and Wai Kitlai (#2953) 290 amperes and 25.1 volts at travel speed of 400 mm per minute to produce a heat input of 1.09 Kj per mm. The welding observed appeared to comply with Welding Procedure Specification (WPS) ABF-WPS-D15-3160-1. See photo below, noting close working conditions.

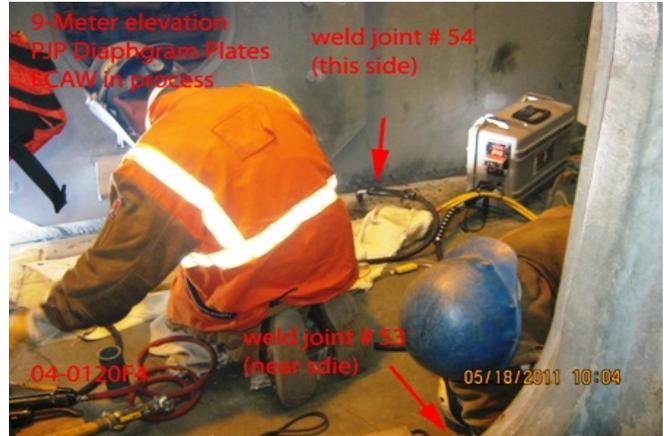
QC Inspector Pat Swain informed this QA Inspector he was rejecting the visual inspection of the root pass on weld joint #53 due to porosity. This QA Inspector performed a random visual verification and concurred, the porosity was intermittent (approximately 25%) for the full length of the root pass. See photo below. This QA Inspector observed ABF welding personnel Xiao Jian Wan (#9677) using a burr to grind out the root pass and was informed by ABF welding Foreman James Zhen (#6001) the entire root pass would be removed.
