DEPARTMENT OF TRANSPORTATION

Office of Structural Materials

Contract #: 04-0120F4Cty: SF/ALA Rte: 80 PM: 13.2/13.9File #: 1.28**WELDING INSPECTION REPORT****Resident Engineer:** Siegenthaler, Peter**Address:** 333 Burma Road**City:** Oakland, CA 94607**Report No:** WIR-023941**Date Inspected:** 23-May-2011**Project Name:** SAS Superstructure**OSM Arrival Time:** 700**Prime Contractor:** American Bridge/Fluor Enterprises, a JV**OSM Departure Time:** 1730**Contractor:** American Bridge/Fluor Enterprises, a JV**Location:** Job Site**CWI Name:** William Sherwood**CWI Present:** Yes No**Inspected CWI report:** Yes No N/A**Rod Oven in Use:** Yes No N/A**Electrode to specification:** Yes No N/A**Weld Procedures Followed:** Yes No N/A**Qualified Welders:** Yes No N/A**Verified Joint Fit-up:** Yes No N/A**Approved Drawings:** Yes No N/A**Approved WPS:** Yes No N/A**Delayed / Cancelled:** Yes No N/A**Bridge No:** 34-0006**Component:** SAS Tower**Summary of Items Observed:**

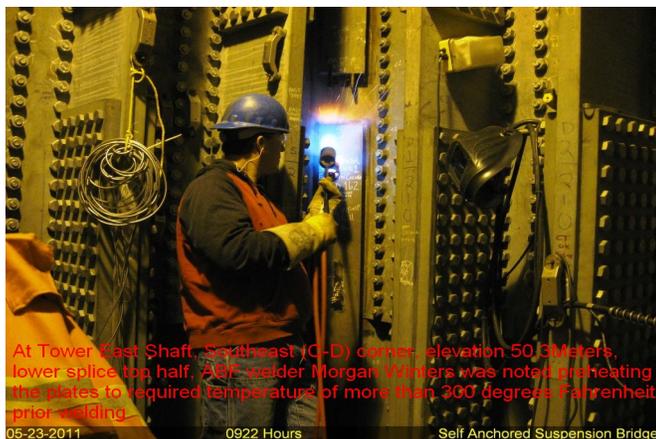
At Southeast (C-D) corner, lower splice plate; This QA Inspector randomly observed ABF welding personnel Morgan Winters continuing to perform production welding on the top half of the lower splice plate using the self shielded Flux Cored Arc Welding (FCAW) process with 1.8mm diameter E71T-8 wire electrode implementing Caltrans approved (WPS) ABF-WPS-D15-F2200-3. This QA Inspector observed ABF personnel using a propylene gas torch on plates to be welded prior to welding. This QA Inspector observed QC Inspector William Sherwood using a Fluke infra red temperature gauge to verify the preheat temperature of more than 300°F. This QA Inspector performed a verification of the welding parameters and observed 240 amperes and 21.3 volts with a travel speed of 90 mm per minute with equivalent heat input of 3.22 KJ per mm. The welding appeared to comply with Welding Procedure Specification (WPS) ABF-WPS-D15-F2200-3. During the shift, 3F fillet welding of the top half was completed and the welder has moved to the bottom of the splice plate and performed 3F fillet welding. The welder was noted using same process as previously used. At the end of the shift, 3F fillet welding was still continuing and should remain tomorrow. ABF personnel were noted covering the weld with heater blanket in preparation for the three hours holding of preheat temperature of more than 300°F as required. ABF personnel were using Miller Proheat 35 Induction Heating System to hold the preheat that was programmed to shut off after three hours.

At Tower East Shaft, Southeast (C-D) corner, elevation 50.3Meters, lower splice top half, ABF welder Morgan Winters was noted preheating the plates to required temperature of more than 300 degrees Fahrenheit prior welding.
05-23-2011 0922 Hours Self Anchored Suspension Bridge

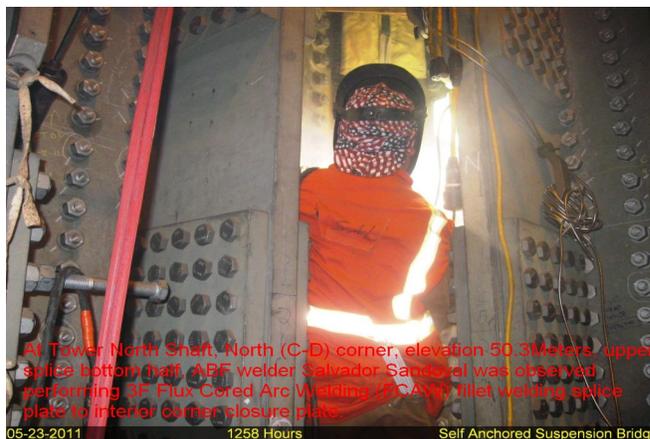
At North (C-D) corner, upper splice plate; This QA Inspector randomly observed ABF welding personnel Salvador Sandoval continuing to perform production welding on the bottom half of the upper splice plate using the self shielded Flux Cored Arc Welding (FCAW) process with 1.8mm diameter E71T-8 wire electrode implementing Caltrans approved (WPS) ABF-WPS-D15-F2200-3. This QA Inspector observed ABF personnel using a propylene gas torch on plates to be welded prior to welding. This QA Inspector observed QC Inspector William Sherwood using a Fluke infra red temperature gauge to verify the preheat temperature of more than 300°F. This QA Inspector performed a verification of the welding parameters and observed 250 amperes and 22.0 volts with a travel speed of 80 mm per minute with equivalent heat input of 4.12 Kj per mm. The welding appeared to comply with Welding Procedure Specification (WPS) ABF-WPS-D15-F2200-3. After the completion of the vertical fillet welds, the welder has moved to the bottom of the plate and fillet welded overhead on the splice joint. The welder's welding parameter was measured 195 amperes on a 5/32" diameter E7018H4R electrode complying with the Caltrans approved ABF-WPS-D15-F1200A. Before the end of the shift, ABF QC William Sherwood called this QA and asked for a Visual Test (VT) on the completely welded upper and lower splice plates. This QA has noted that the upper splice plate top and bottom halves were deemed acceptable but the lower splice plate top and bottom halves were noted underfill on the right side of the plate. Since it was already the end of the shift, the welder has told QA and QC that the underfill will be fixed tomorrow. ABF personnel were noted covering the weld with heater blanket in preparation for the three hours holding of preheat temperature of more than 300°F as required. ABF personnel were using Miller Proheat 35 Induction Heating System to hold the preheat that was programmed to shut off after three hours.

At Tower North Shaft, North (C-D) corner, elevation 50.3Meters, upper splice bottom half, ABF welder Salvador Salsorel was observed performing 3F Flux Cored Arc Welding (FCAW) fillet welding splice plate to interior corner closure plate.
05-23-2011 1258 Hours Self Anchored Suspension Bridge

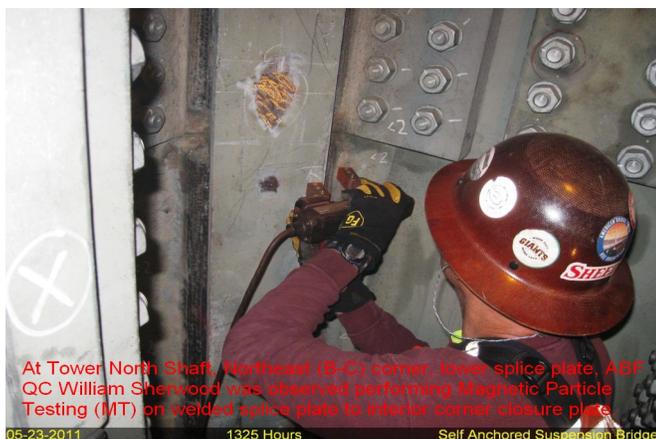
At Tower North Shaft, Northeast (B-C) corner, lower splice plate, ABF QC William Sherwood was observed performing Magnetic Particle Testing (MT) on welded splice plate to interior corner closure plate.
05-23-2011 1325 Hours Self Anchored Suspension Bridge

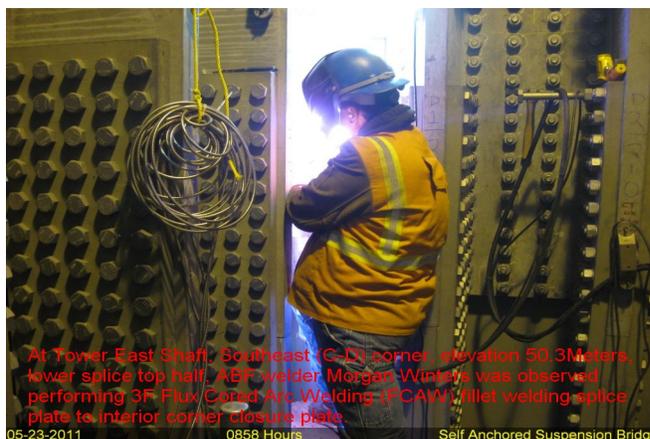
At Tower East Shaft, Southeast (C-D) corner, elevation 50.3Meters, lower splice top half, ABF welder Morgan Winters was observed performing 3F Flux Cored Arc Welding (FCAW) fillet welding splice plate to interior corner closure plate.
05-23-2011 0858 Hours Self Anchored Suspension Bridge
