DEPARTMENT OF TRANSPORTATION

Contract #: 04-0120F4Cty: SF/ALA Rte: 80 PM: 13.2/13.9File #: 1.28**WELDING INSPECTION REPORT****Resident Engineer:** Siegenthaler, Peter**Address:** 333 Burma Road**City:** Oakland, CA 94607**Report No:** WIR-023958**Date Inspected:** 25-May-2011**Project Name:** SAS Superstructure**OSM Arrival Time:** 700**Prime Contractor:** American Bridge/Fluor Enterprises, a JV**OSM Departure Time:** 1930**Contractor:** American Bridge/Fluor Enterprises, a JV**Location:** Job Site**CWI Name:** Pat Swain**CWI Present:** Yes No**Inspected CWI report:** Yes No N/A**Rod Oven in Use:** Yes No N/A**Electrode to specification:** Yes No N/A**Weld Procedures Followed:** Yes No N/A**Qualified Welders:** Yes No N/A**Verified Joint Fit-up:** Yes No N/A**Approved Drawings:** Yes No N/A**Approved WPS:** Yes No N/A**Delayed / Cancelled:** Yes No N/A**Bridge No:** 34-0006**Component:** Tower**Summary of Items Observed:**

WELDING INSPECTION REPORT

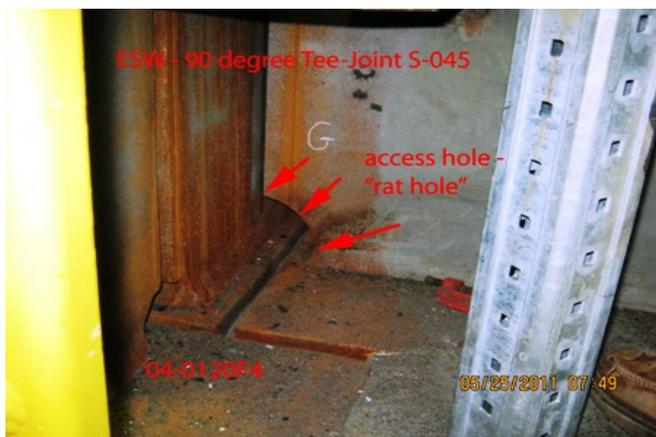
informed this QA Inspector the root opening was between 16 mm and 25 mm, within the range specified on the WPS. This QA Inspector used a taper gauge and took random measurements from the 3-meter to 13-meter elevations to verify this information. This QA Inspector did not observed any gaps less than 16 mm or greater than 25 mm. The root gap appeared to comply with ABF-WPS-ESW-90T. See photo below of root gap and access hole.
