Contract #: 04-0120F4Cty: SF/ALA Rte: 80 PM: 13.2/13.9File #: 1.28**WELDING INSPECTION REPORT****Resident Engineer:** Siegenthaler, Peter**Address:** 333 Burma Road**City:** Oakland, CA 94607**Report No:** WIR-024062**Date Inspected:** 27-May-2011**Project Name:** SAS Superstructure**OSM Arrival Time:** 700**Prime Contractor:** American Bridge/Fluor Enterprises, a JV**OSM Departure Time:** 1530**Contractor:** American Bridge/Fluor Enterprises, a JV**Location:** Jobsite**CWI Name:** John Pagliero**CWI Present:** Yes No**Inspected CWI report:** Yes No N/A**Rod Oven in Use:** Yes No N/A**Electrode to specification:** Yes No N/A**Weld Procedures Followed:** Yes No N/A**Qualified Welders:** Yes No N/A**Verified Joint Fit-up:** Yes No N/A**Approved Drawings:** Yes No N/A**Approved WPS:** Yes No N/A**Delayed / Cancelled:** Yes No N/A**Bridge No:** 34-0006**Component:** SAS OBG**Summary of Items Observed:**

WELDING INSPECTION REPORT

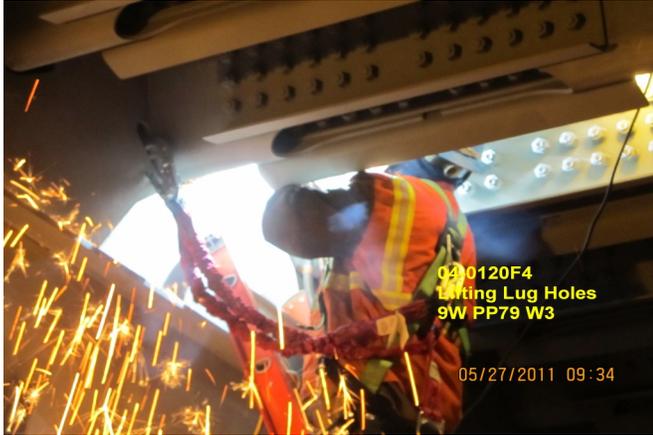
1. 9W PP79 W3 Lifting Lug Holes (Inside)

The QA Inspector randomly observed the ABF welder Darcel Jackson performing SMAW on the LLH's located at 9W PP79 W3. The QA Inspector noted that the QC Inspector identified as John Pagliero was present in order to monitor the progress and ensure the welding parameters were within the established WPS. The work was completed on this date and the QA Inspector noted that the work appeared to be in general conformance with the contract documents.
