Contract #: 04-0120F4Cty: SF/ALA Rte: 80 PM: 13.2/13.9File #: 1.28**WELDING INSPECTION REPORT****Resident Engineer:** Siegenthaler, Peter**Address:** 333 Burma Road**City:** Oakland, CA 94607**Report No:** WIR-024080**Date Inspected:** 31-May-2011**Project Name:** SAS Superstructure**OSM Arrival Time:** 700**Prime Contractor:** American Bridge/Fluor Enterprises, a JV**OSM Departure Time:** 1530**Contractor:** American Bridge/Fluor Enterprises, a JV**Location:** Job Site**CWI Name:** Pat Swain**CWI Present:** Yes No**Inspected CWI report:** Yes No N/A**Rod Oven in Use:** Yes No N/A**Electrode to specification:** Yes No N/A**Weld Procedures Followed:** Yes No N/A**Qualified Welders:** Yes No N/A**Verified Joint Fit-up:** Yes No N/A**Approved Drawings:** Yes No N/A**Approved WPS:** Yes No N/A**Delayed / Cancelled:** Yes No N/A**Bridge No:** 34-0006**Component:** Tower**Summary of Items Observed:**

WELDING INSPECTION REPORT

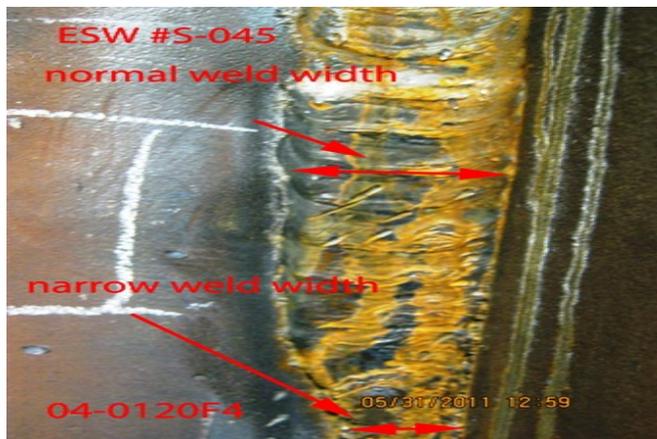
This QA Inspector performed a random visual and observed the vast majority of the weld appeared to have a "normal" width and the sides (toes) appeared to be fused to the base metal, whereas when the weld appeared to have a narrow width the filler metal did not appear to be fused to the base metal. See photo below.
