Contract #: 04-0120F4Cty: SF/ALA Rte: 80 PM: 13.2/13.9File #: 69.28**WELDING INSPECTION REPORT****Resident Engineer:** Siegenthaler, Peter**Address:** 333 Burma Road**City:** Oakland, CA 94607**Report No:** WIR-024096**Date Inspected:** 25-May-2011**Project Name:** SAS Superstructure**OSM Arrival Time:** 700**Prime Contractor:** American Bridge/Fluor Enterprises, a JV**OSM Departure Time:** 1900**Contractor:** Zhenhua Port Machinery Company, Ltd (ZPMC), Changxing Island **Location:** Shanghai, China**CWI Name:** Mr. An Qing Xiang**CWI Present:** Yes No**Inspected CWI report:** Yes No N/A**Rod Oven in Use:** Yes No N/A**Electrode to specification:** Yes No N/A**Weld Procedures Followed:** Yes No N/A**Qualified Welders:** Yes No N/A**Verified Joint Fit-up:** Yes No N/A**Approved Drawings:** Yes No N/A**Approved WPS:** Yes No N/A**Delayed / Cancelled:** Yes No N/A**Bridge No:** 34-0006**Component:** Orthotropic Box Girder (OBG)**Summary of Items Observed:**

OBG Trial Assembly open yard.

Segment: 13AW

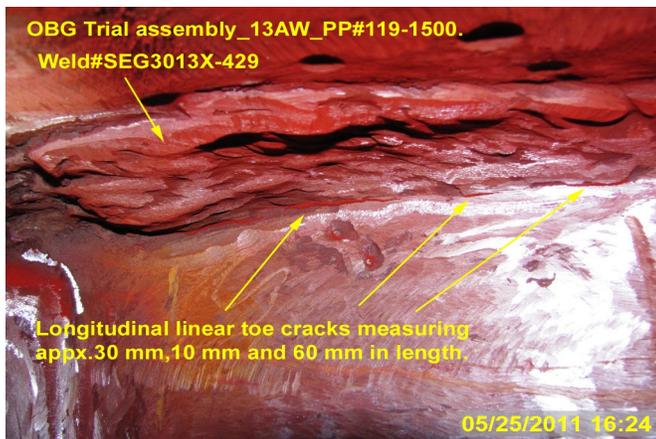
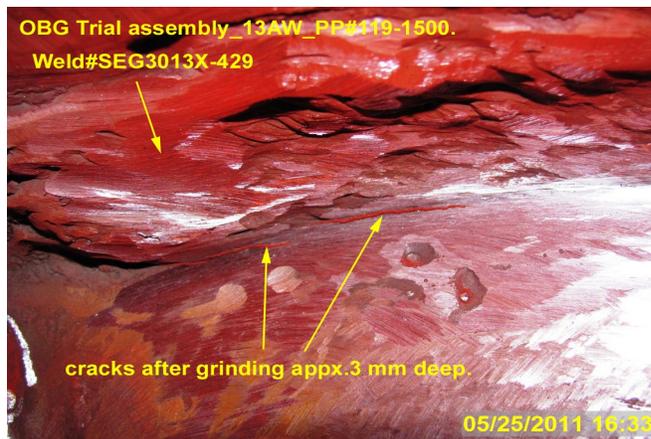
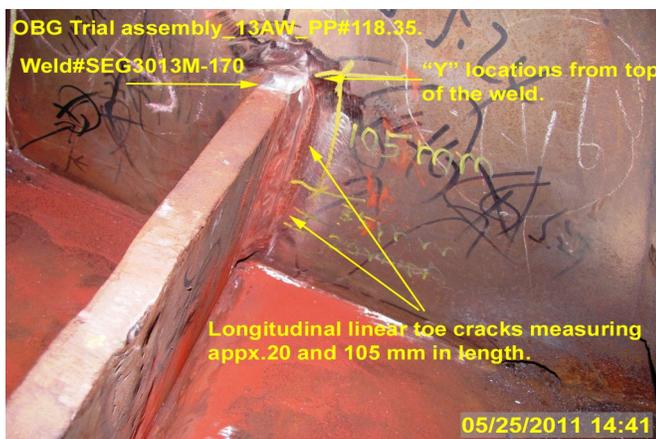
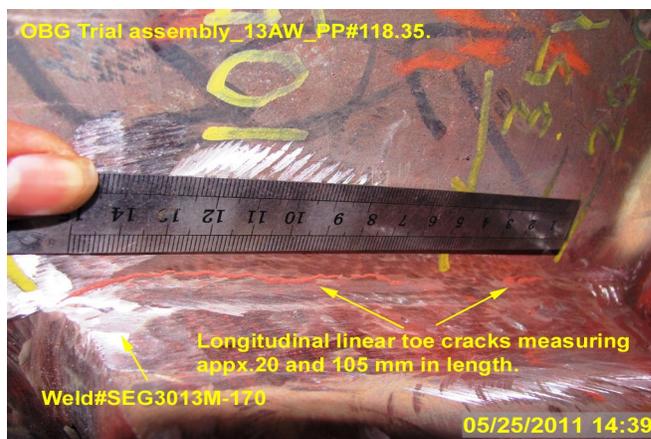
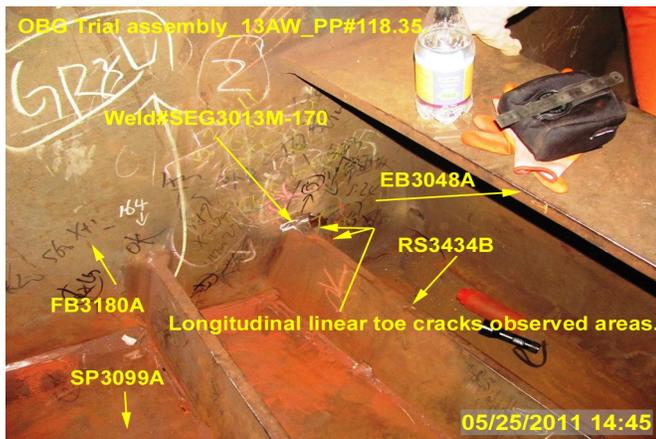
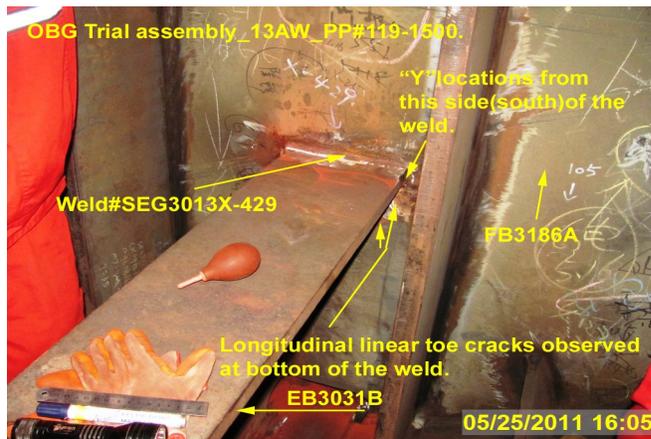
During QA Visual Inspection and MT review of welds located on OBG at panel point 119-1500 and 118.35 cross beam and counter weight side respectively, this QA observed three Longitudinal toe cracks measuring approximately 10~60 mm in length. The weld is identified as: SEG3013X-429. This weld is a Complete joint penetration (CJP) with reinforcement fillet weld joining Edge Beam (EB3031B) to floor beam (FB3186A). The weld is designated as Fracture Critical weld (FCW) on approved shop drawing. The “Y” locations are approximately 50 mm, 120 mm and 180 mm from south end of the weld termination (as shown on picture below). Two Longitudinal toe cracks measuring approximately 30 mm and 105 mm in length. The weld is identified as: SEG3013M-170. This weld is a CJP with reinforcement fillet weld joining floor beam (FB3180A) to “I” stiffener plate (RS3434B). The “Y” locations are approximately 130 mm and 0 mm from top of the weld termination (as shown on picture below). The cracks are clearly marked on the material near the weld. Segment 13AW is currently located in the OBG Trial assembly area.

The Notice of Witness Inspection Number (NWIT) is 09251. The weld no SEG3013X-429 indications are located within an area that has been previously tested and accepted by ZPMC Quality Control (QC) personnel. As per the contract documents, the contractors personnel are required to perform 100% MT inspection of this weld.

The weld no SEG3013M-170 indications are not located within an area that has been previously tested and accepted by ZPMC Quality Control (QC) personnel. As per the contract documents, the contractors personnel are required to perform 25% MT inspection of this lot. These indications were found visually and confirmed by MT. This QA generated an incident report on this date for the above issue, for further information see the incident report and attached photos.
